RISK Assessment® Report

**1 Newport Beach Pier
Newport Beach, CA 92663**

**Confidential Inspection Report
1 Newport Beach Pier
Newport Beach, CA 92663**

Prepared for: City of Newport Beach

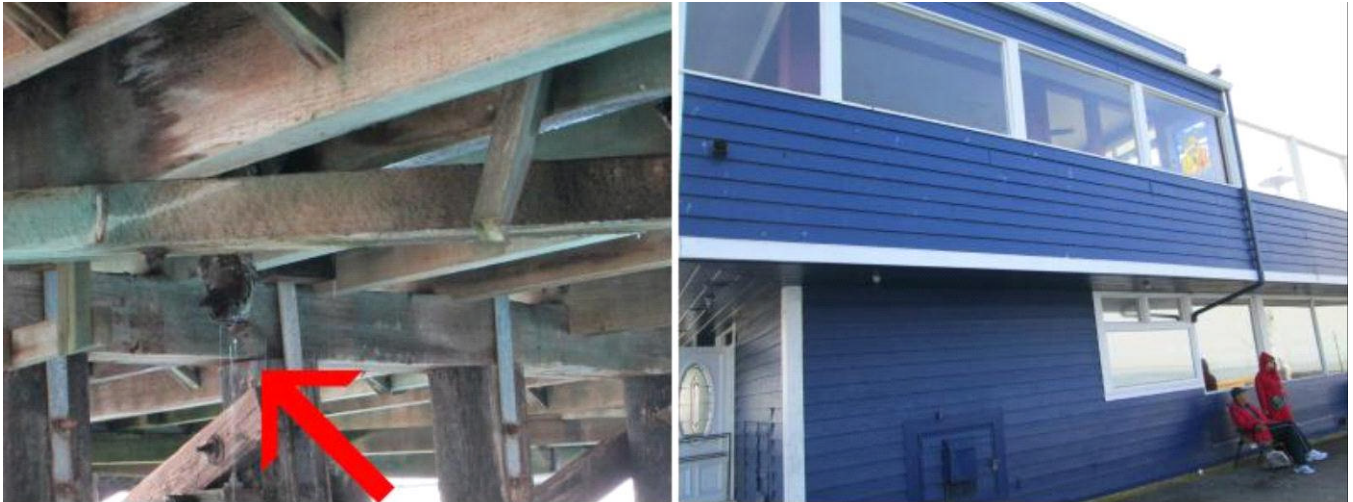
View of leak area under building

The restaurant is an older building which shows age and wear throughout. Moisture intrusion was noted from the roof area down to the foundation. Leaks were noted under the building from pipes which were not visible without actual intrusive investigation.

There is a plumbing leak which is visible from a walkway under the pier floor. The steady stream of water coming down appears to be a fresh water leak and can be coming from supply lines or Fire Sprinkler system pipe. An intrusive inspection needs to be done by a qualified plumbing contractor. Orange Coast Plumbing was contacted as a local Plumbing company and they would be able to do the needed intrusion and repairs of what is leaking.

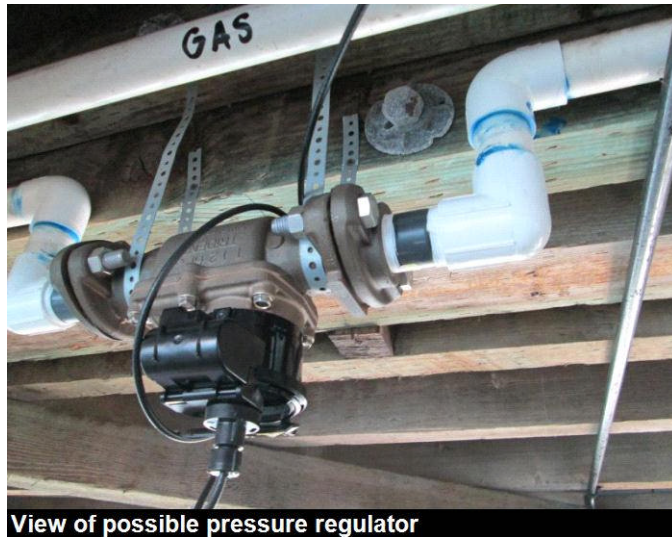
Specialty equipment is installed. What appears to be a pressure regulator looks quite new.

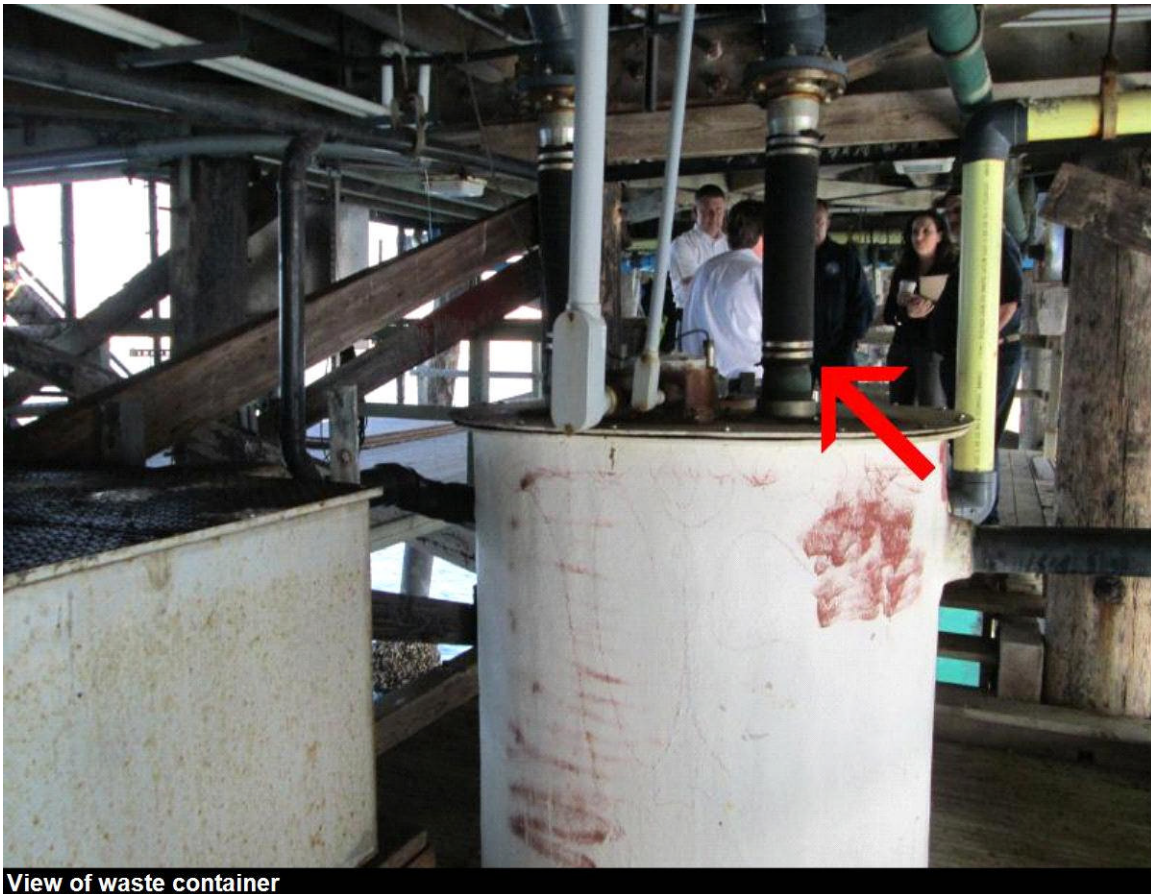
View of waste container

The visible waste lines appear to be serviceable.

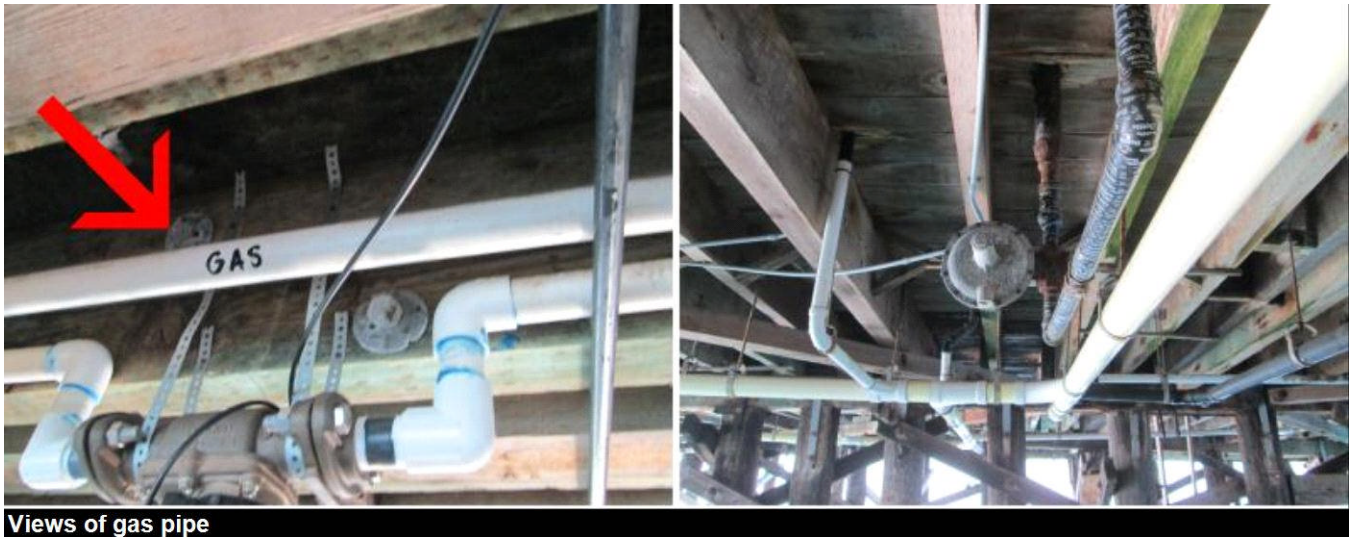
Needs Attention: Gas pipe is a white plastic under the pier and becomes a metal pipe inside the building. Plastic pipe is acceptable for natural gas provided it is the correct type of plastic pipe. The specifications of the plastic pipe need to be ascertained by a licensed plumbing contractor and verification is then needed as to whether this is acceptable. The City of Newport Beach Building and Safety can answer this question if they are given the specifications for the pipe that is currently installed.

Views of gas pipe

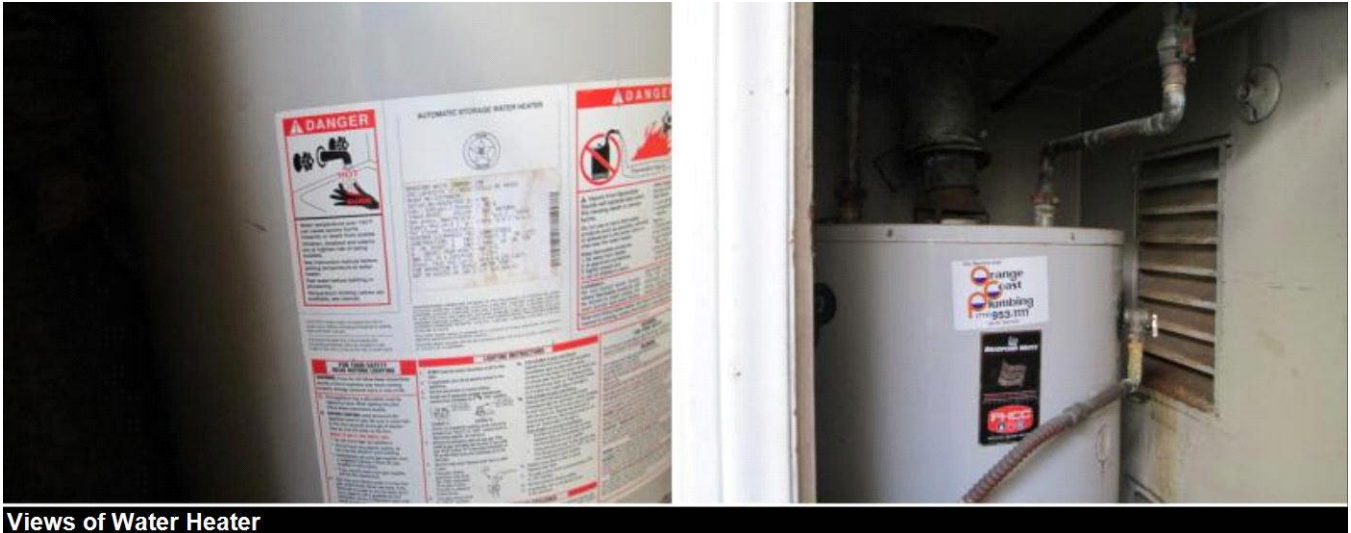
Views of Water Heater

Not tested as utilities are off. Unit appears serviceable however.

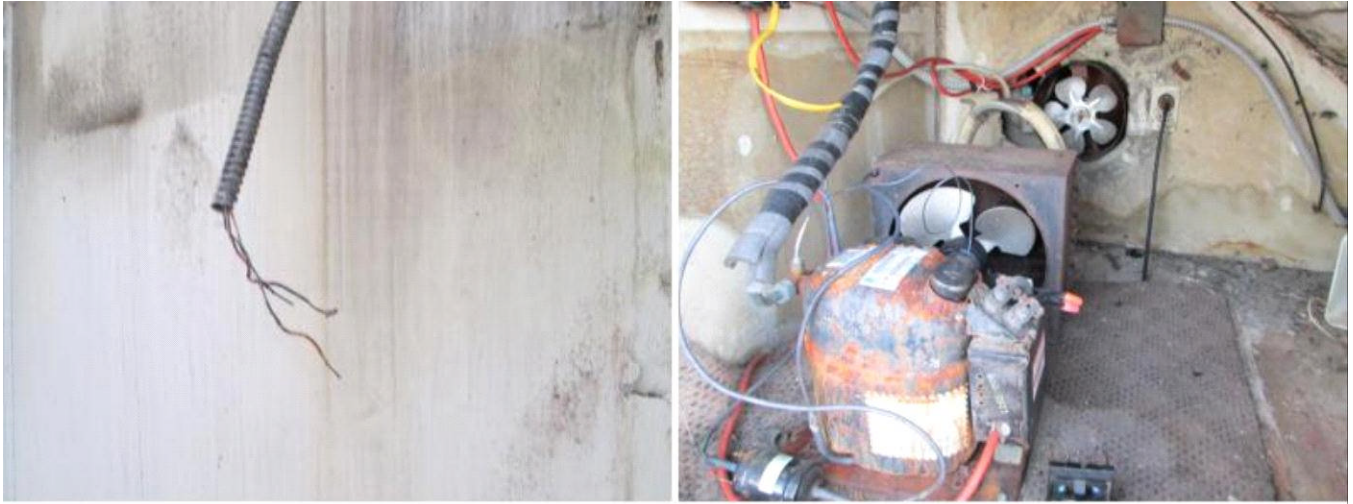
Exposed wiring in areas

Needs Attention: Wiring is exposed in several areas as the front kitchen. All wiring and circuits should be reviewed by a Licensed Electrician to make everything safe and operational.

It is advisable to have an electrician examine the system and make all needed repairs to ensure a properly installed and correctly operating electrical system. This investigation of the system should be done prior to the expiration of the contingency period so the repair or replacement costs are known and unwanted expenses are avoided. It is expected that when the electrical specialist checks out the system they will find more problems as this is a general inspection and not designed to list every fault but to isolate areas in need of further detailed inspections by a specialist

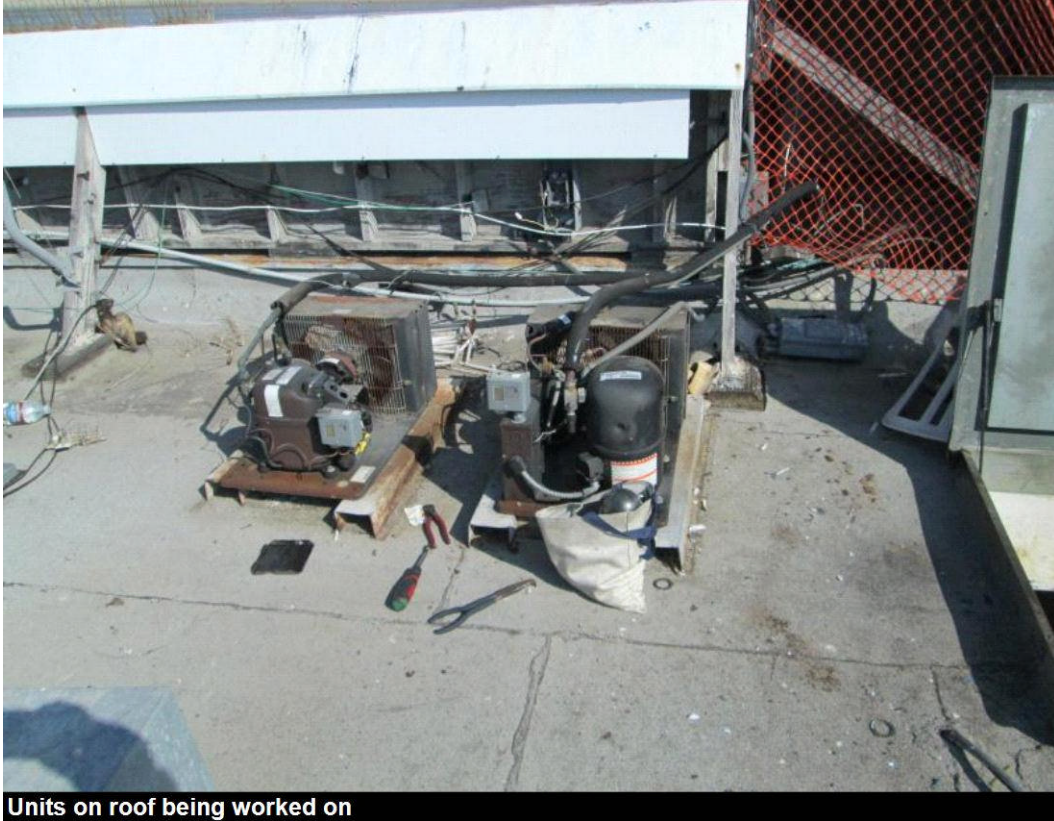
There are Refrigerator and Freezer units in the restaurant which have their own compressors and equipment.

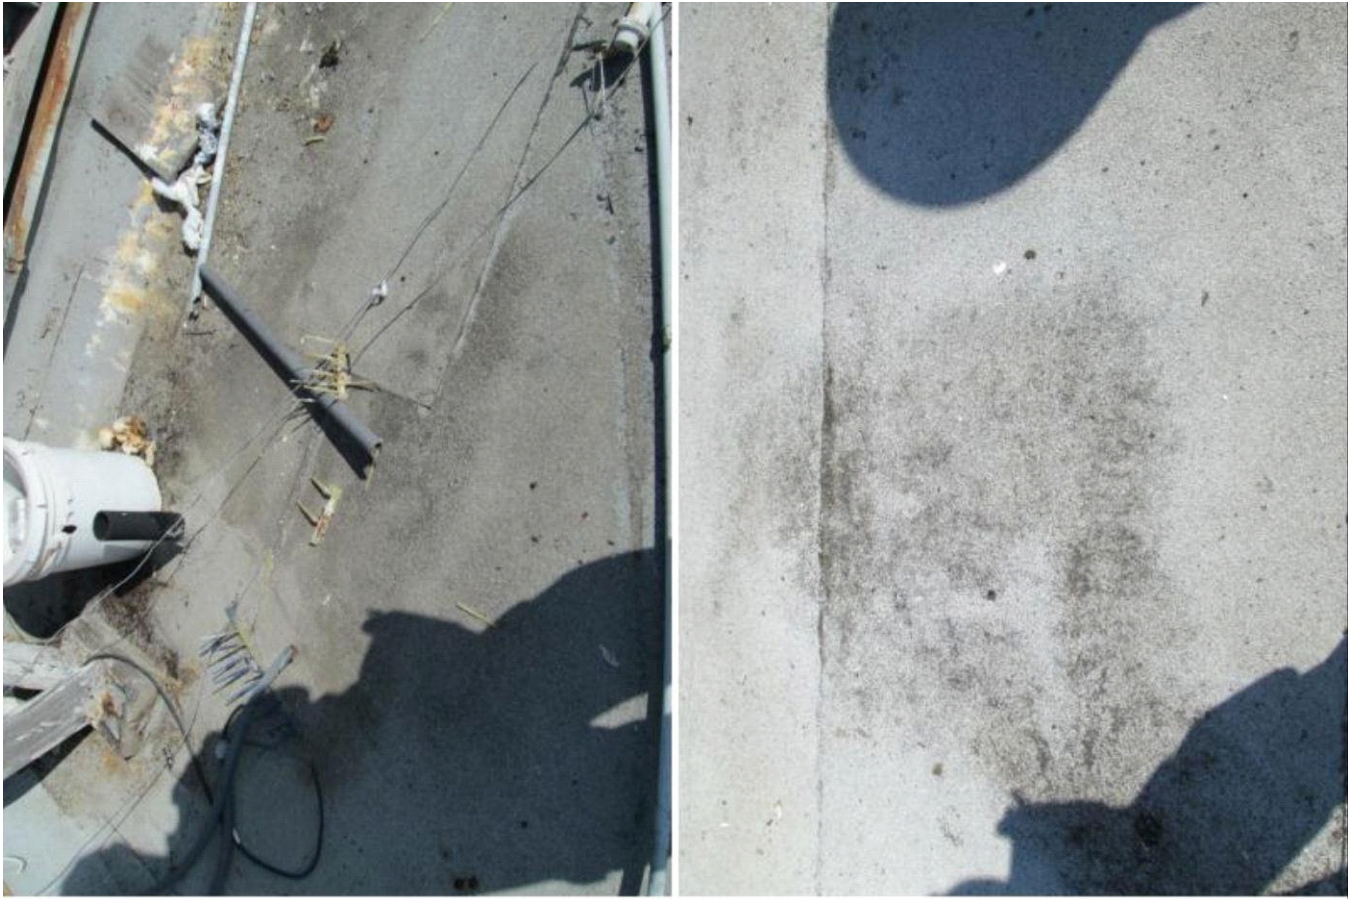
Views of roof

Needs Attention There are areas of wear and deterioration to the roofing material. The roofing system appears to be near or at the end of it's expected useful life.

A licensed roofing contractor should examine the roofing system now and make all needed repairs (or replacements) to ensure a long lasting leak free condition. The roofing contractor may find more problems with the roof. It is for this reason it is being referred to a specialist, as he can determine all the problems and give an accurate estimate of the costs involved.

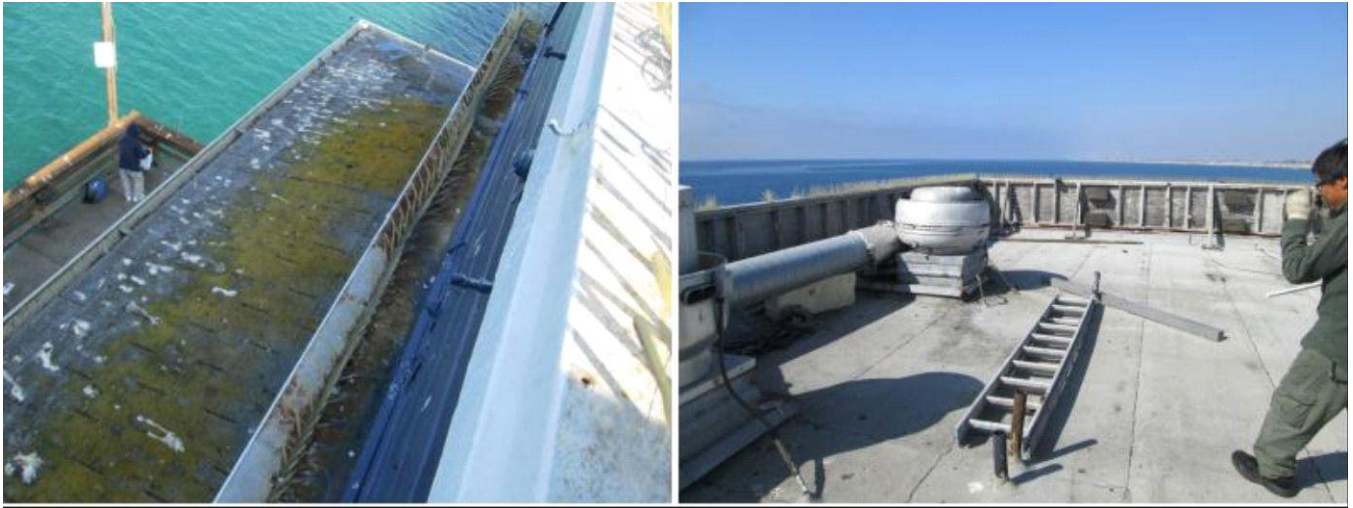
More views of roof

Needs Attention: Lower roof section is old and has moss growing on it.

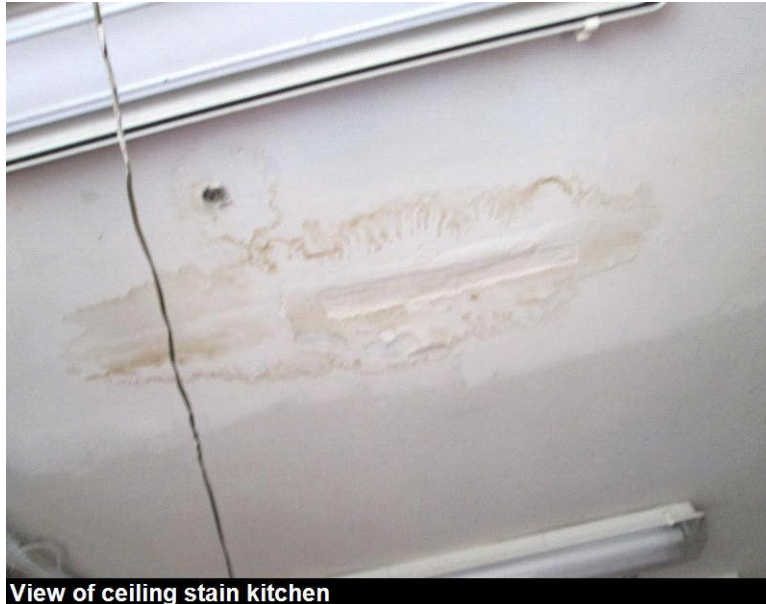
View of ceiling stain kitchen

As noted at the interior portion of the report, there are signs of water intrusion and moisture stains inside the building indicating a history of leaks.

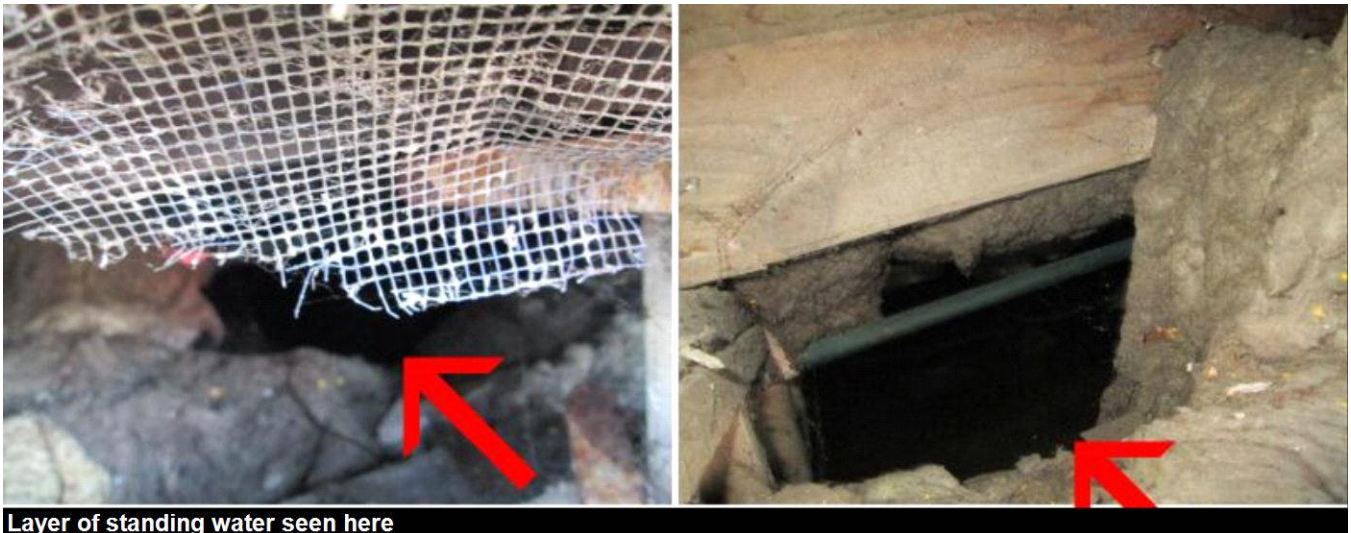
Layer of standing water seen here

Needs Attention: The small crawl space under the building has a layer of standing water which can be seen through the air vents on the North side. Wood framing and footings for the structure are soaked.

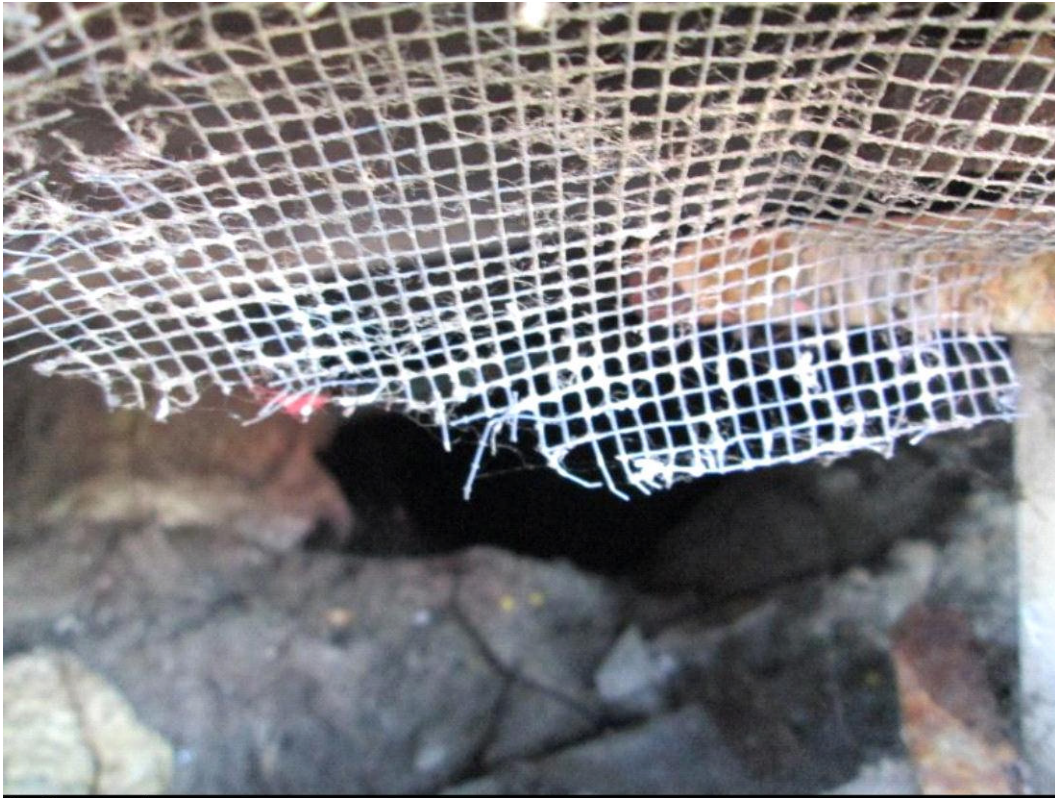
broken vent screen

Needs Attention: Venting appears to be minimal and only on one side. Vents are also rusted and broken.

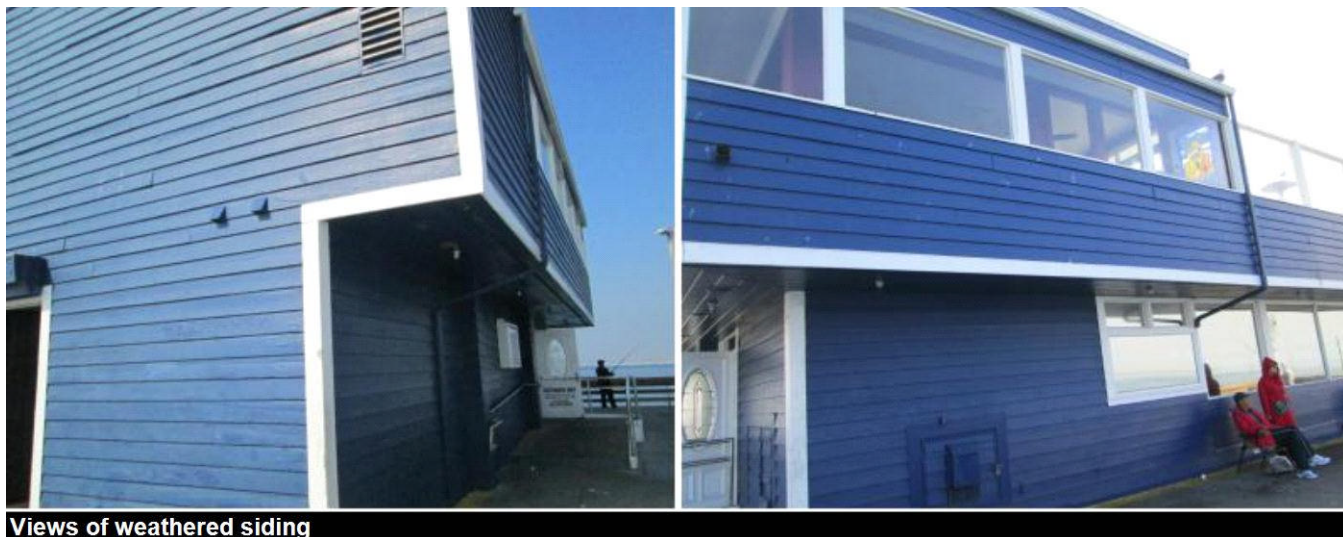
Views of weathered siding

Needs Attention: Siding is broken and decayed in some areas though painted with multiple layers.

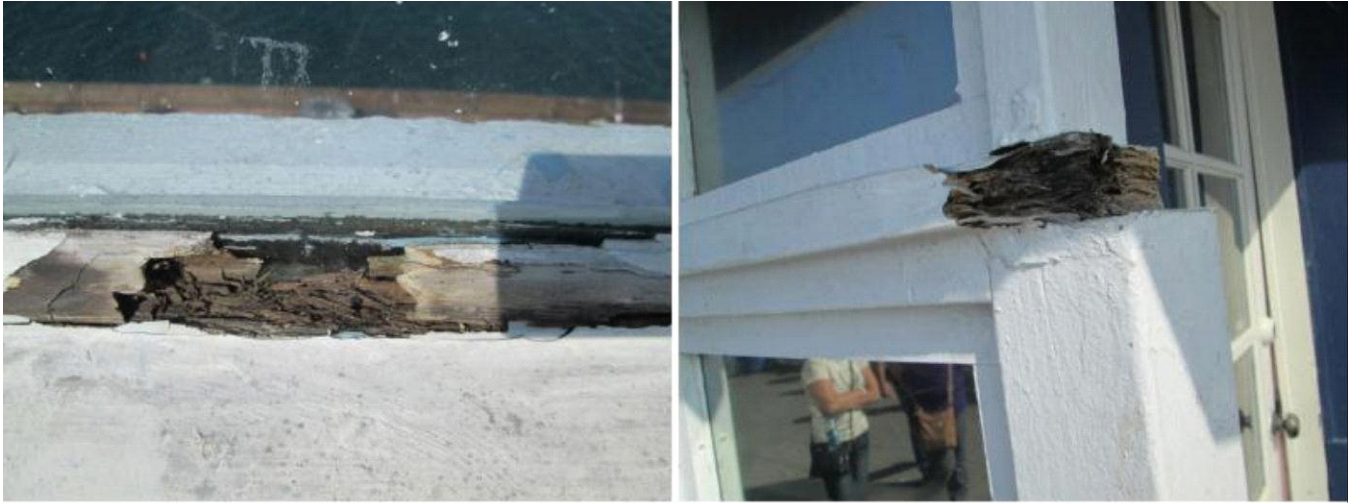
View of rotten trim

Needs Attention there are areas of damage to the exterior of the windows. Also wood trim has termite evidence on the upper balcony.

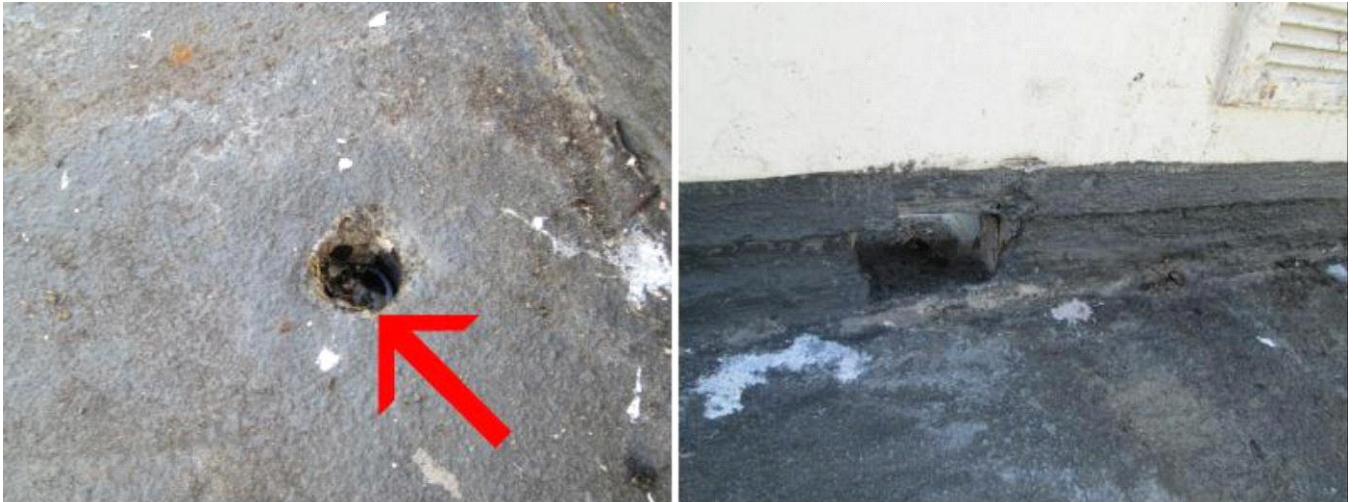
Deck drain is clogged & full water

Needs Attention There are Damaged Areas of the decking especially around the drain holes where the floor is spongy.

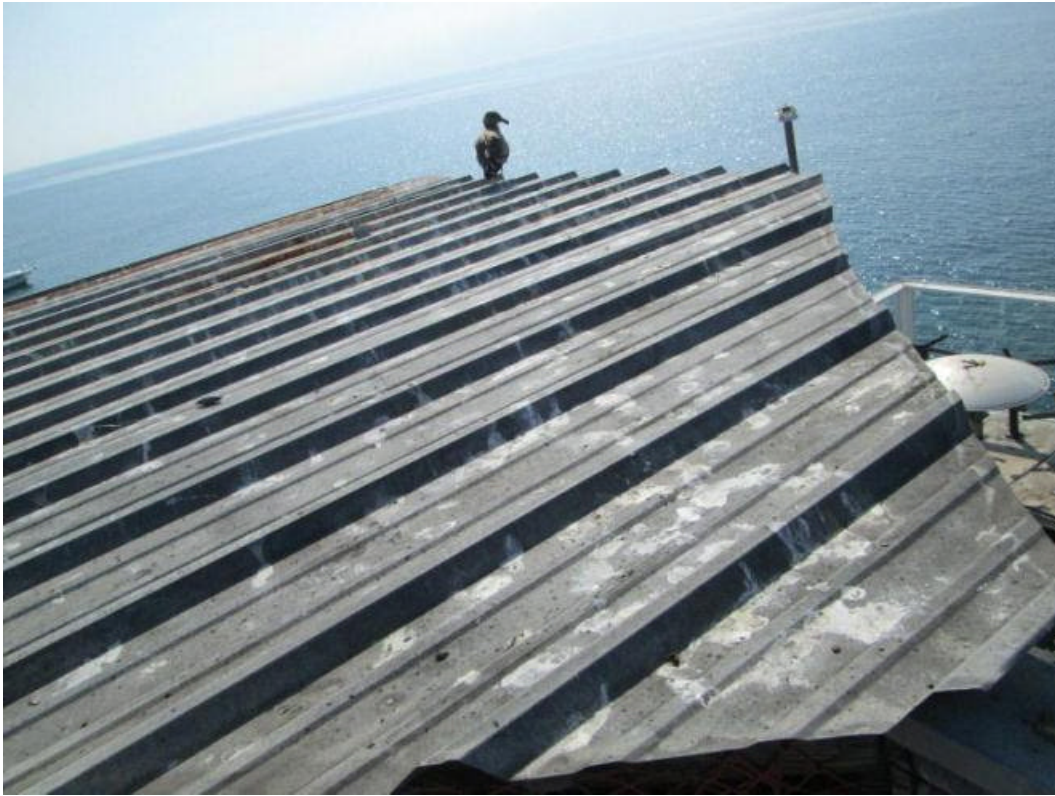
The patio cover is a lightweight metal design

Serviceable but showing typical wear.

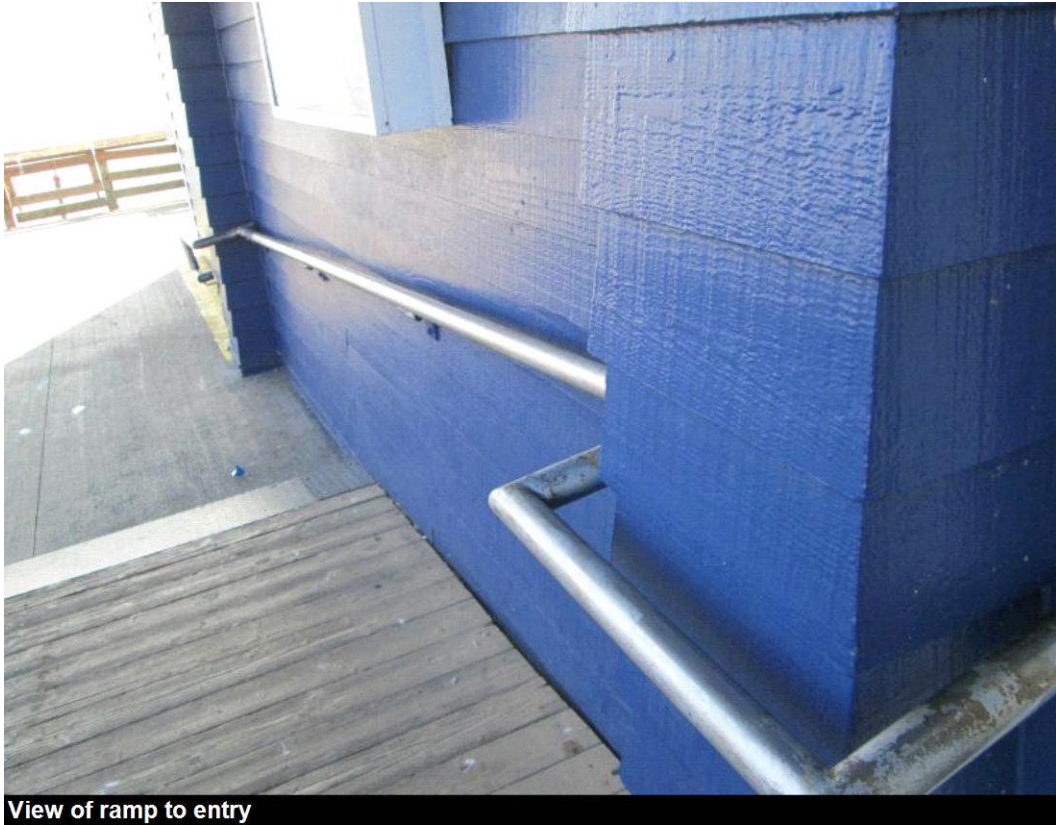
View of ramp to entry

Needs Attention: Ramp needs some repair for handi-cap access

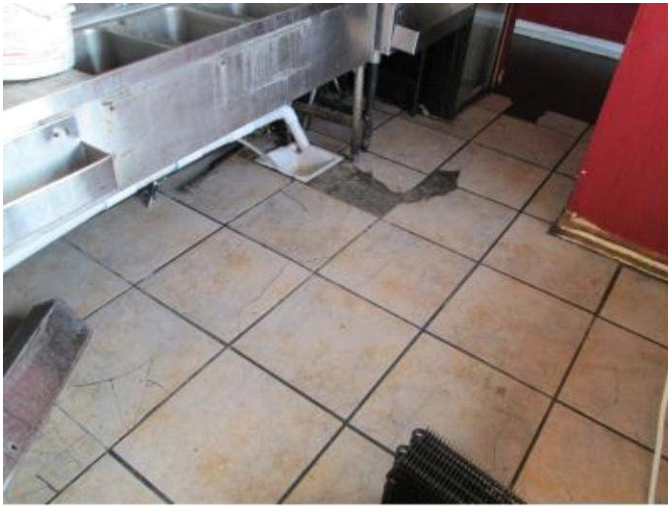
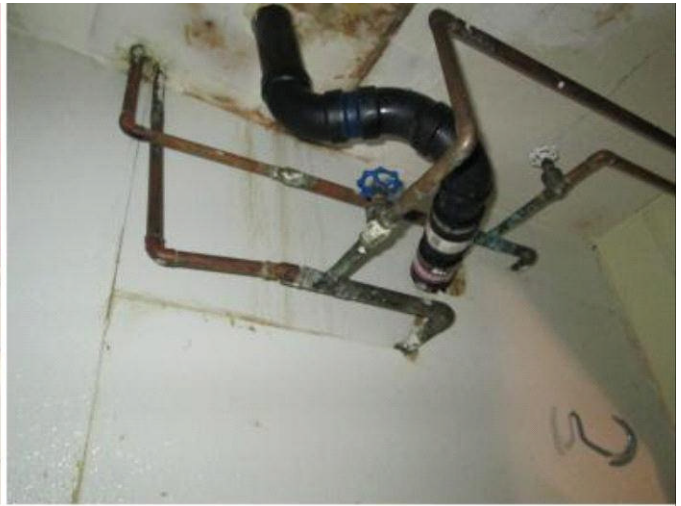
Kitchens need full clean up/repair

Not Acceptable: This kitchen is showing excessive wear.

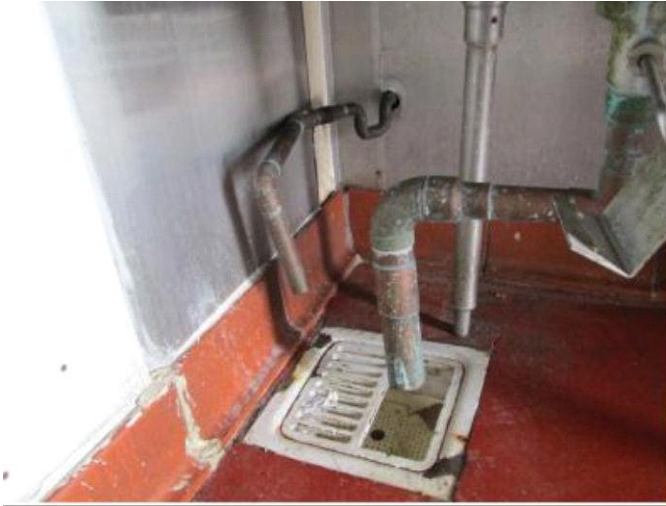
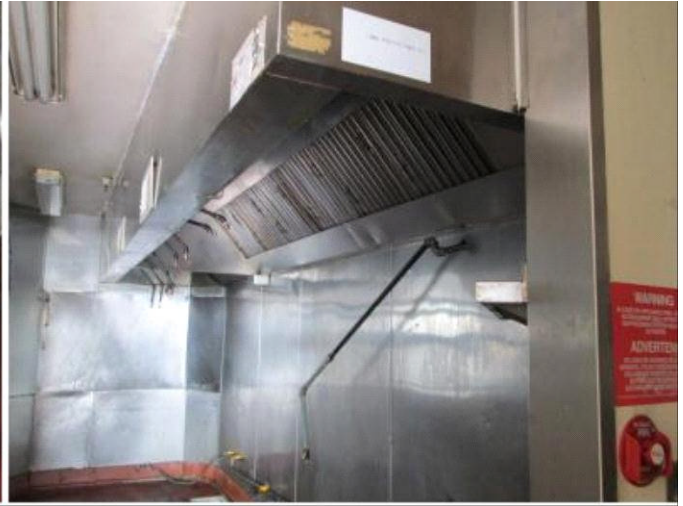
Views of kitchen equipment

The stainless steel equipment appeared aged and worn however it appeared overall serviceable.

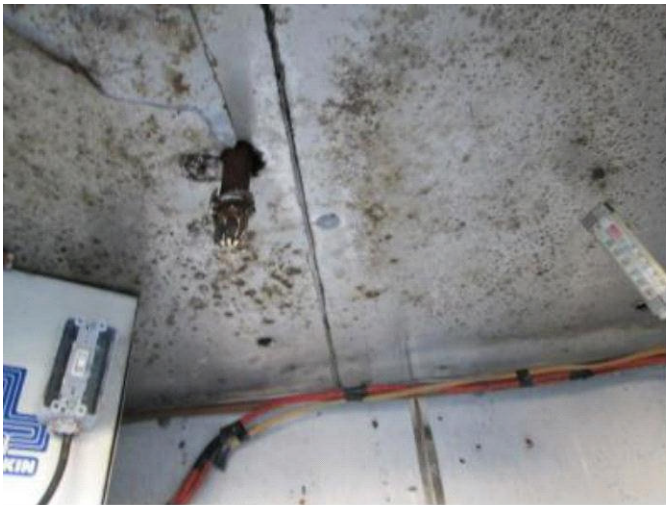
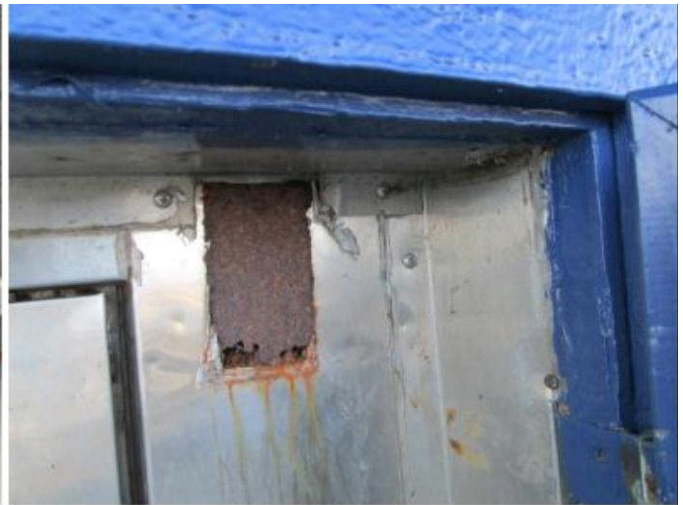
Views inside refer equipment

Needs Attention: The Walk-in Freezer and Reefer plus the smaller refrigerator with the entry door on the floor of the pier are empty and have mold-like substance on the surfaces. They need to be cleaned and serviced possibly needing an acid wash to ensure they meet health dept standards. However, this being accomplished, they appear to be aged and worn but , overall, in serviceable condition.

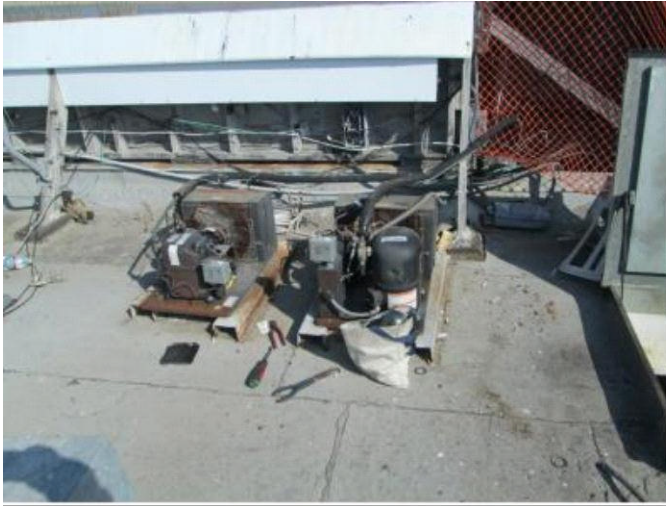
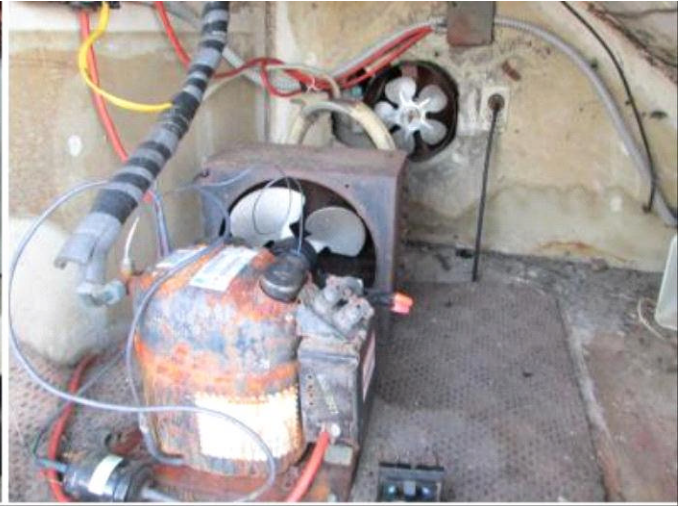
Views of refrigeration equipment

Needs Attention: Compressor equipment which services the kitchen Refrigeration, is old and worn. They will need to be inspected by specialists in Refrigeration to determine their remaining lifespan. A serviceman was there during the inspection and was doing some work on them, it appeared.

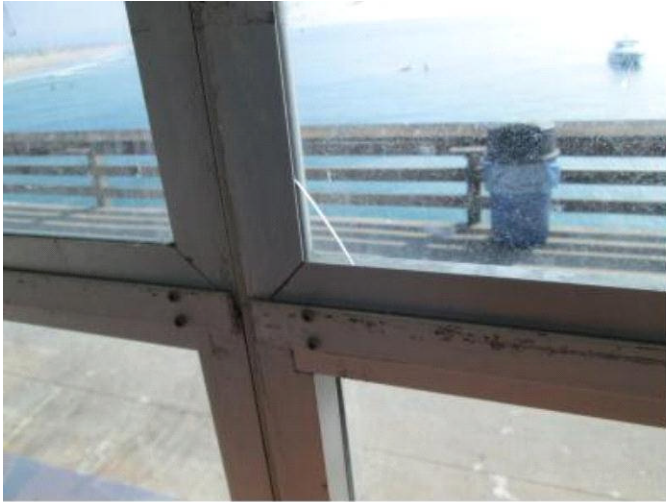
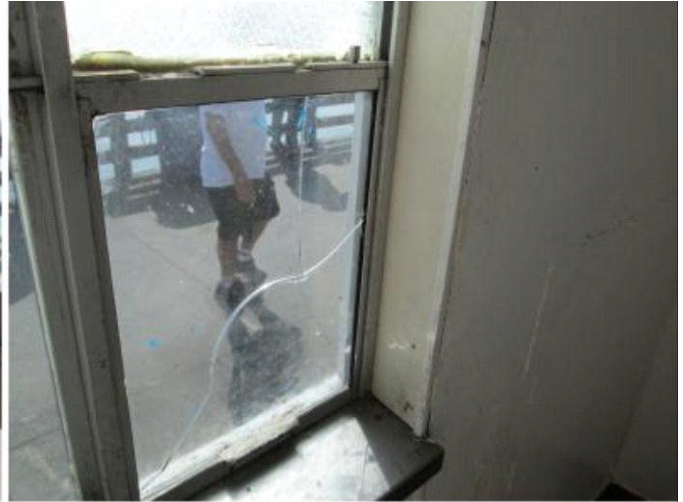
Views of broken glass

Needs Attention: Windows are broken in some places. Also they are plexi in some glass in other places.

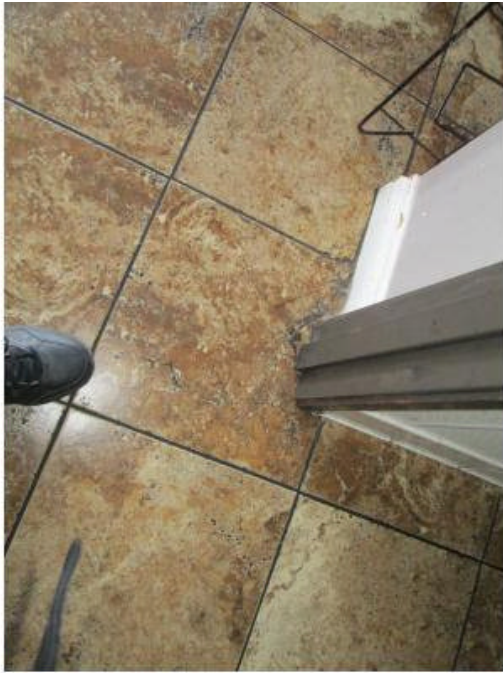
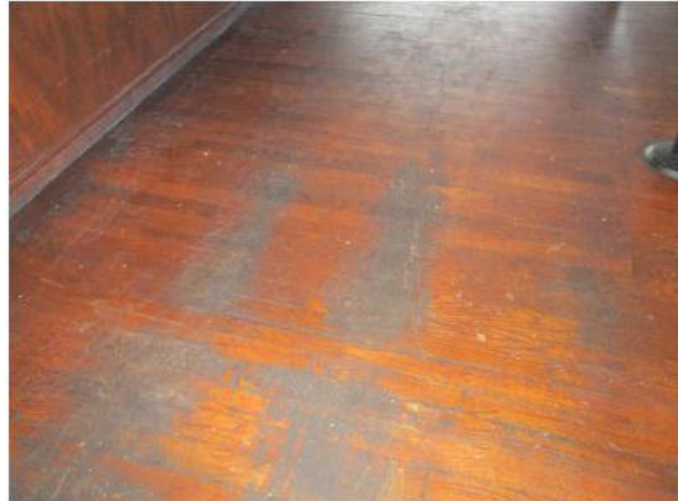
Needs Attention there are areas of cracked floor tiles and un-even surfaces.

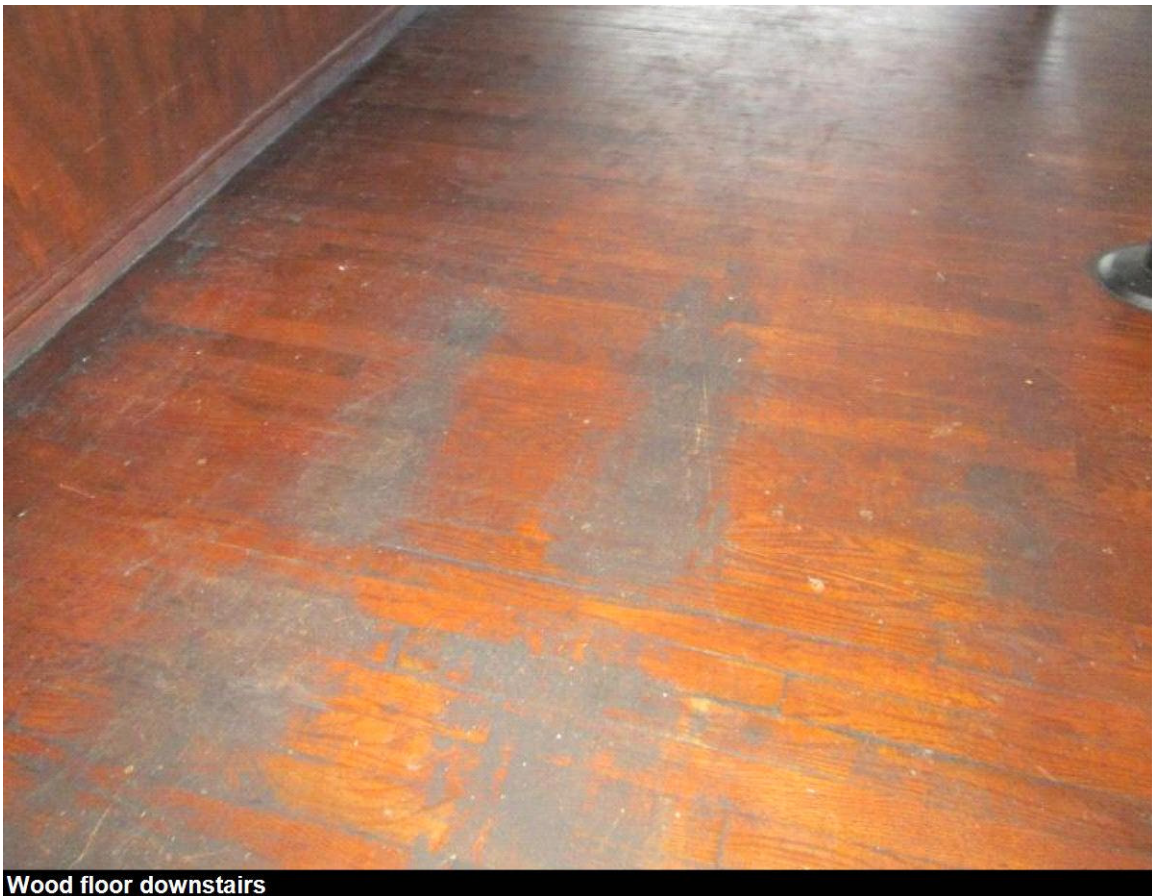
Wood floor downstairs

Needs Attention: Flooring in the retail area downstairs is a wooden floor which has ripples and waves in it. It may need to be replaced completely or at least extensively repaired.

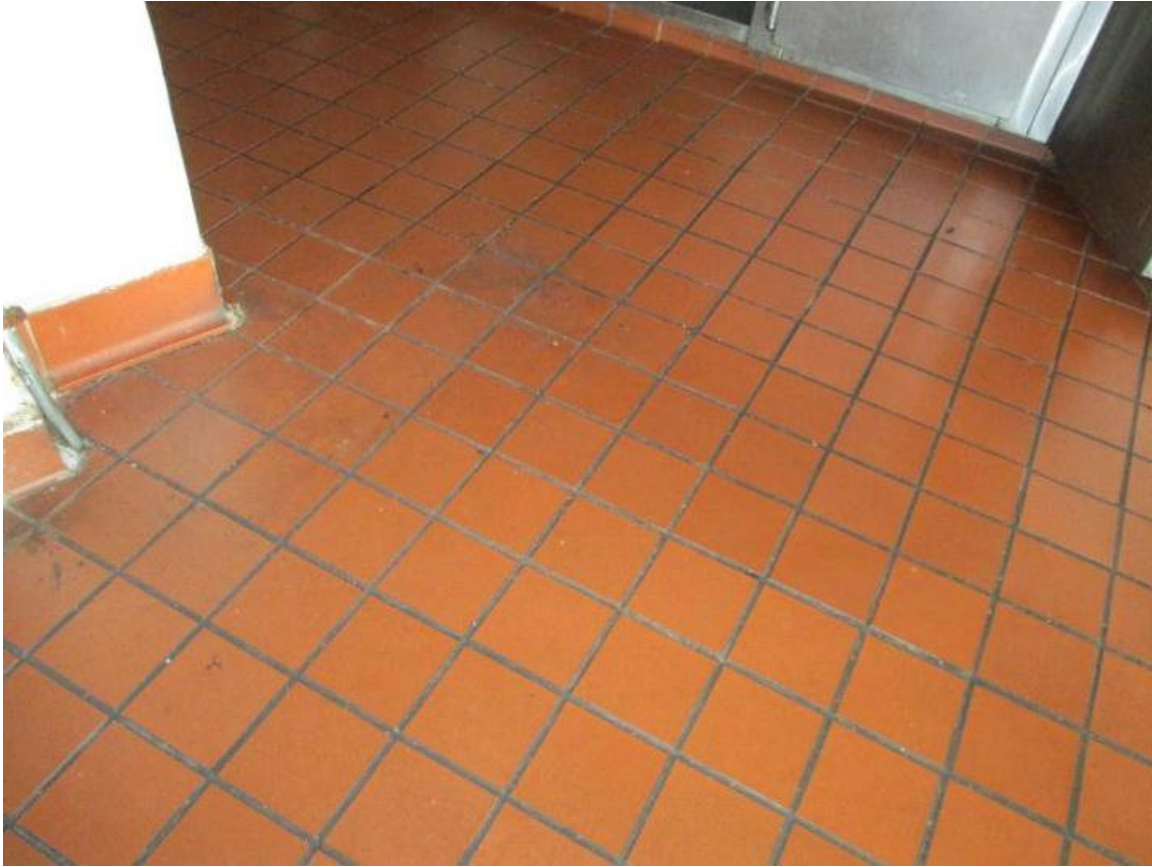
Needs Attention: Tile floor in kitchen is mostly serviceable.

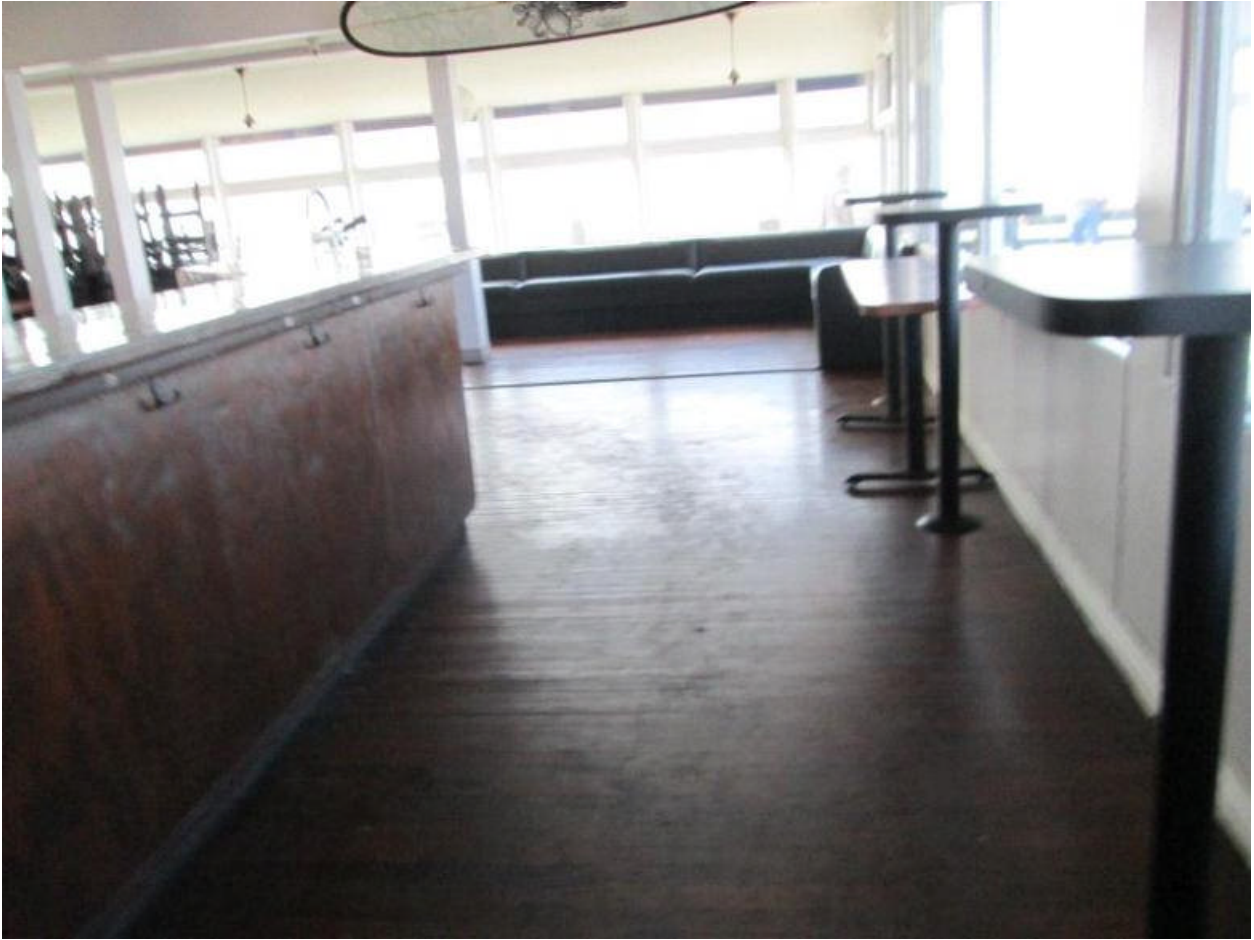
Upstairs ,The general condition of the flooring appears serviceable in the retail area.

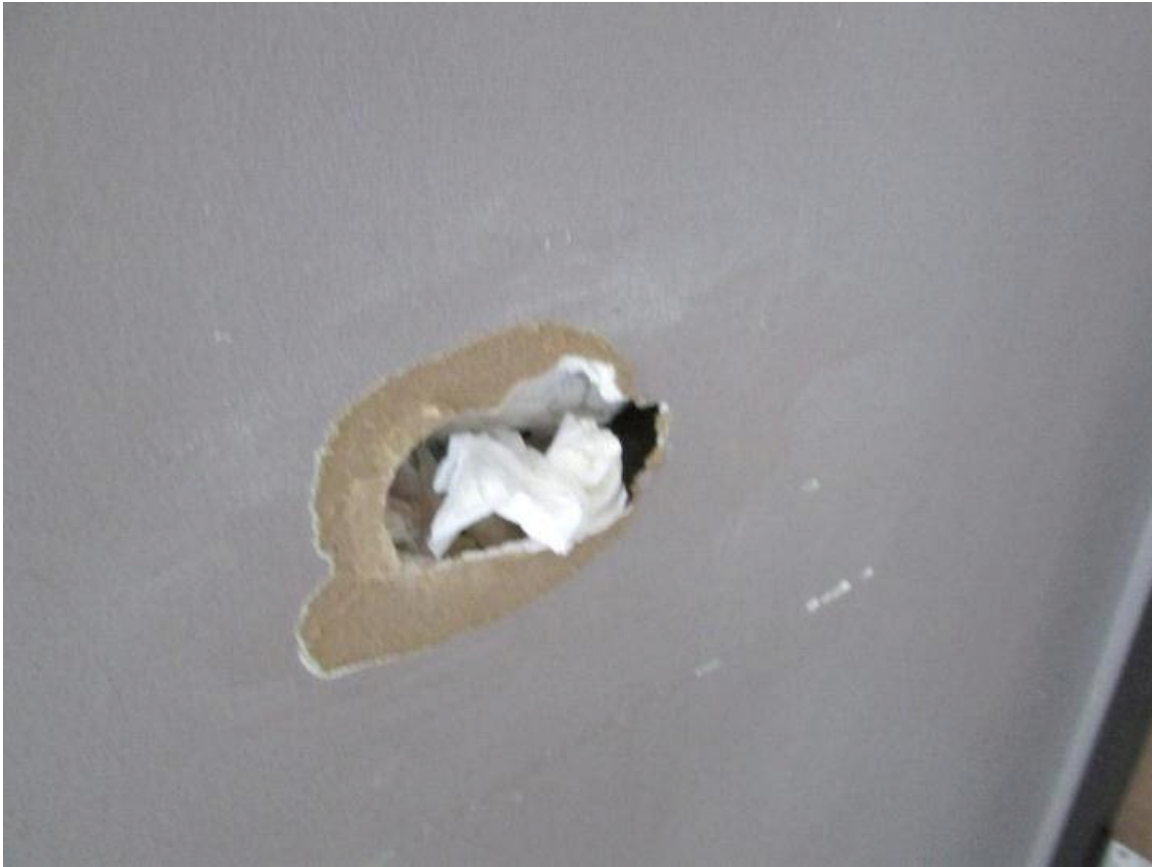
Needs Attention: Walls have damages in areas such as near the entry. Serviceable
