RISK Assessment® Report

**1 Newport Beach Pier
Newport Beach, CA 92663**

**Confidential Inspection Report
1 Newport Beach Pier
Newport Beach, CA 92663**

Prepared for: City of Newport Beach

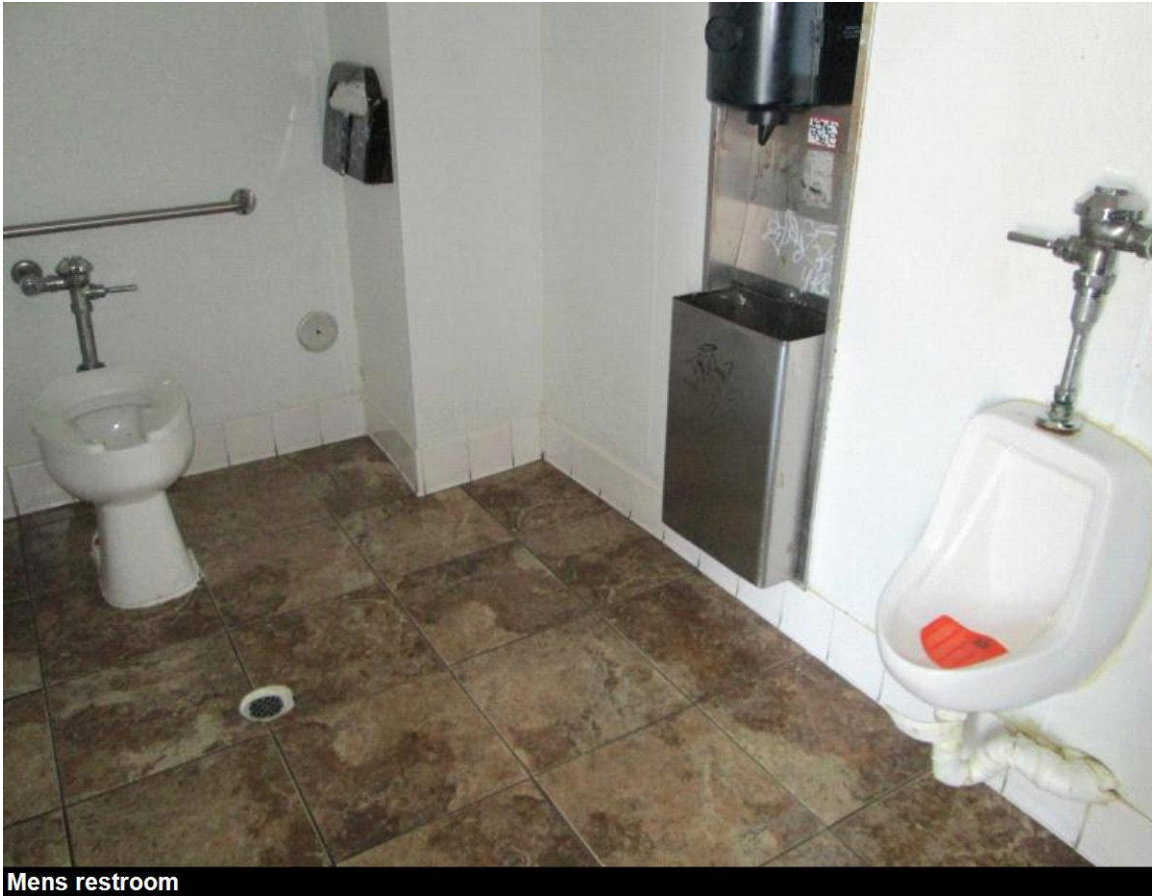
Mens restroom

Needs Attention: Men's Restroom has one urinal, one sink and one toilet. They are aged and worn. They do have handi-cap bars installed.

The floors tile is loose and needs repair.

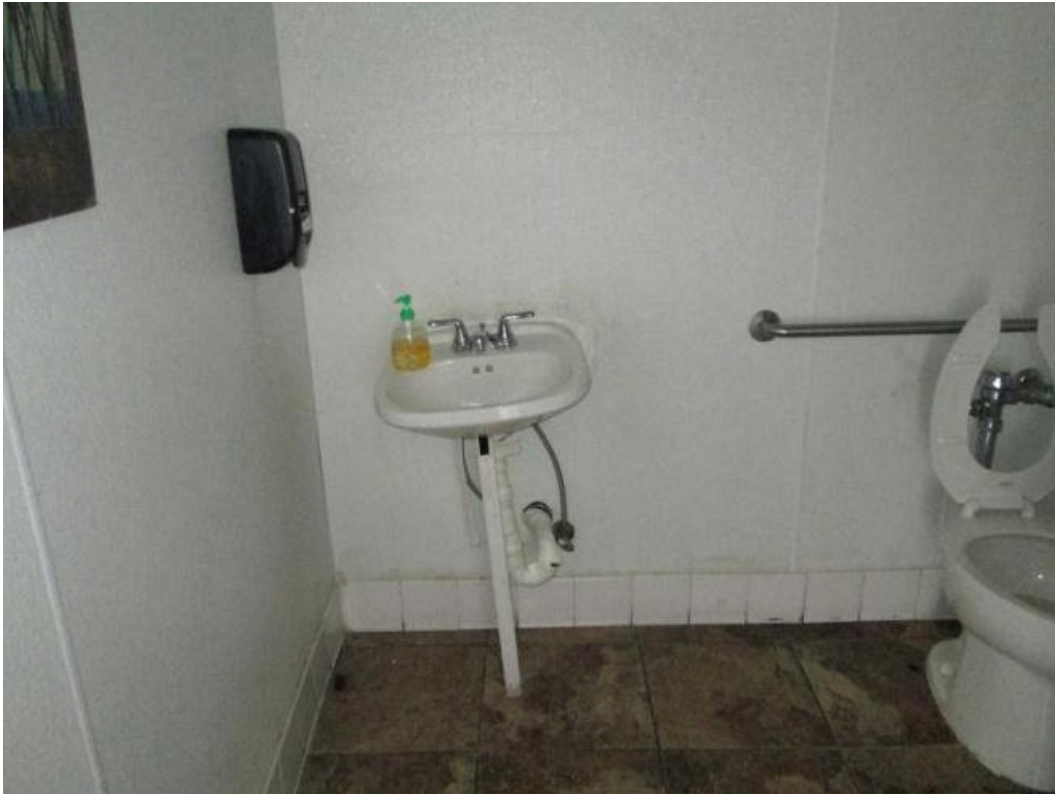
Needs Attention: Sink in the Women's restroom is leaning and not well attached to the wall. There is one sink and one toilet.

The flooring is loose and needs repair.
