**Subject: City of Newport Beach Balboa Island Coping Repair Project (C-7066-1)**

**PROPOSED PROJECT:** Balboa Island Seawall Coping Repair Project

Repair and maintenance of existing seawalls, and increase  
height of seawalls by 9 inches.

# Bulkhead Condition Report for Portions of the Balboa Island Seawall

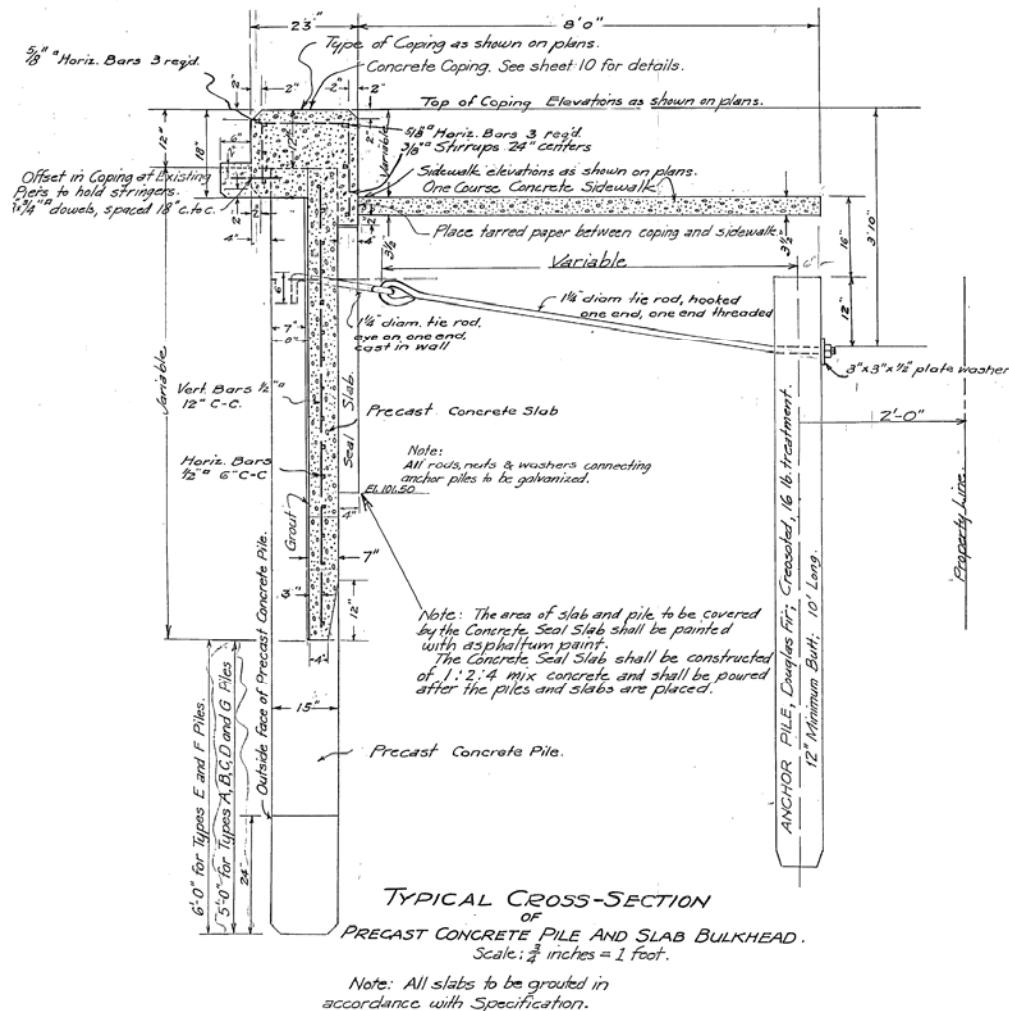
Figure 1 - Original Seawall Construction, 1938

According to a Cash & Associates Report (C&A, 2005), the current bulkhead for the majority of the perimeter of the island was rebuilt circa 1938 using plans completed a few years earlier (Newport Beach, 1935). The design utilized precast soldier concrete piles spaced typically at 11 ft – 8 in. on-center, with precast concrete in-fill panels between the piles. The soldier piles were restrained at the top with 1¼" steel tie-back rods anchored to Douglas fir timber pile dead men. Figure 1, taken from the original drawings, shows the typical cross-section of the seawall.

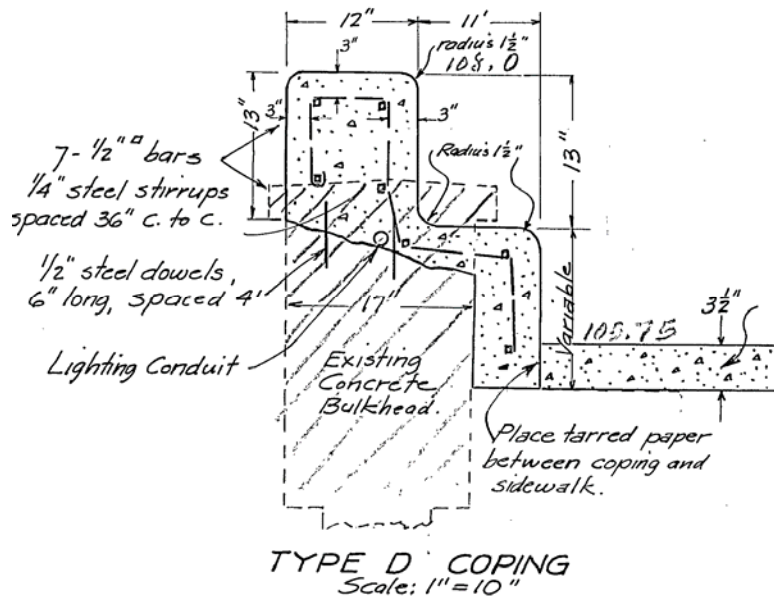
Figure 2 - Existing Seawall Incorporated into Project

Previously constructed timber bulkheads were replaced by this project. However, a 500 ft reach of the then pre-existing concrete sheet pile wall at the west end of the island (between Emerald Avenue at Bayfront South and Park Avenue) was incorporated "as is", with just a partial

replacement of the coping to match the rest of the project. Apparently, this wall was constructed in the mid-1920's, and evidently was considered sufficiently adequate to be incorporated into the project in lieu of removal and reconstruction. Figure 2, taken from the original drawings, shows the 1920's wall with the new coping.

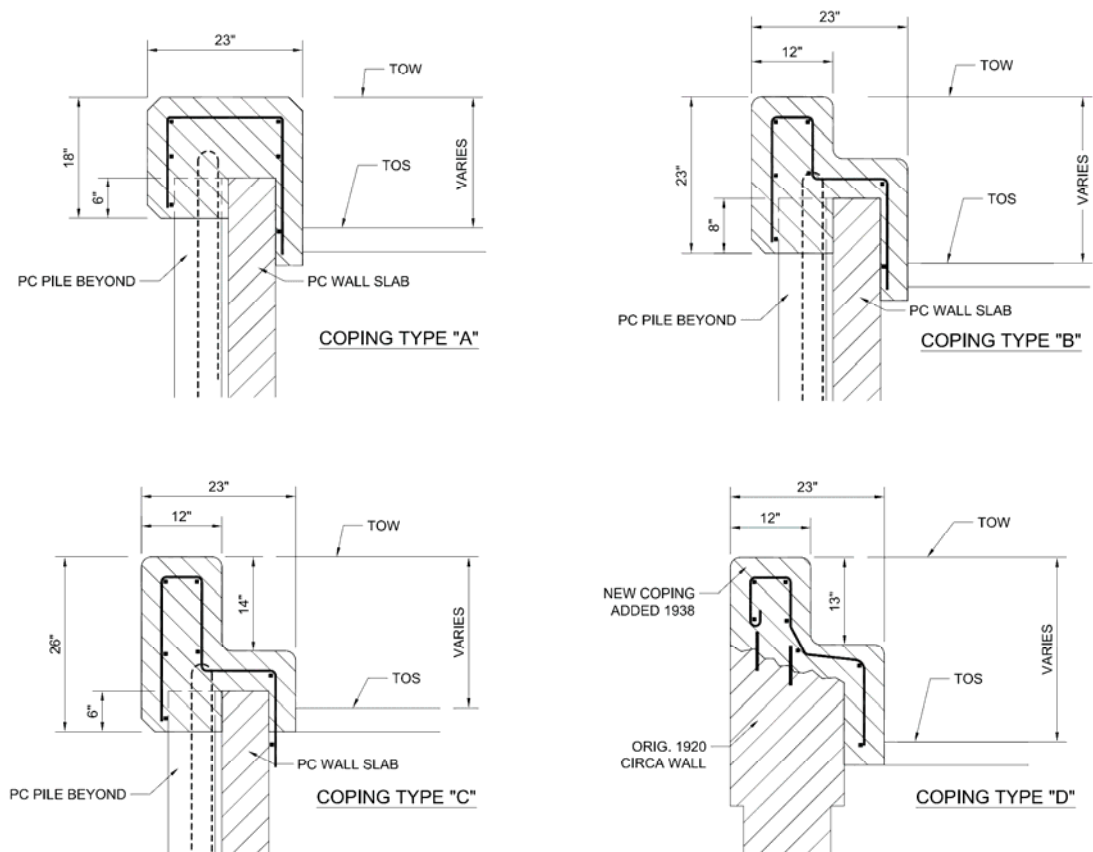
Figure 3 - Coping cross-sections, A, B, C, and D

As mentioned in previous reports and confirmed herein, there is no positive connection between the top of the 1938 precast wall planks (slabs) and cast-in-place coping. As shown below (Figure 3), reproduced to scale from the original construction drawings, the only connection is the lifting hook in the precast soldier pile (shown as a dashed line). We cannot be sure that this even exists, as there is the possibility it was burned-off to facilitate driving. In fact, there is a handwritten notation on the current version of the drawings that this hook does not exist for most of the piles. In any case, calculations show that this hook would not be sufficient to transmit all of the lateral loads against the coping into the wall (or more likely the soldier piles) below.

Thus, the coping remains in place due to its own self-weight and any bond value and friction that might develop along the boundary between it and the pre-cast plank, embedded 6 to 8 in. into the coping. Coping type D is unique in that it re-uses an existing wall constructed before the 1938 project, and modifies the existing coping to resemble the other coping types used in the project.

The coping raise will add 9 in. to the height of the walls. To accomplish this, the existing corner chamfers and rounds will be removed and the top of existing coping will be intentionally roughed to create a good bond with the new concrete. When found, any loose and deteriorated concrete will be removed to sound concrete. Next hooked rebar dowels will be drilled and grouted into the top of the existing concrete. Continuous rebar will be placed along the top, and the new raise will be poured. The positive connection between the coping and the piles below is made by extending one of the dowel holes that falls over each pile an additional 2 ft or so, through the cap and into the pile underneath. A singular, larger and longer dowel is grouted in place.

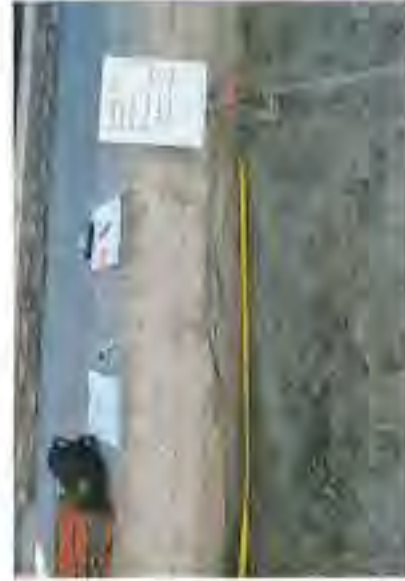
North Bay Front, 40' East of Pearl

| Item Location | Description |
|---|---|
| 9 General Notes | Shrinkage cracks at 10' o.c. nothing serious, seawall is straight and in good condition |
