4 SEAWALL CONDITION ASSESSMENT

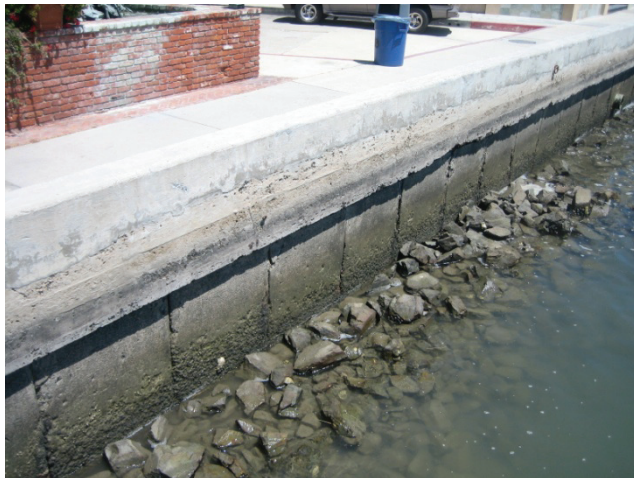
The 1985 Report prompted the City to stabilize the toe of the seawall at four critical locations around the Island by constructing rock revetments as shown in Figure 4.1. Observations also noted a separate seawall stabilization project performed along the seawall east of the Balboa Island Ferry Boat Landing. Earth anchors were installed, as shown in Figure 4.2, and a submerged concrete block revetment was placed at the toe of the seawall.

**Figure 4.1 Rock Revetment Stabilization
at Western End of Balboa Island**

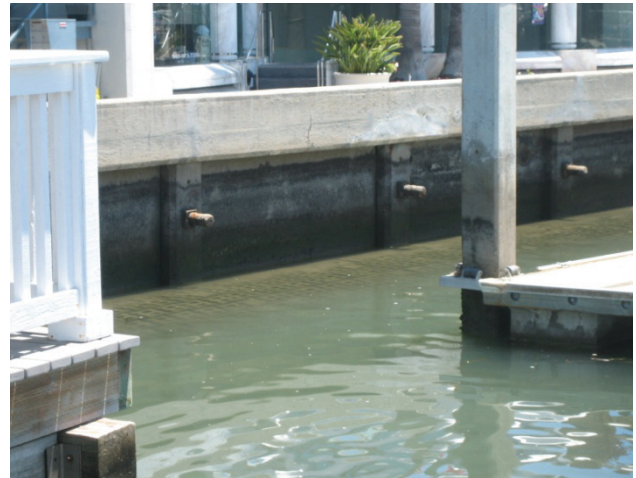
**Figure 4.2 Earth Anchors and Concrete
Block Revetment (Submerged) at Balboa Island
Ferry Boat Landing**

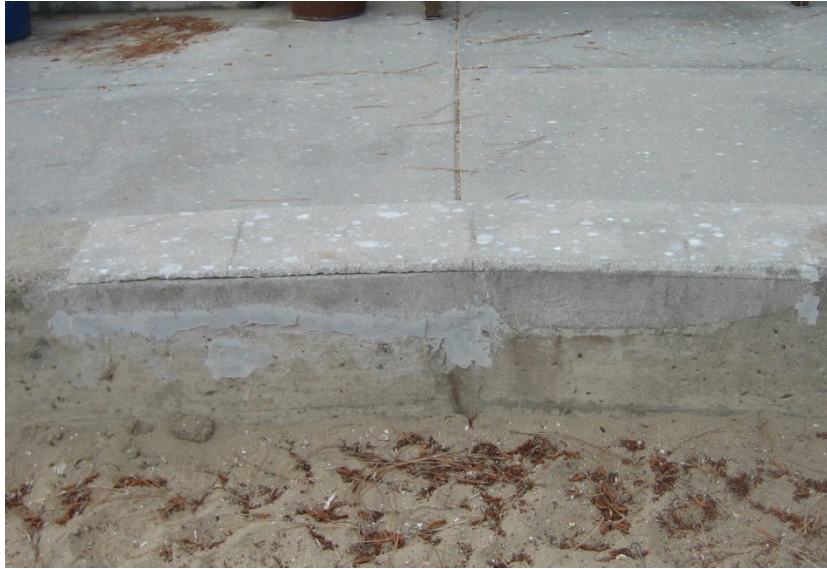
The City also responded by pursuing a repair and maintenance program. Most of the noted distresses in the seawall cap and soldier piles were repaired. An example of a typical repair is shown in Figure 4.3.

Figure 4.3 Use of Elastomeric Filler to Seal Cracks to Prevent Seawater Intrusion

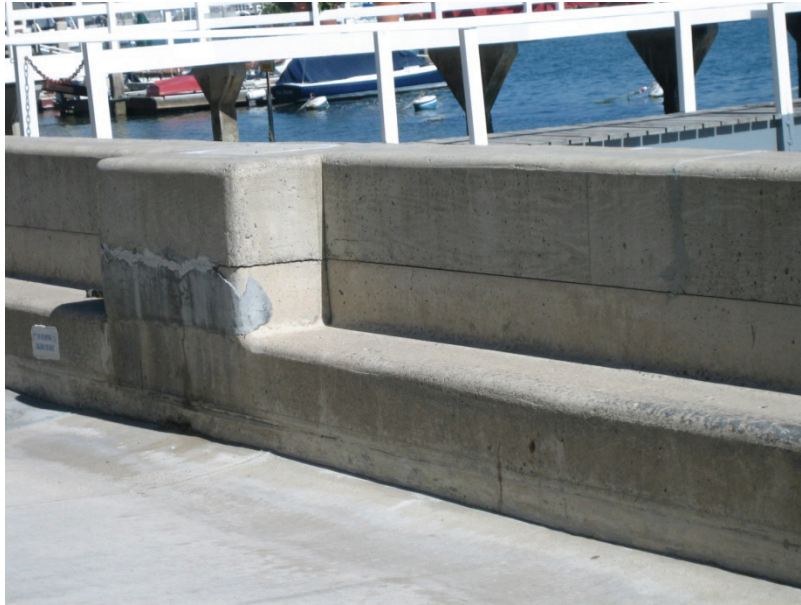
During the visual survey of the seawall, seawall cap extensions were observed in the Little Balboa Island. The extension raises the top of wall elevation by between 6 and 12 inches depending on location around Little Balboa. An example of this cap extension is shown in Figure 4.4. Although this extension provides a defense against high water events, the limited remaining useful life and the existing condition of the underlying seawall make further extensions questionable.

Figure 4.4 Little Balboa Seawall Cap Extension

If a mechanical extension (Alternative 2, Option 1) of the seawall cap is chosen, there is precedent for an extension of up to 8 inches, since the Little Balboa seawall was previously extended by this amount. This extension is referred to as a mechanical extension because it utilizes rebar dowels to mechanically connect the new extension to the existing cap. First, the top surface of the existing cap would be roughened. Then, the existing cap would be drilled at distances and to depths to be determined pending tests of the existing cap and a

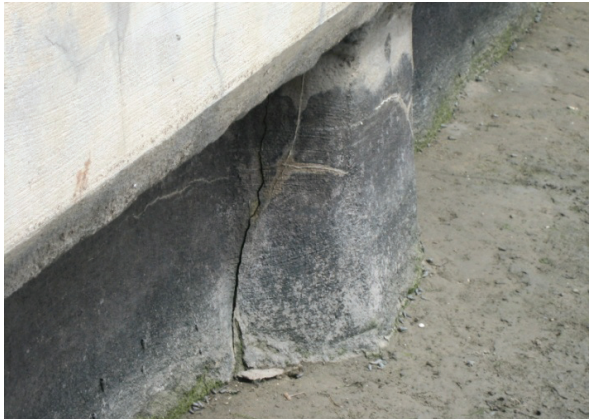
Figure 4.5 Shot-crete on Grand Canal Seawall

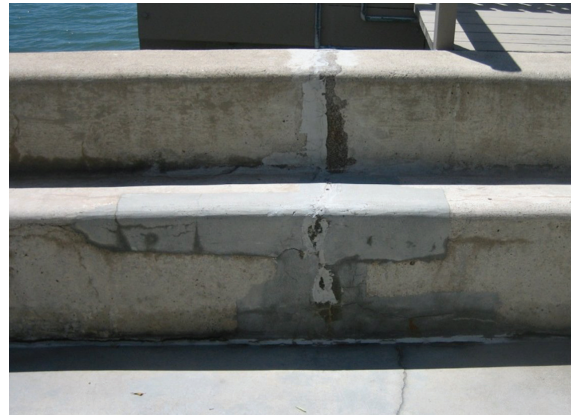
The visual survey also found universal distresses in the cap, specifically multiple cracks, coinciding with the locations of the soldier piles. The development of these cracks at the specific locations of the soldier piles is likely due to a reduced structural cross-section and a concentration of load ultimately relating to concrete stress. Despite a concentration of cracks at the soldier piles, cracking also can be found at many locations along the concrete cap including the structural cap along the Grand Canal. Coupled with similar cracks found on the exposed portions of the soldier piles and panels, the evidence portends to universal distress throughout the seawall. The shot-creted piles and panels along the Grand Canal walls (see Figure 4.5) are of particular concern because the condition of the original concrete is hidden by the shot-crete repairs. Despite repairs to cracks over the years, cracks are still prevalent in the seawall cap (see Figures 4.6 and 4.7).

Figure 4.6 Typical Crack and Spall Repairs

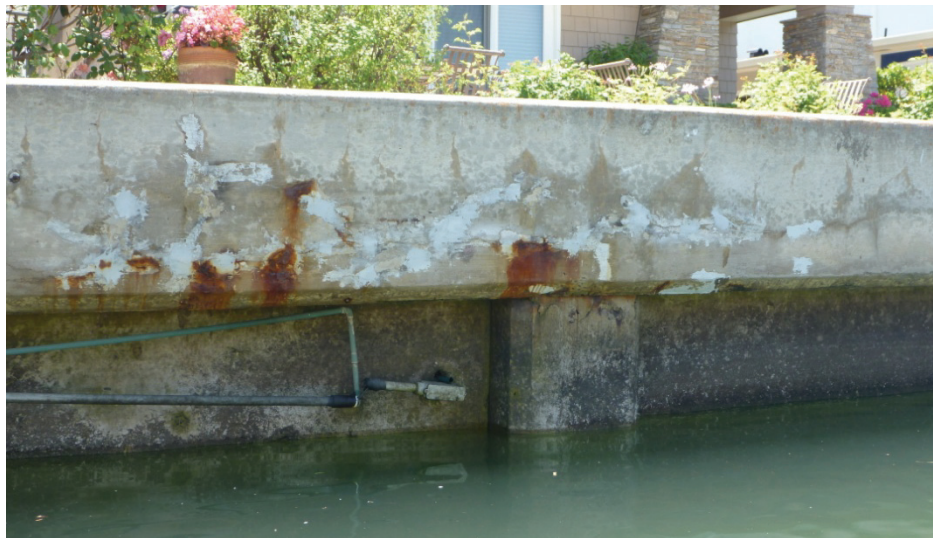
Figure 4.7 Crack Repairs with Corroding Rebar

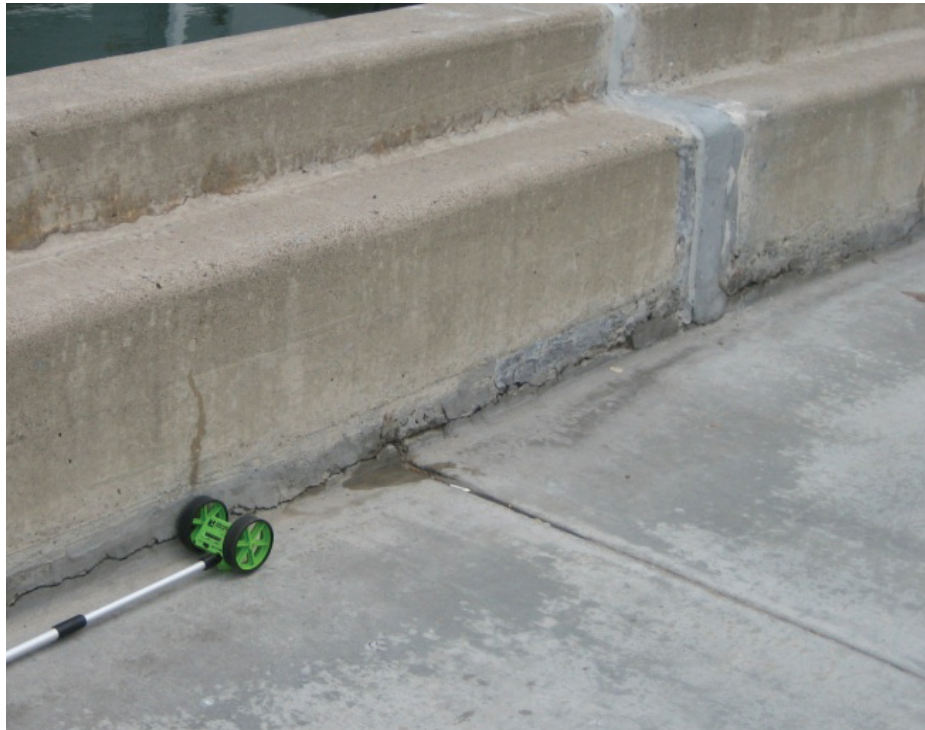
Another common and continuous distress point along the seawall is parallel to and approximately 2 to 4 inches above the boardwalk. As part of the drainage mitigation project performed in the 1980's, the boardwalk was lowered several inches from its original design elevation in order to facilitate drainage away from private properties. This placed the boardwalk below the bottom of the existing cap and it is assumed a patch was done to fill the gap between the boardwalk and the cap. Therefore, the continuous crack appears to be

non-structural and related to the patchwork as shown in Figure 4.8. This assumption should be confirmed as part of a subsequent study.

Figure 4.8 Sidewalk Separation from Seawall

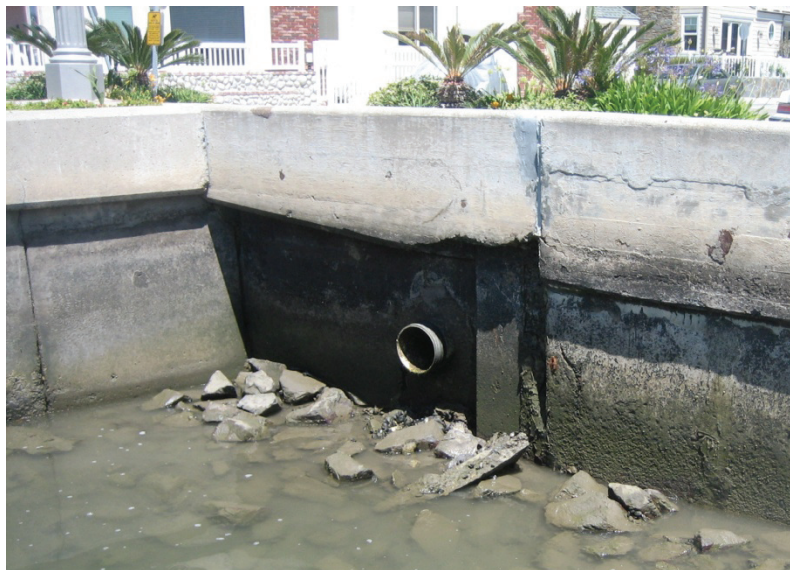
Storm drain outlets that drain through the seawall and into the Bay (see Figure 4.9) have existed for decades at the street ends of Balboa Island, based on the 1935 record drawings and the recent visual survey. In the 1980's as part of the boardwalk reconstruction, a storm water drainage system with 4- to 6-inch diameter drains was constructed landward of and parallel to the seawall. These drains connect to the City's storm drain system outlets at the street ends and were designed to keep water from ponding along the seawall and from spilling onto private property.

Figure 4.9 Storm Drain Outlet Through Seawall

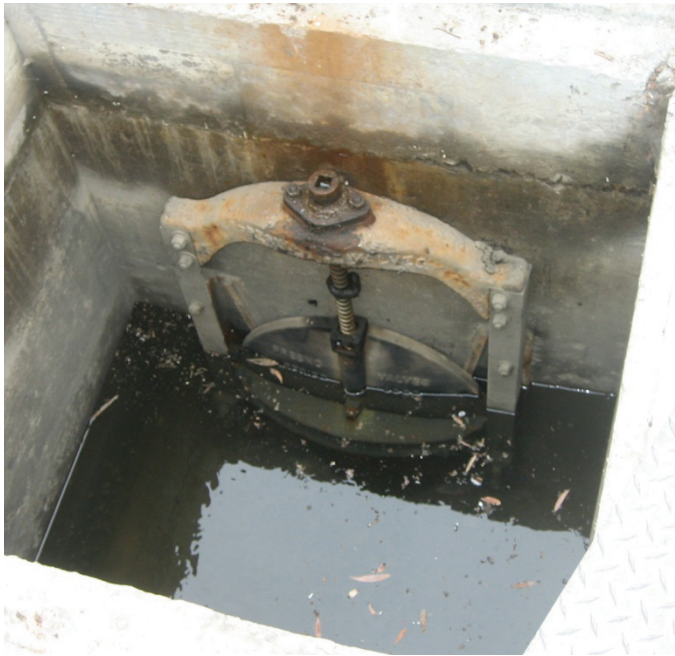
This drainage system would not have functioned without the installation of gate valves at all storm water outlets on Balboa Island, as shown in Figures 4.10 and 4.11. These valves are closed during high water events to prevent seawater from flooding low lying spots on the Island. Prior to the valve installation, the storm drain outlets were a major source of flooding during high water events.

Figure 4.10 Hand-Operated Gate Valve in Storm Drain Manhole

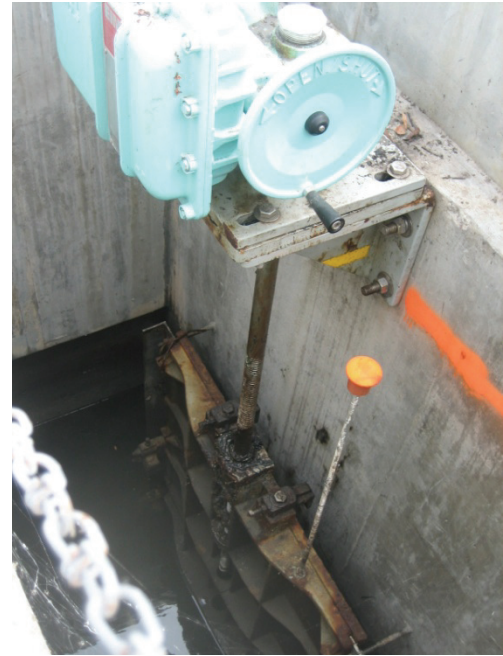
Figure 4.11 Actuated Gate Valve in Storm Drain Vault

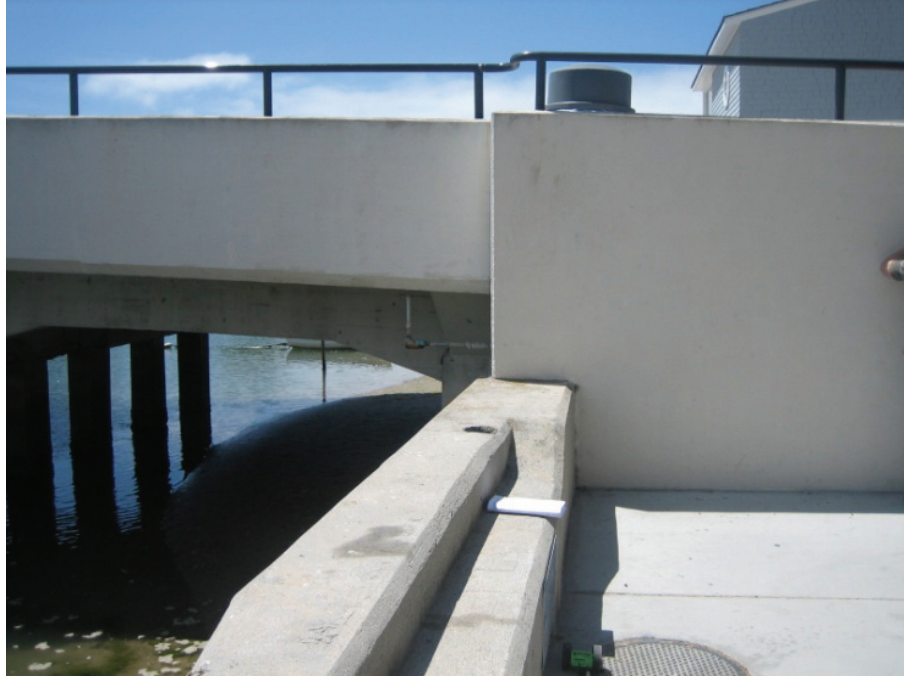
The Marine and Park Avenue bridges have solid concrete parapet (side) walls that tie into the existing seawall (see Figure 4.12) and have peak roadway elevations about the current Base Flood Elevation of 9.0 feet NAVD88 (9.18 feet MLLW). The Collins Island Bridge cuts through the seawall, has an open metal rail wall (see Figure 4.13) and a peak roadway elevation of approximately 7.3 feet NAVD88 (7.5 feet MLLW), which is below BFE. This bridge will require thorough waterproofing as well as solid concrete parapet (side) walls sealed to the seawall to prevent it from becoming a source of flooding. The seawalls on

Figure 4.12 Park Avenue Bridge Interface at Big Balboa Seawall

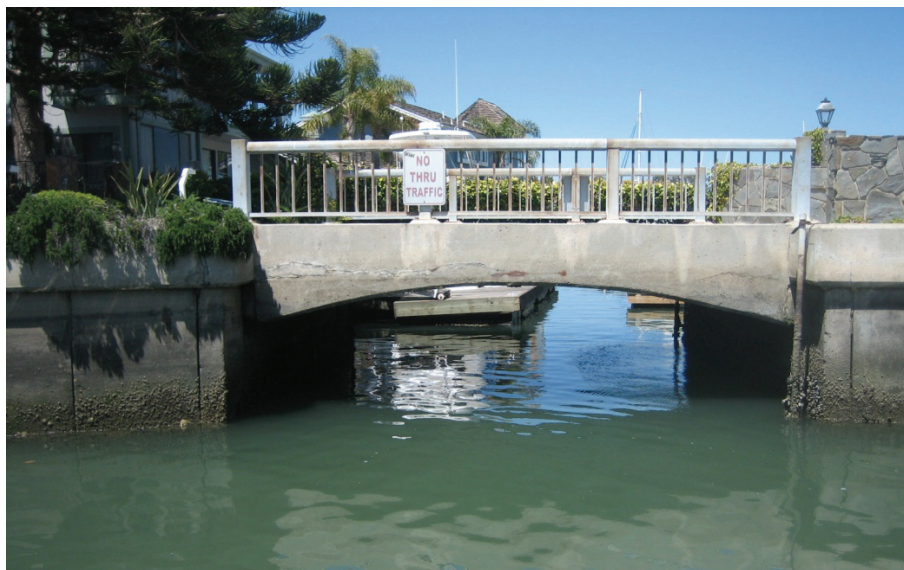
Collins Island will need to be retrofitted or replaced in concert with Balboa Island, to prevent flooding of that island and to prevent seawater from flanking the Balboa Island barriers.

Figure 4.13 Collins Island Bridge Interface at Seawall Abutment

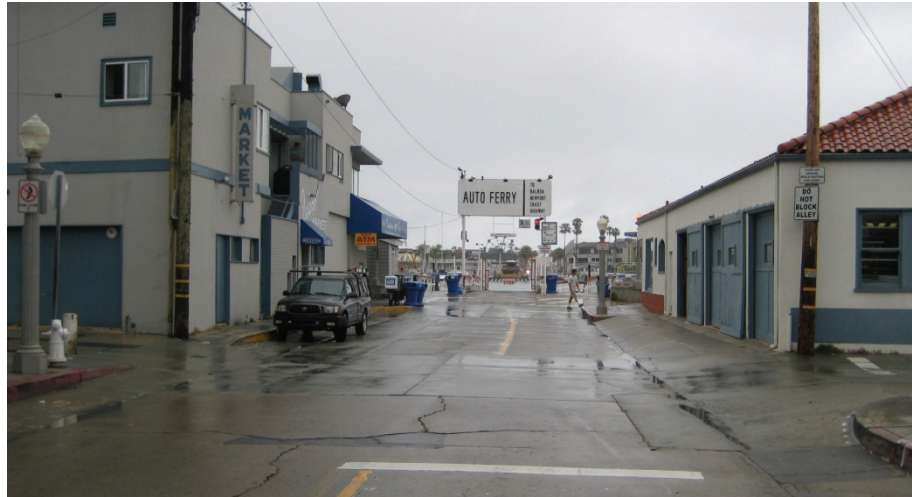
The approach to the Balboa Island Ferry Boat Landing also breaches the seawall, as shown in Figure 4.14, allowing a path for water to enter the Island. In addition, the Ferry Boat Launch Ramp is particularly low in its current configuration as shown in Figure 4.15. The approach elevation is 6.6 feet NAVD88 (6.8 feet MLLW) at the seawall opening and 7.0 feet NAVD88 (7.2 feet MLLW) at the ramp leading to the ferry boat dock. During high water events, the launch ramp must be shut-down until water recedes.

Figure 4.14 Balboa Island Ferry Boat Landing Approach

If the dock and launch ramp are left in their basic current location, a major effort would be required to raise the launch ramp and the approach street, Agate Avenue. This would impact adjacent buildings and the intersecting boardwalk. Two options of raising the launch ramps are provided in Chapter 5.

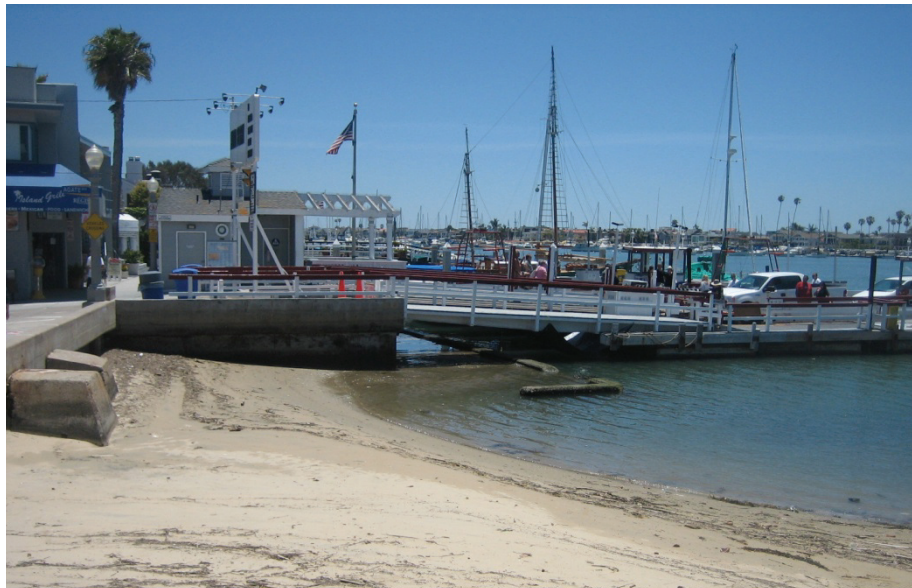
Figure 4.15 Balboa Island Ferry Boat Landing as Viewed from Side
