Although a full geotechnical and structural evaluation has not been performed, we can offer the following general observations about the bulkhead wall at Lower Castaways:

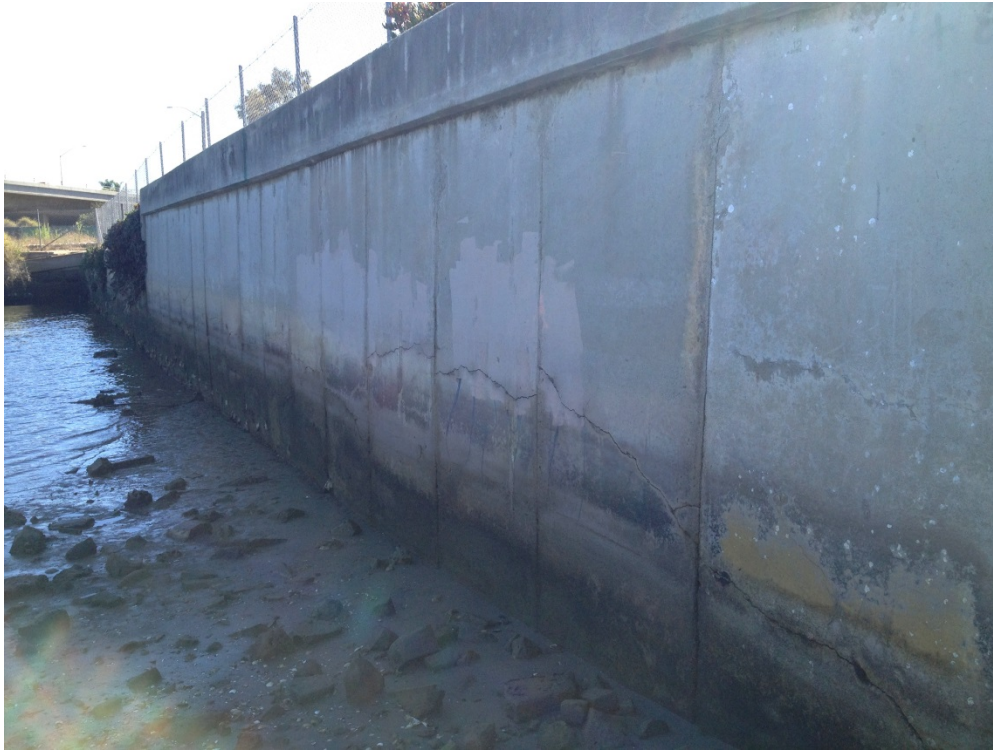
- The wall and its concrete cap appear to be displaying significant signs of wear and structural distress. In particular, the wall shows horizontal cracking along its tallest section, at a height that seems to correspond to where outward bending may be emerging.
- The relatively large cracking and spalling evident in the wall and cap at locations B and C may imply a combination of age (weathering over time) and stress effects (cracking in response to applied forces).

Photograph 1. Northern stretch of wall, showing horizontal cracking on the face.

If the City wishes instead to use or improve the parcel, then we recommend designing and installing a new wall. A reasonable and potentially cost-effective option would be to install a new wall face in front of the old one and fill in (grout) the space between. General order-of-magnitude cost for a new sheetpile wall installed in this fashion would likely range from approximately \$500,000 to \$1 million.

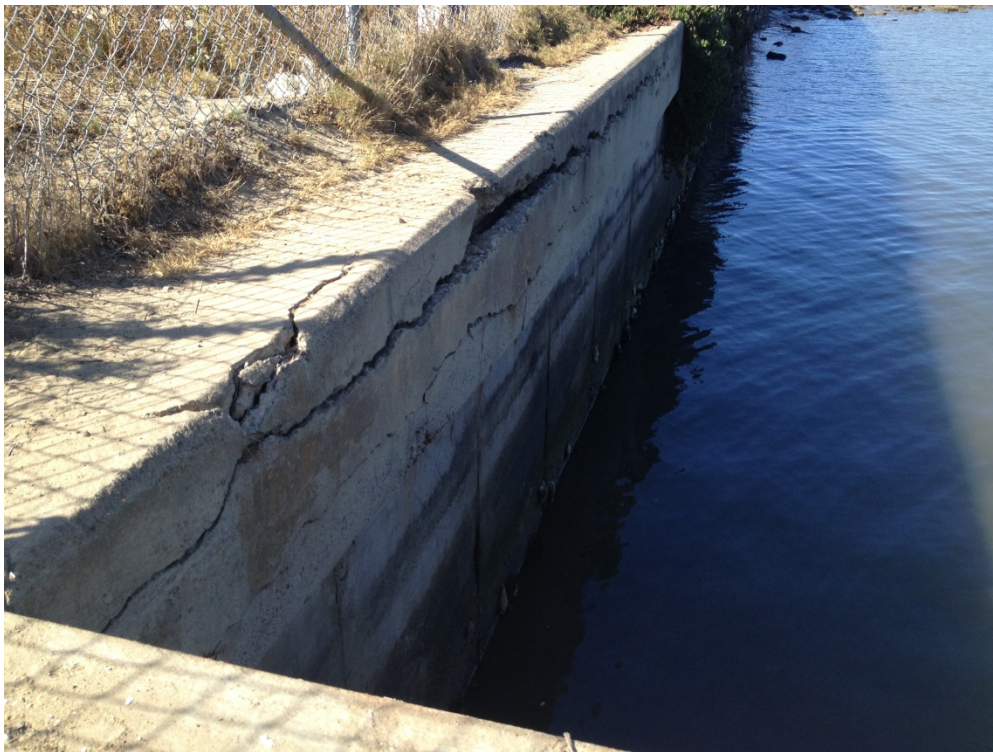
Photograph 2. Cracking in wall cap.

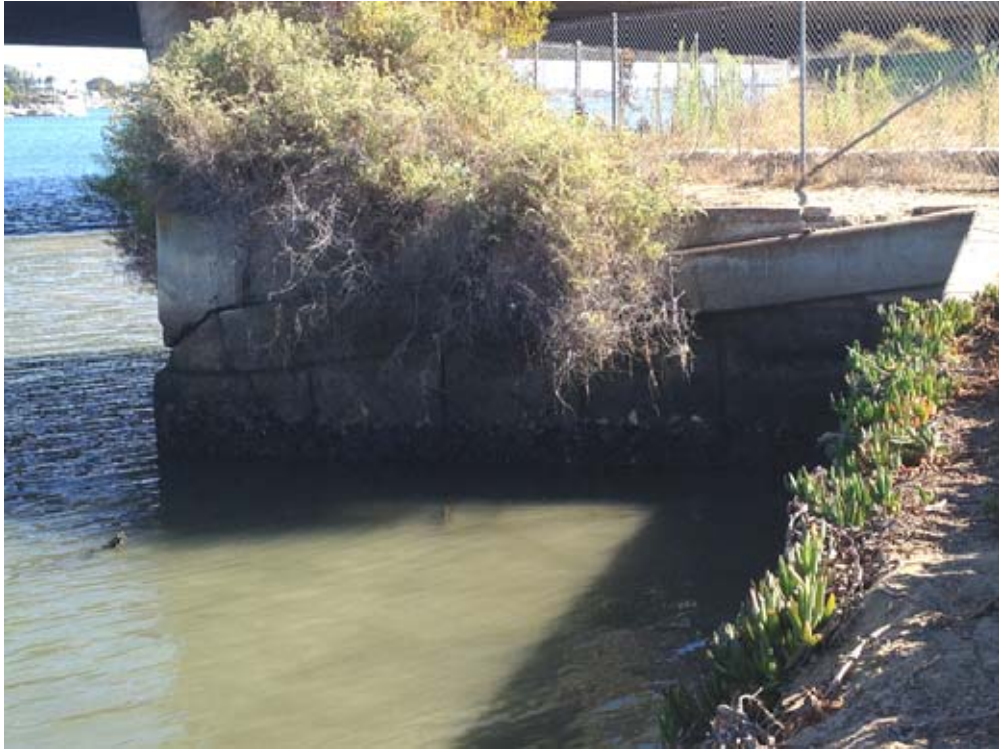
Photograph 3. Spalling and cracking at wall outer corner.

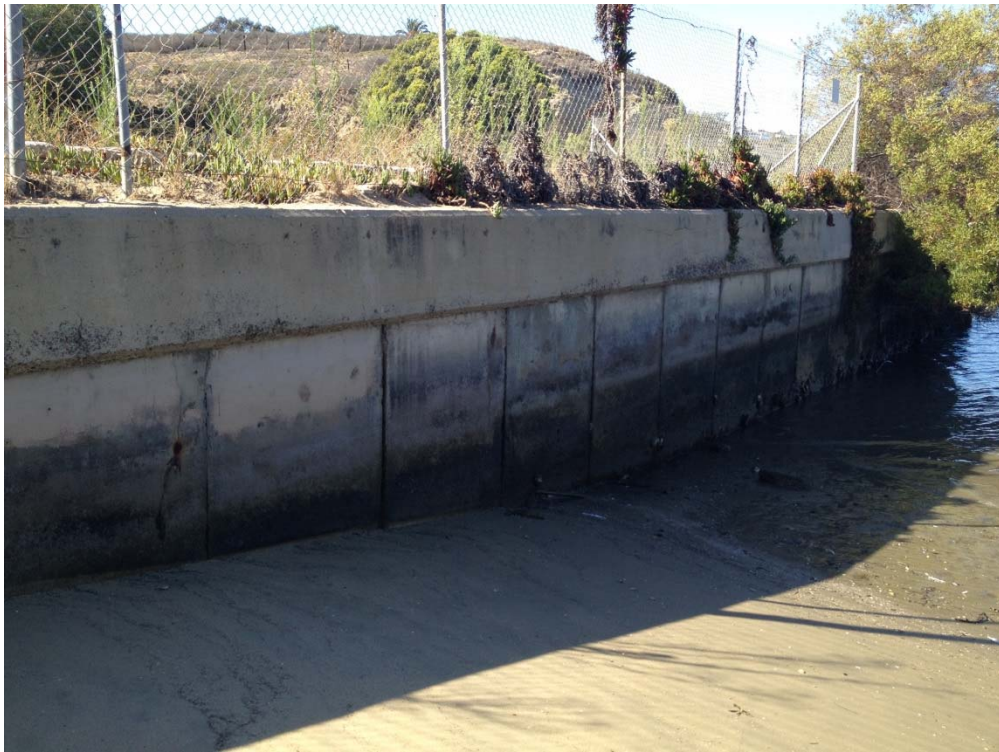
Photograph 4. Southern stretch of wall.

Photograph 4 in Attachment A.
