**CITY OF NEWPORT BEACH  
COMMUNITY DEVELOPMENT DEPARTMENT**

**Re: Response to Request for Additional Information for the City of Newport Beach**

**Case No.: 12-09-1324S  
Docket No.: FEMA-B-1673**

January 2018  
City of Newport Beach

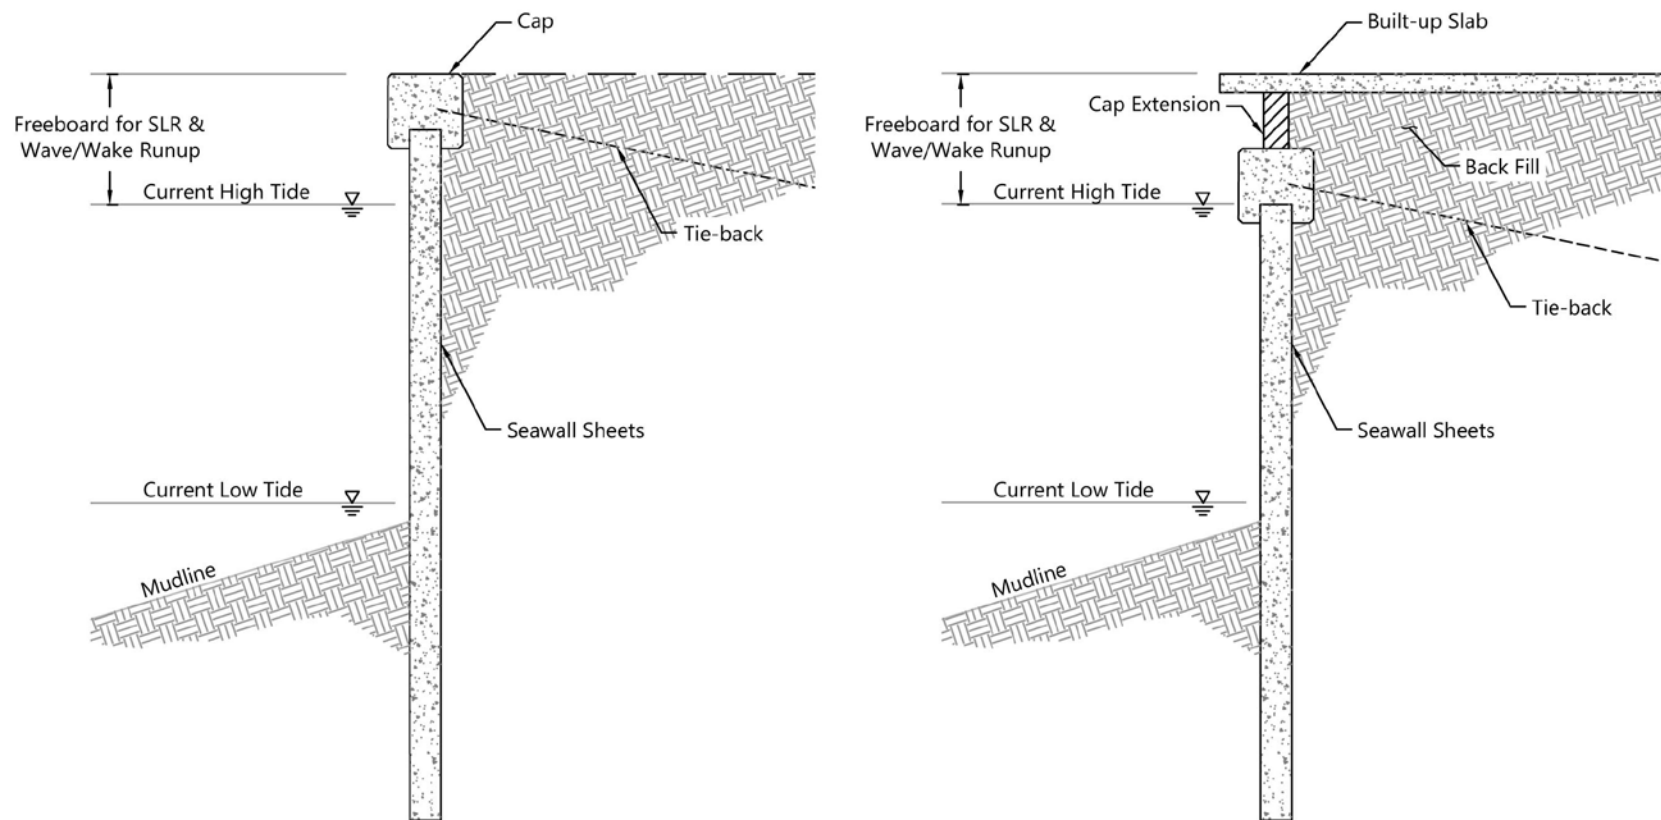
**Figure 5**  
**Seawall Section – Example of Level 1 Conditions**

- Level 1: No perceived risk, which is defined as a wall that has survived past storm surge and king tide events, appears to be structurally sound, and appears to be in fair to excellent condition.

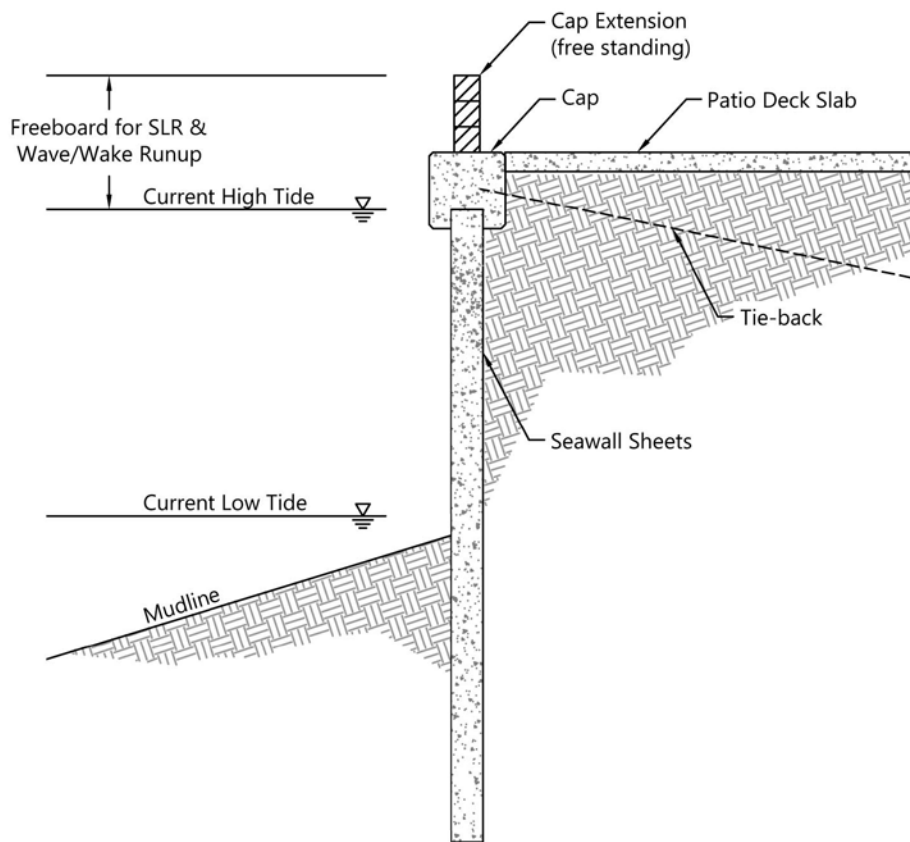
**Figure 8**  
**Seawall Section – Typical Level 2 Condition**

- Level 2: Possible risk, which is defined as a wall that has survived past storm surge and king tide events and appears to be in fair condition but given its age and construction may require modifications to withstand future flooding events. This type includes seawalls with cap extensions for which documentation may not exist and is intended to prevent seawall overtopping.

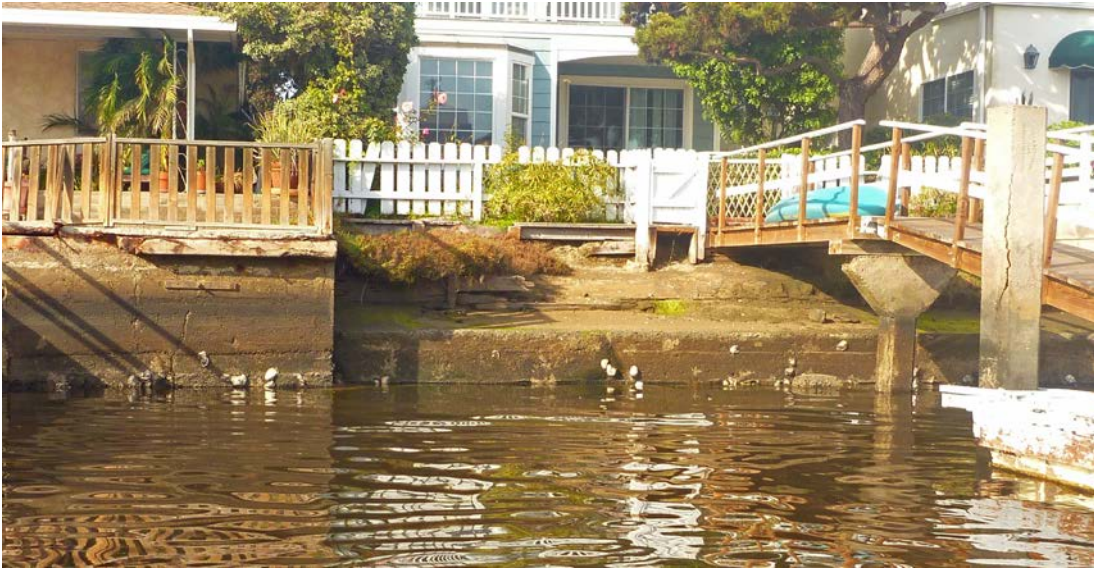
**Figure 11**  
**Residential Seawall – Level 3 Condition**

- Level 3: Higher risk, which is defined as a wall that has survived past storm surge and king tide events but is either in poor condition, or does not visually appear to be structurally sound. A Level 3 seawall classification does not necessarily mean that the building structures it protects are in danger; that assessment is dependent on many other factors that are not the focus of this report.

The remaining 194 feet of seawall represent Level 3 locations and relate to a higher risk of concern based on observed condition, deterioration, or suspect wall construction. These areas are along Newport Island, Rhine Channel, and Mariners' Mile, and include five properties. One of the Level 3 locations along Mariners' Mile has been redesigned and has been submitted for local and state permits. Once completed construction is completed, this location would be removed from the list.

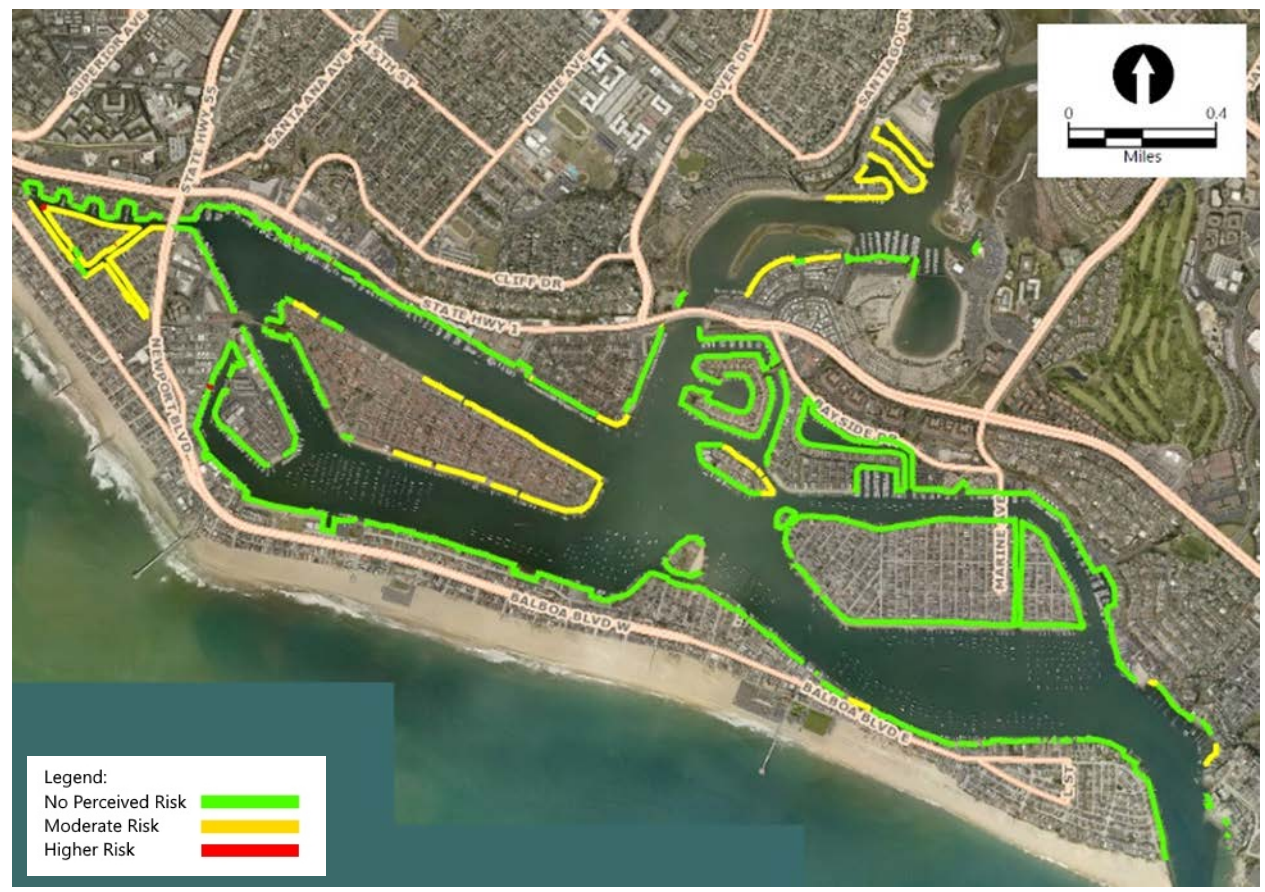
**Figure 14**  
**Observed Condition Summary – Levels 1, 2, and 3**

Based on these observations, most seawalls and slope protection structures in Newport Harbor are currently exhibiting no or little perceived risk of distress in the event of flood conditions. This represents approximately 82,248 feet of seawall, or 77% of the overall inventory of waterfront structures within Newport Beach. Those locations have been identified as Level 1 condition frontage.
