BALBOA ISLANDS SEAWALL REHABILITATION PROJECT

Tidelands Management Committee
September 17, 2014

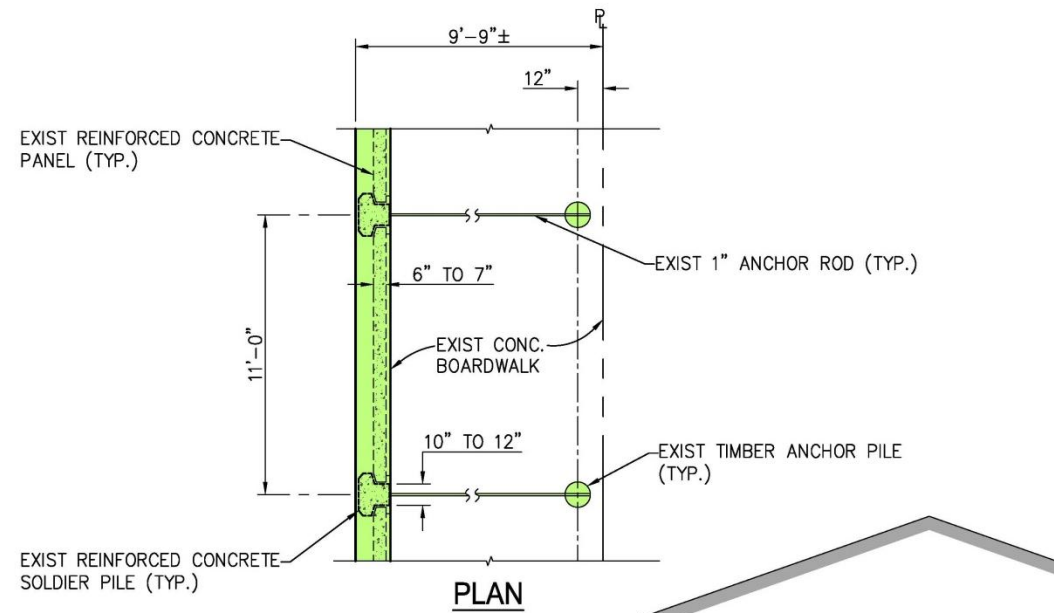
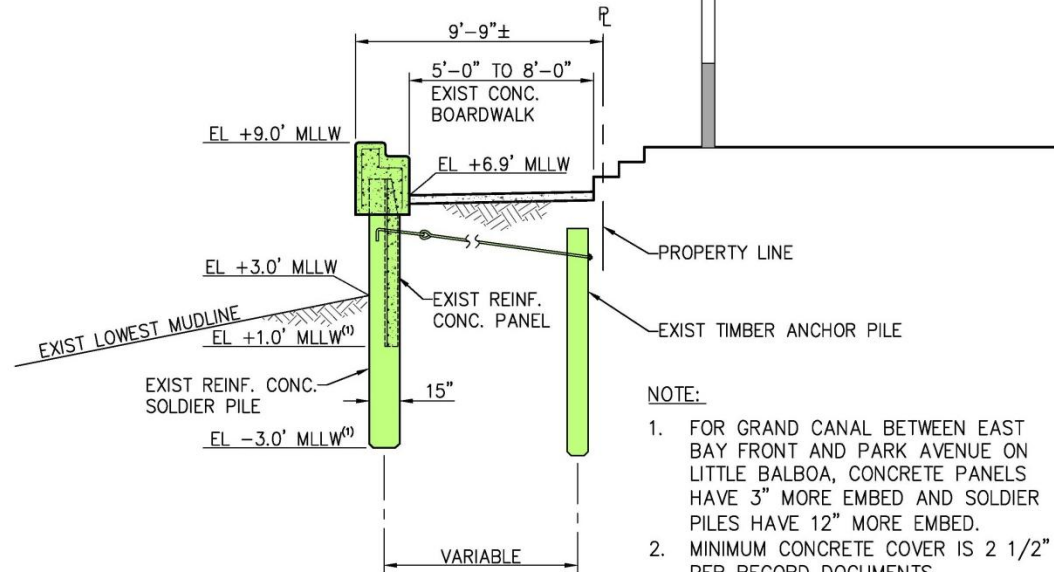
CASE 1 - EXISTING CONDITION at GRAND CANAL

3a. Existing Seawall Along Grand Canal

Constructed: ~1935

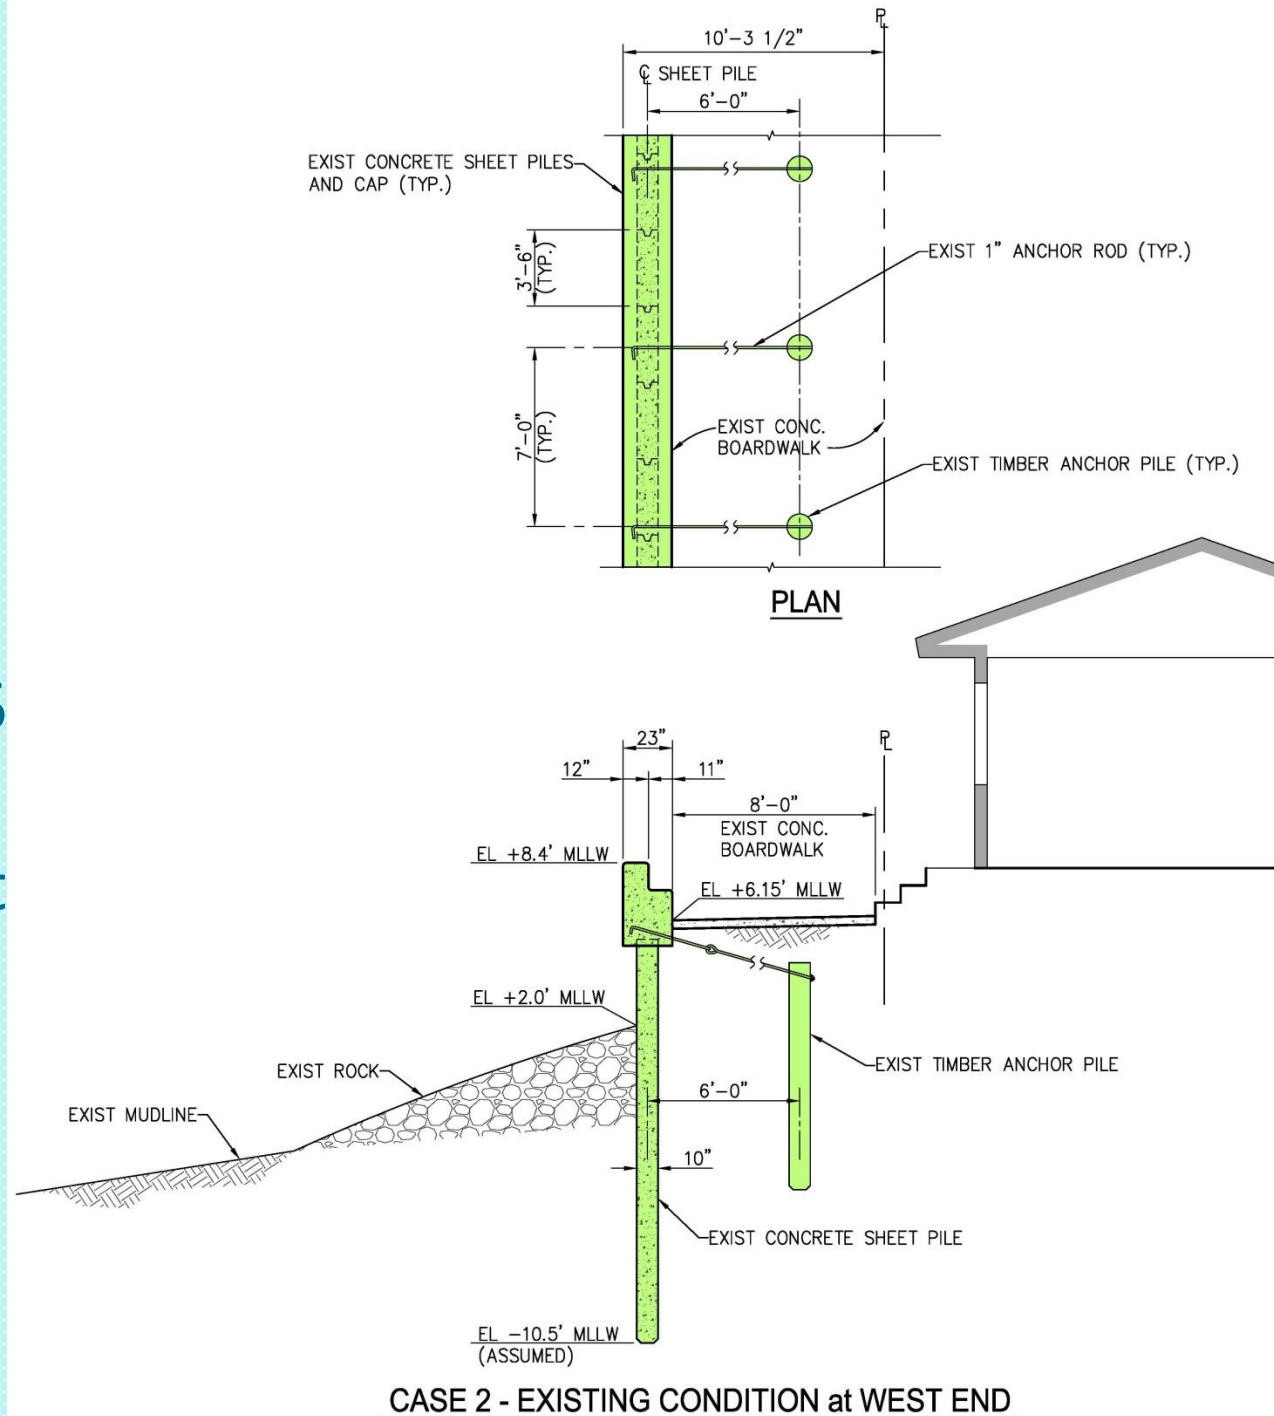
Existing Seawall at Balboa Island West End

Constructed: ~1935

Rock reinforcement
installed 1985

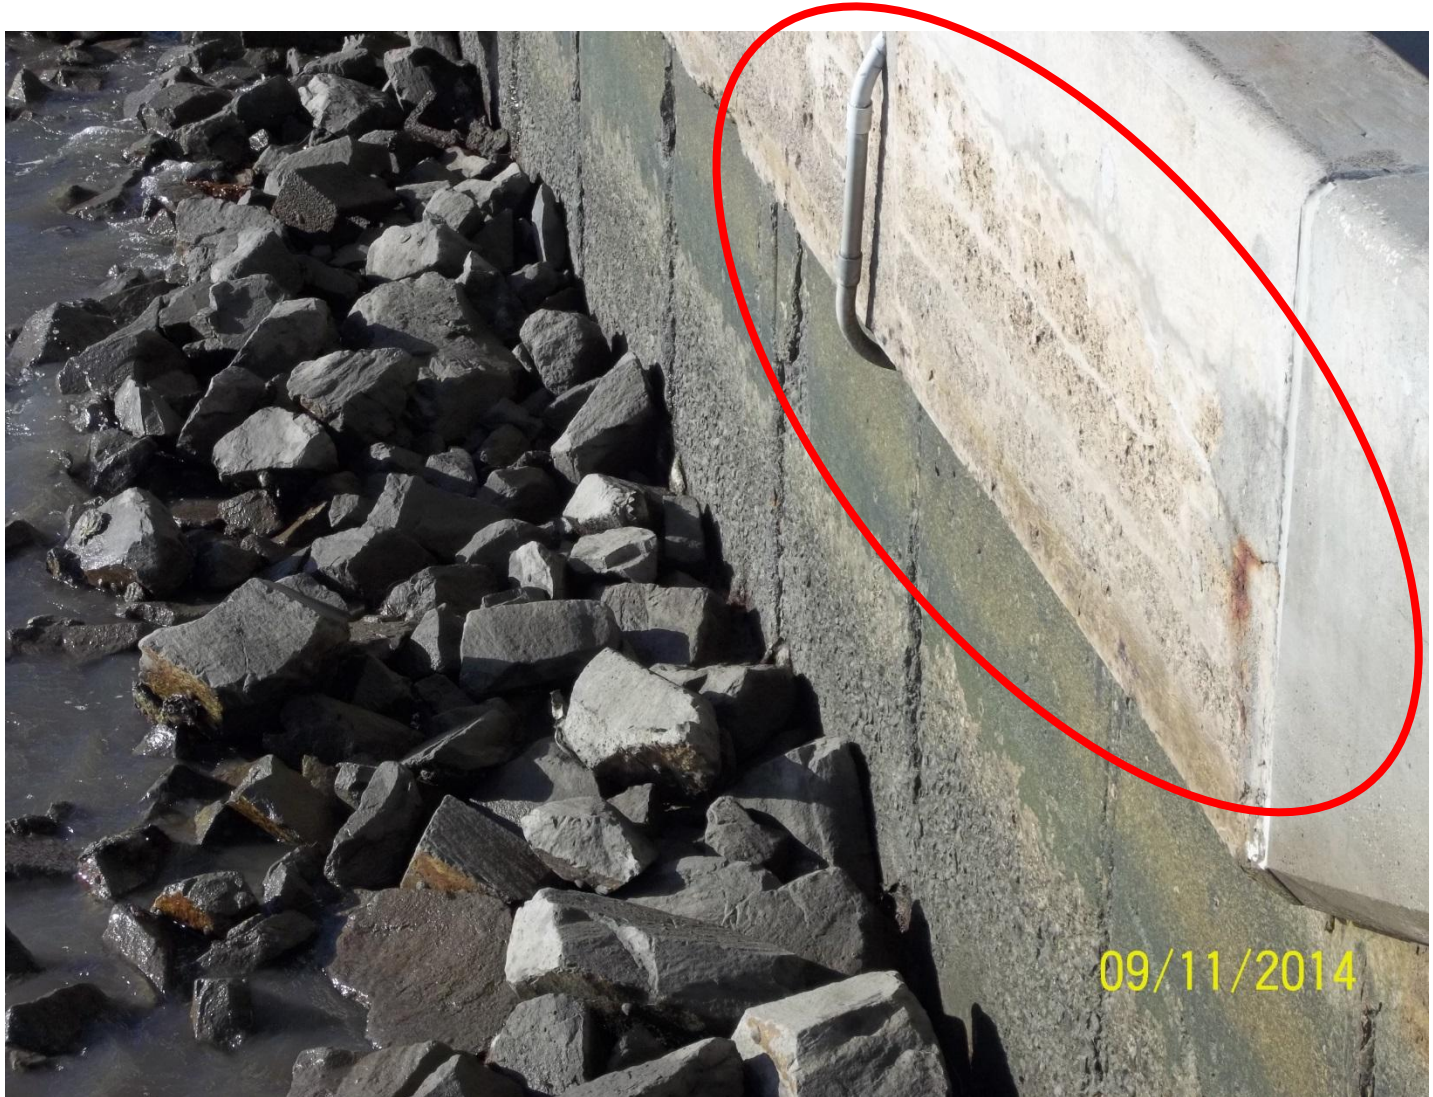
West End Wall at Park Avenue

Spalled Concrete Repairs

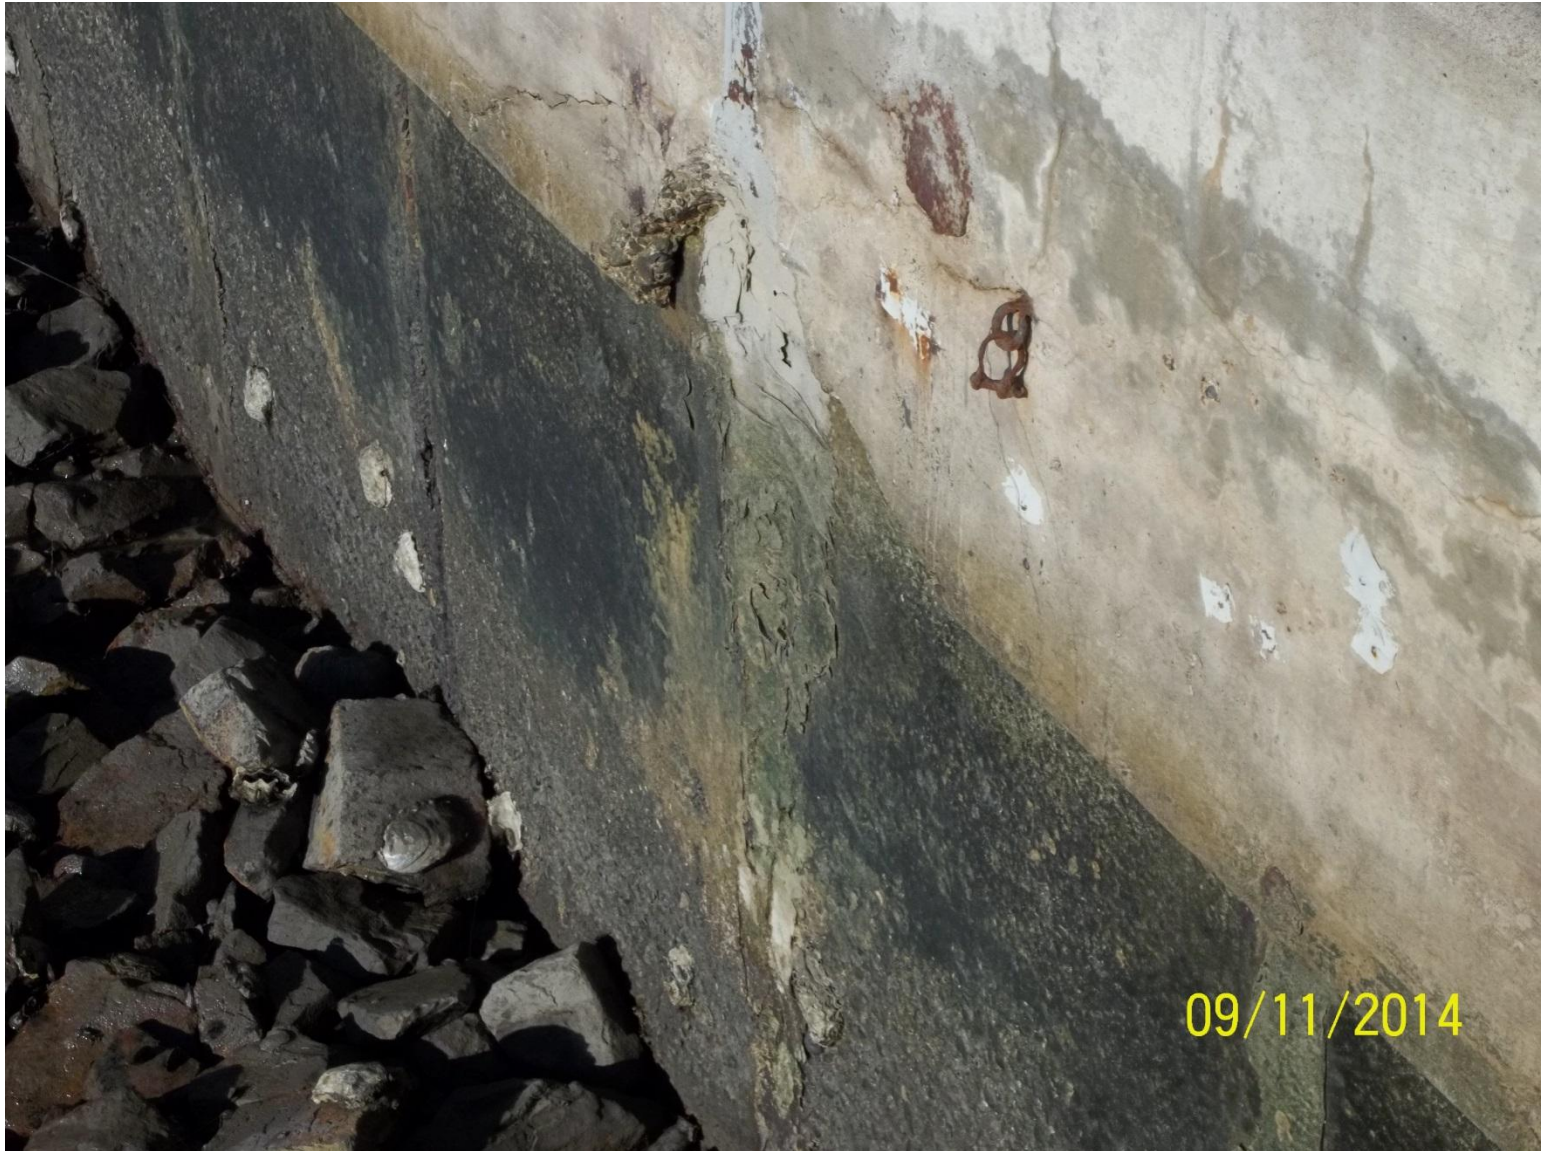
Spalled Concrete at West End Wall

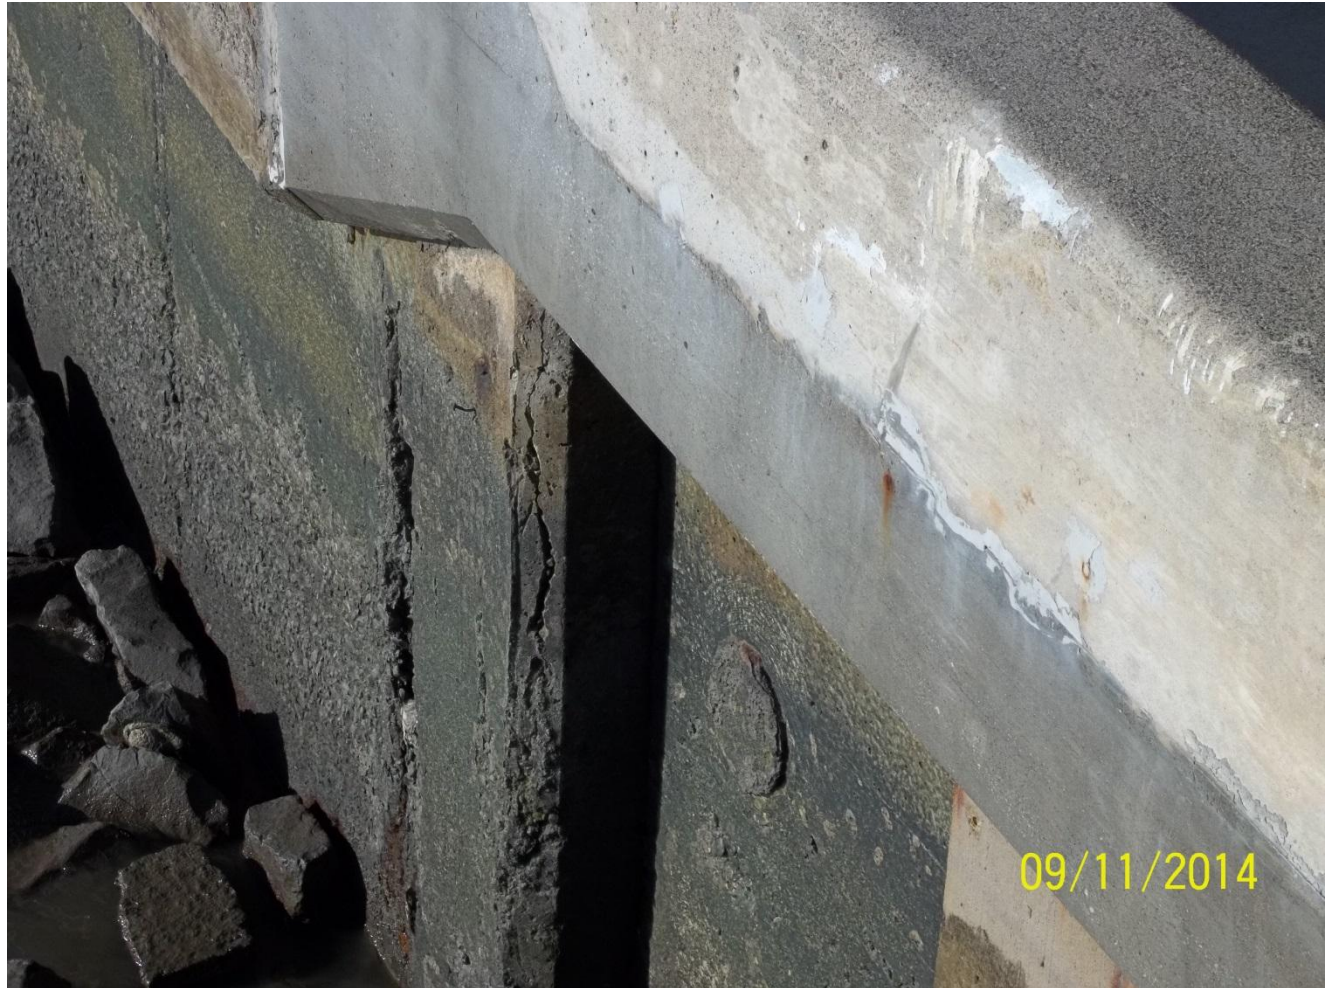
West End Wall – Cap and Sheet Pile

Cap Spalls – repaired. Vertical cracks observed.

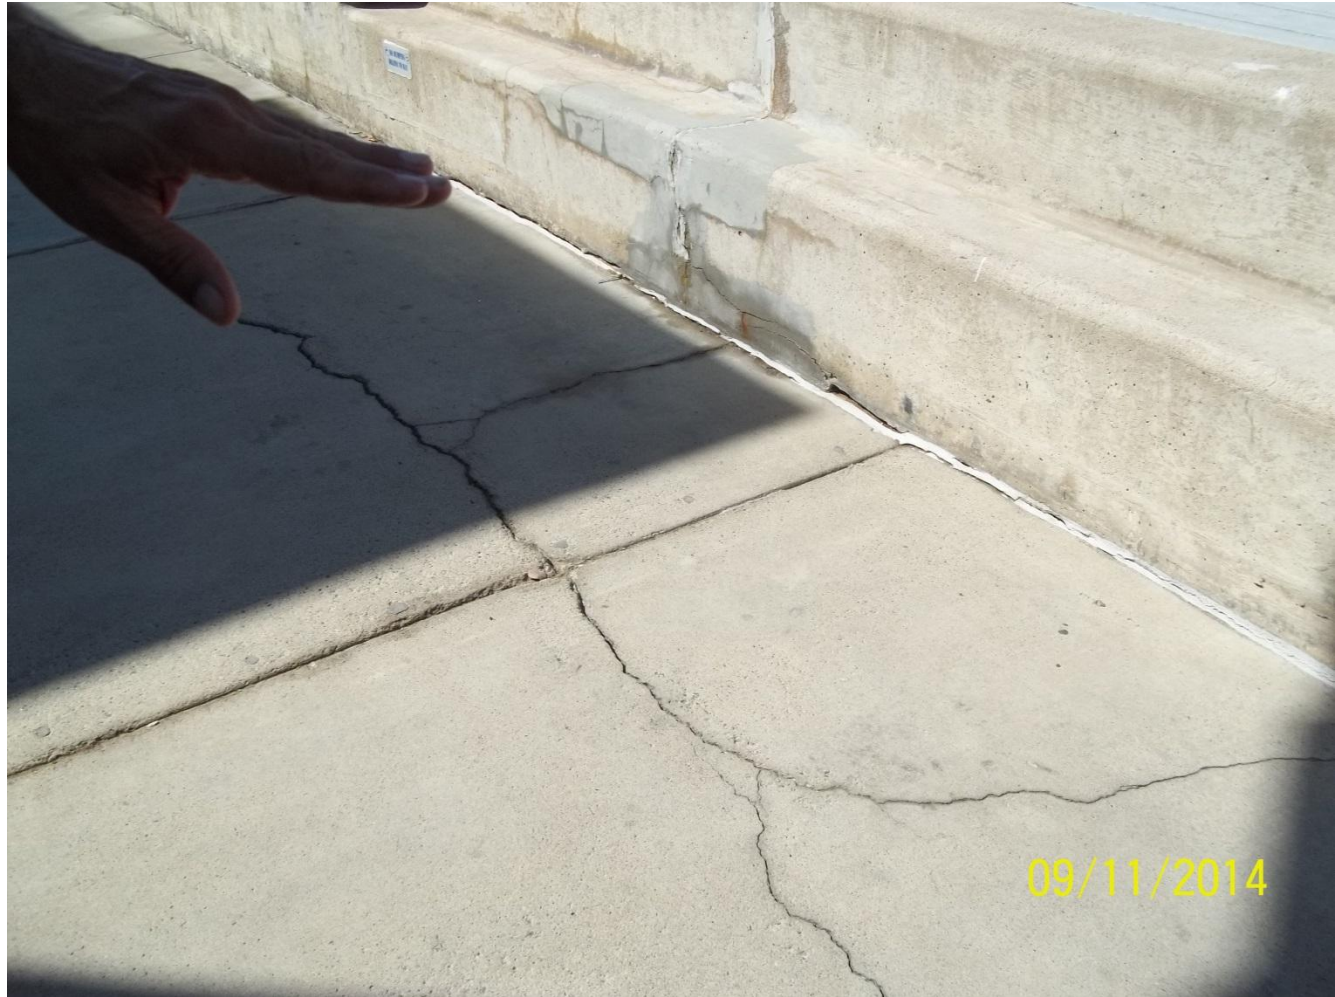
Sidewalk Settlement at West End Wall

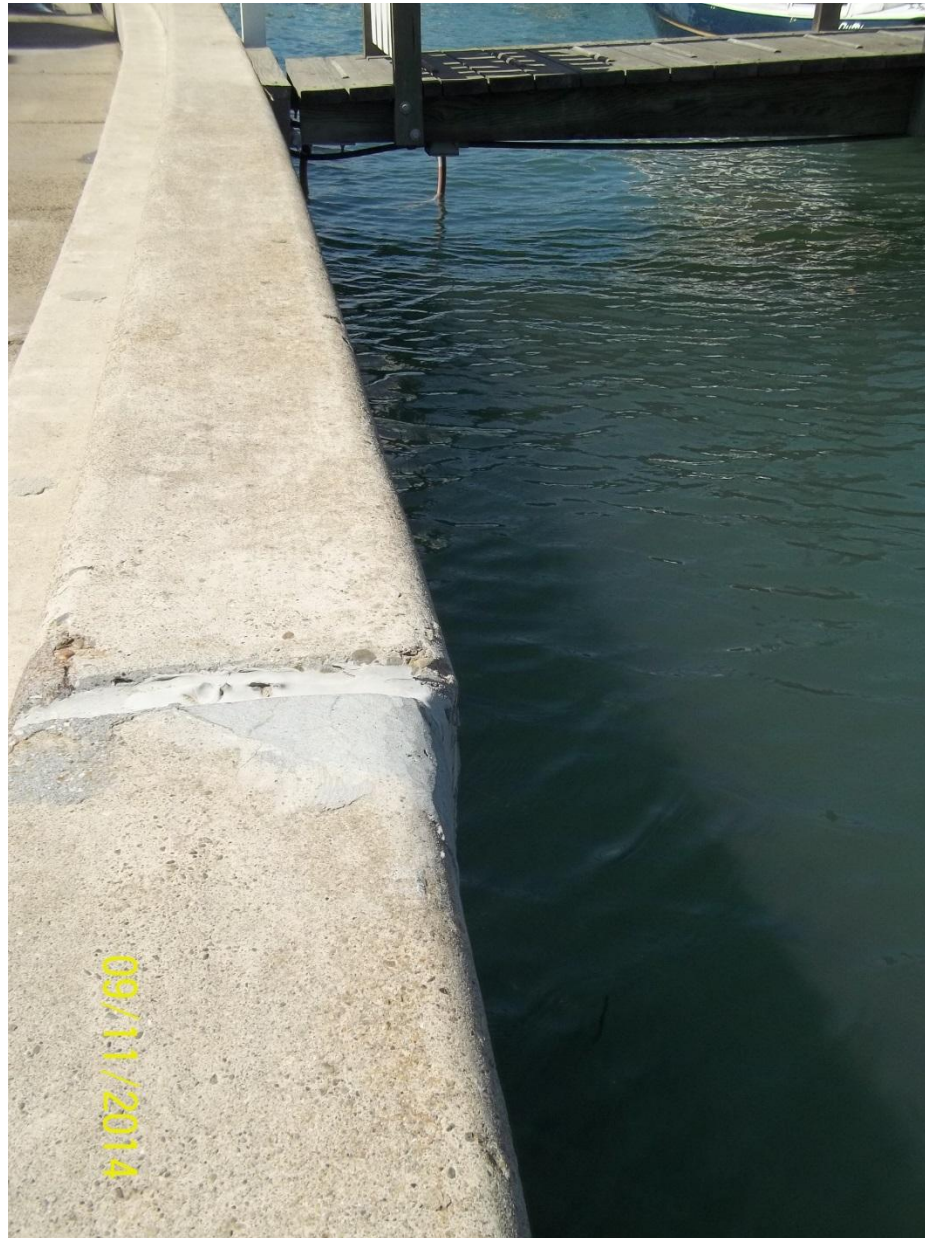
Sheet Pile Movement at West End Wall

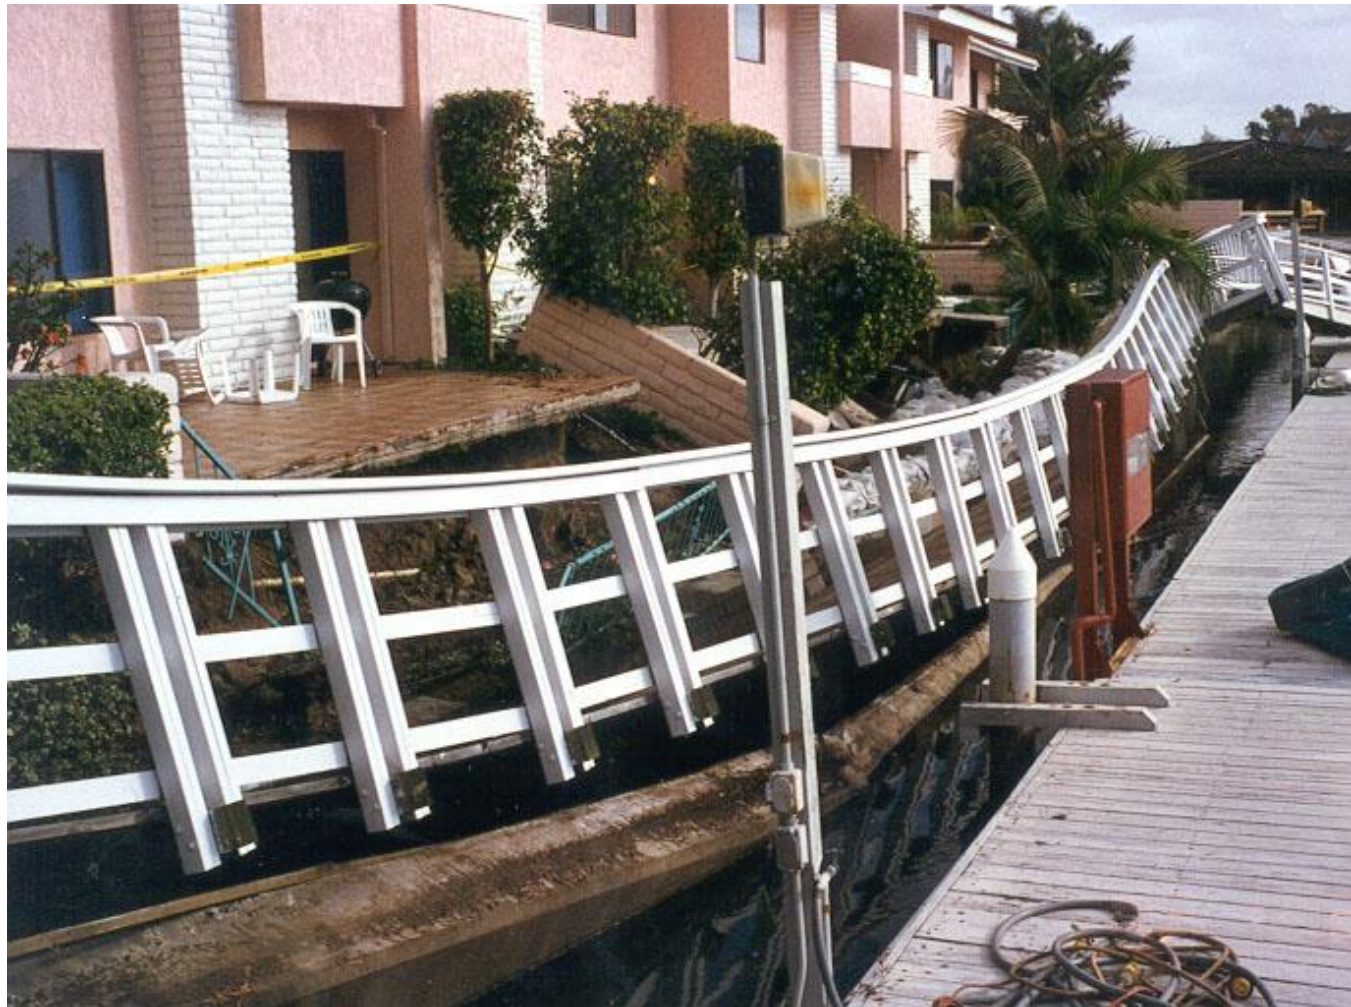
Newport Marina Villas Townhomes

Seawall Failure – Shallow Pile Embedment

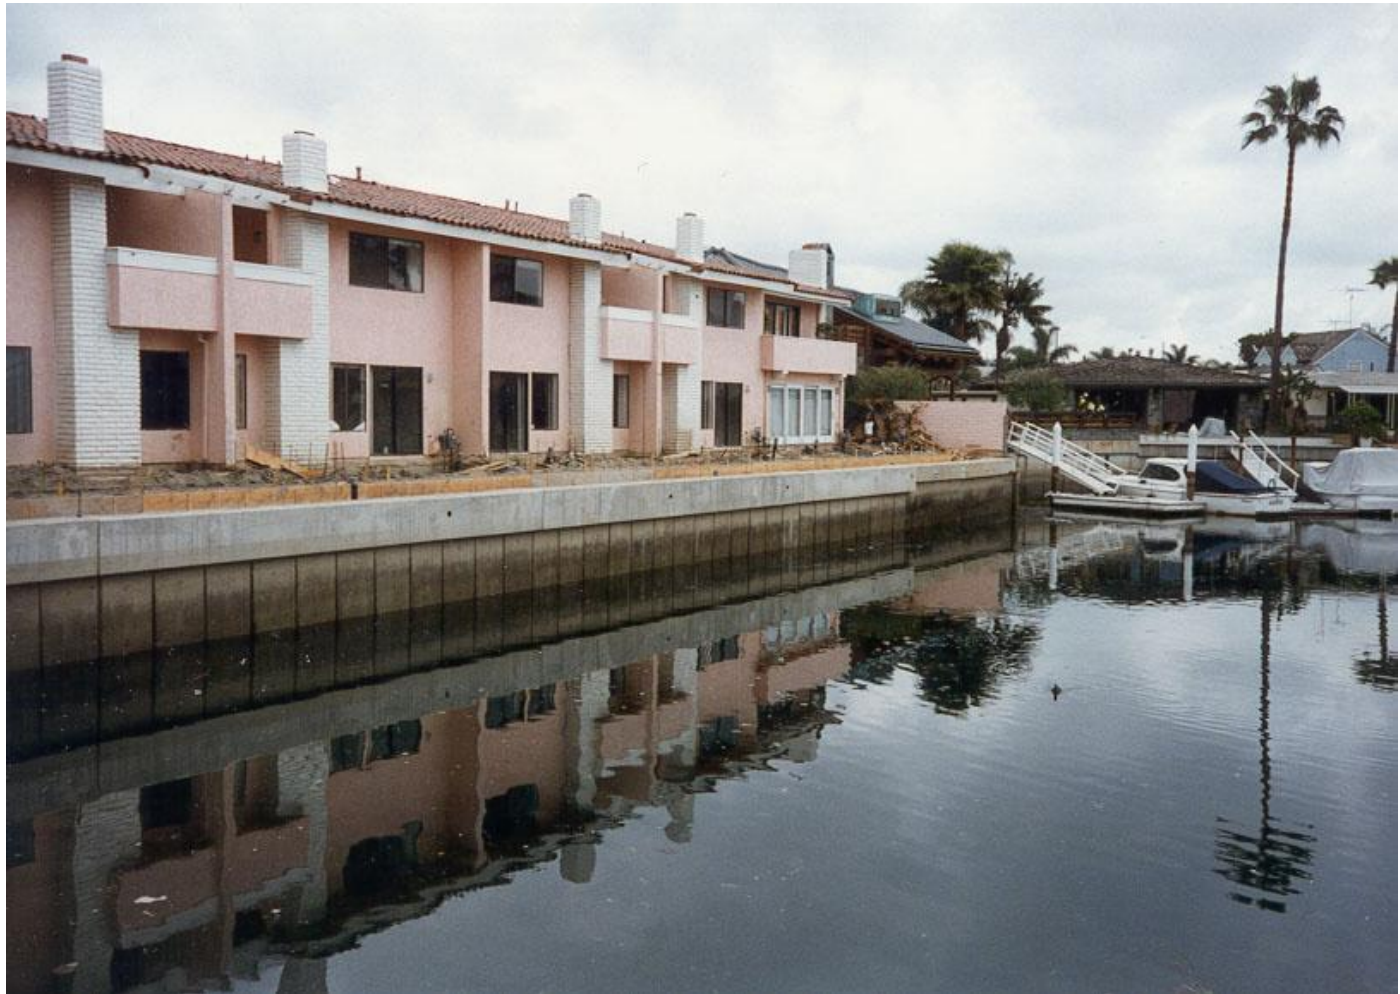
Newport Marina Villas Townhomes

New Seawall after Repairs

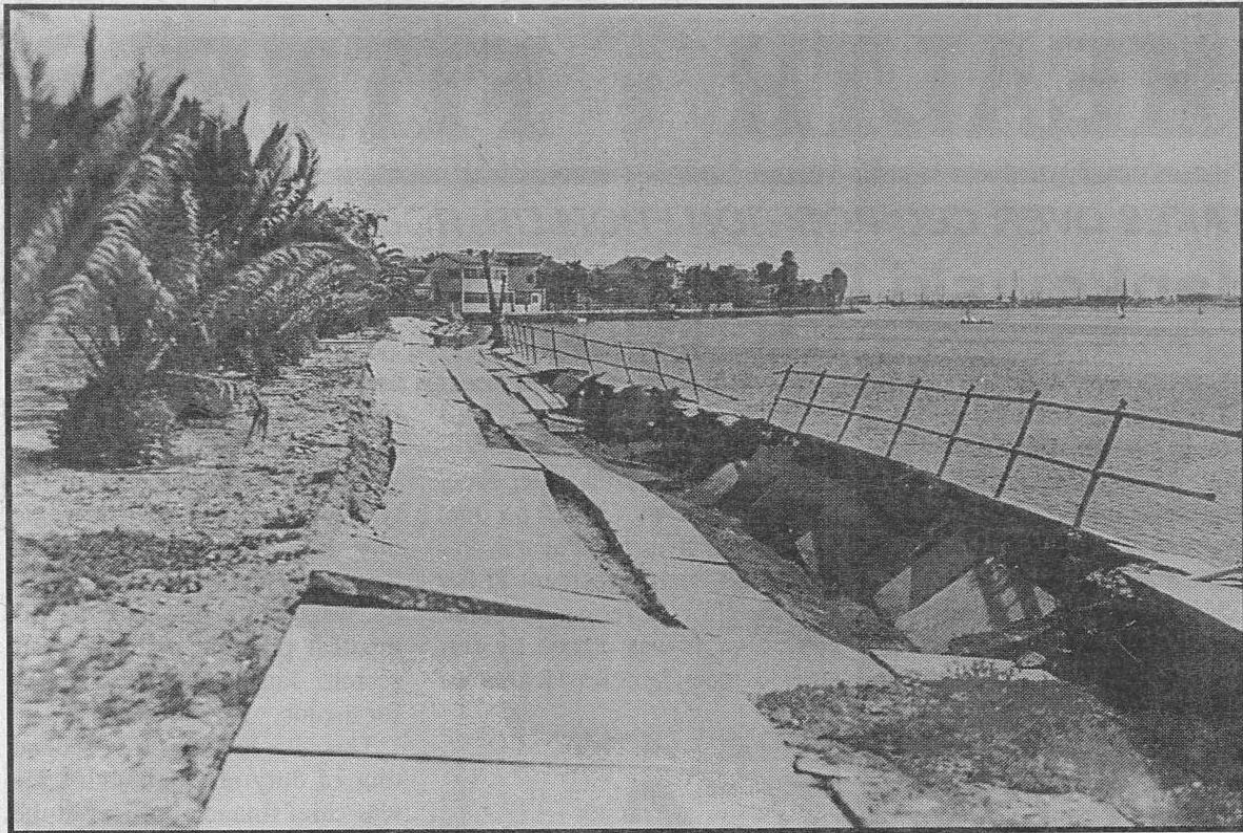
Naples Seawall Failure (1933)

EARTHQUAKE DAMAGE. The Naples sea wall suffered extensive damage, as did much of the Long Beach area, in the 1933 earthquake. —Photo courtesy Historical Society of Long Beach
