# **ENCROACHMENT REMOVAL AND RESTORATION PLAN**

## **PENINSULA POINT CITY OF NEWPORT BEACH ORANGE COUNTY, CALIFORNIA**

**October 10, 2019**

**Prepared by:  
Glenn Lukos Associates, Inc.  
Contact: Sheri Asgari  
29 Orchard, Lake Forest, CA 92630-8300  
Telephone: (949) 837-0404**

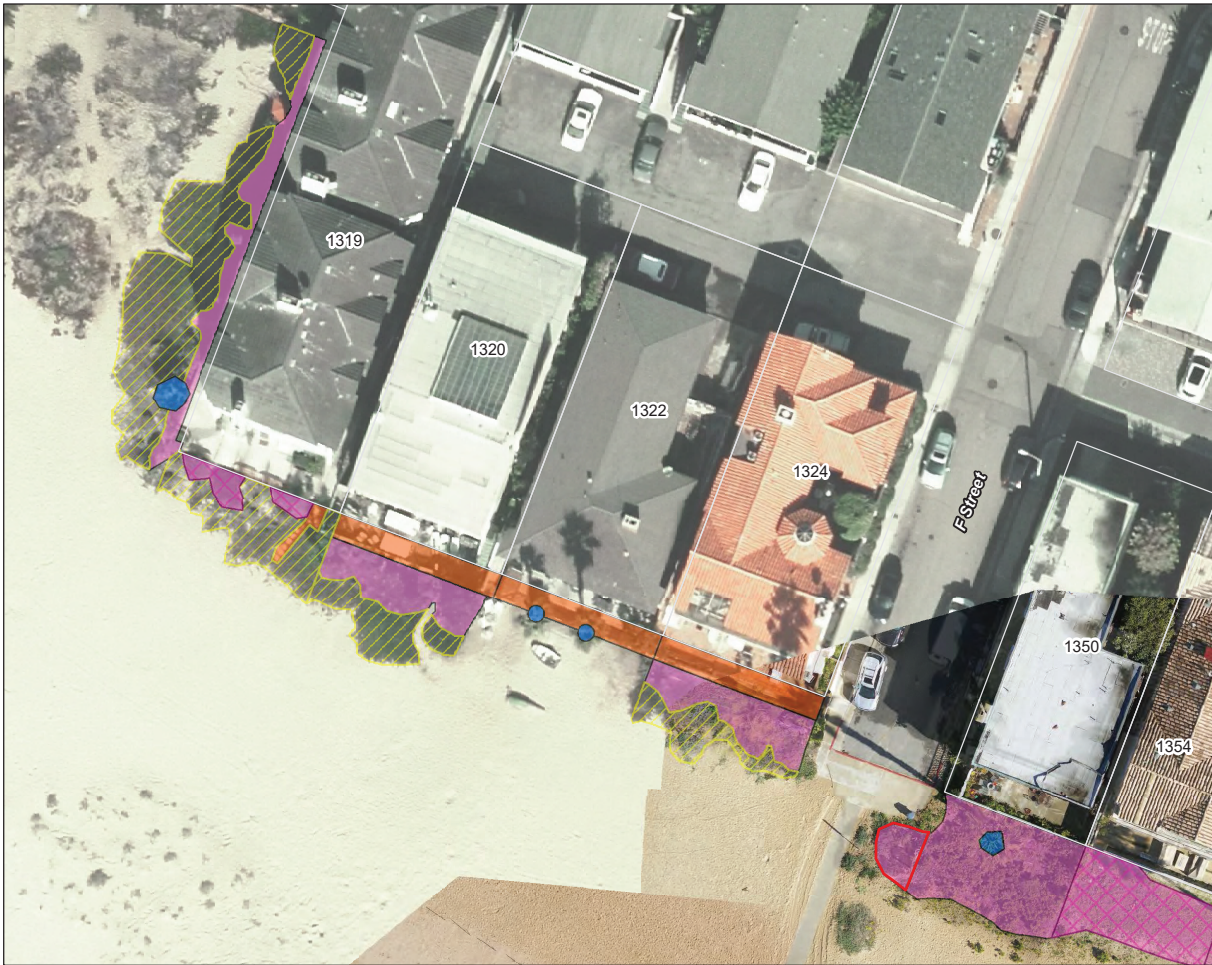
Exhibit 3 - Page 1

**PENINSULA POINT ENCROACHMENT  
REMOVAL AND REPLACEMENT PLAN**  
West of F Street

Appendix A provides a measurement of encroachments by type at each property, and at City property at street ends. Appendix A includes detailed notes regarding type and material of hardscaping, presence of irrigation systems, invasive plants, and any other notable information for each property. Appendix B provides a measurement of iceplant and wildland weeds/escaped ornamentals associated with each property and at City property at street ends. Exhibit 3 provides a map of encroachments by type for each property.

A total of 54,154 square feet (1.24 acres) of encroachments were mapped based on the April 2019 aerial photography and using the encroachment mapping methodology described above. Of the total square footage, 52,170 square feet (1.19 acres) were associated with private residences and 1,984 square feet (0.05 acre) were associated with the City (primarily areas at street ends). Appendix A provides a measurement of encroachments by type associated with each property and City, as appropriate. Exhibit 3 provides a map of encroachments by type for each property and City.

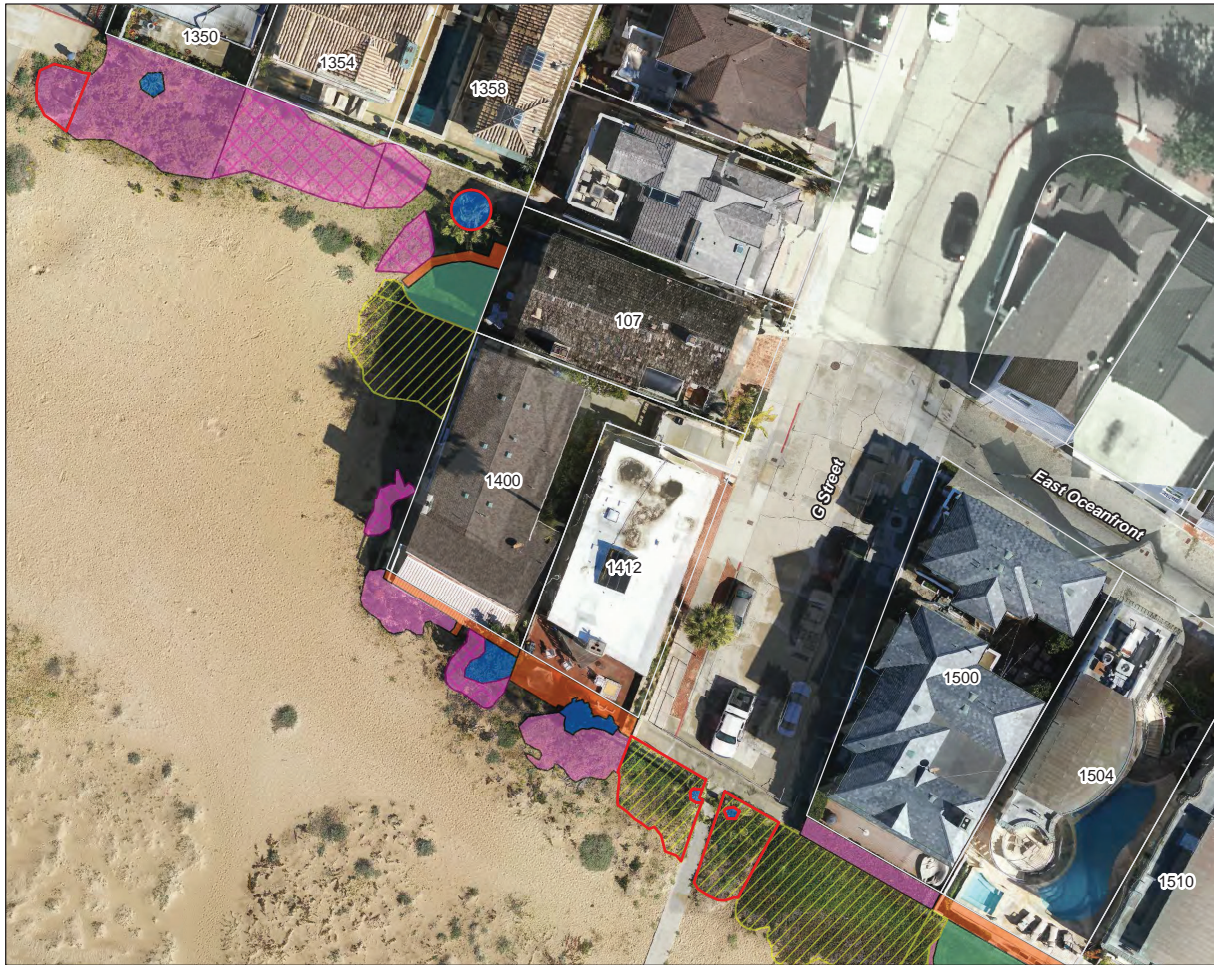
Exhibit 3 - Page 2

**PENINSULA POINT ENCROACHMENT  
REMOVAL AND REPLACEMENT PLAN**  
G Street

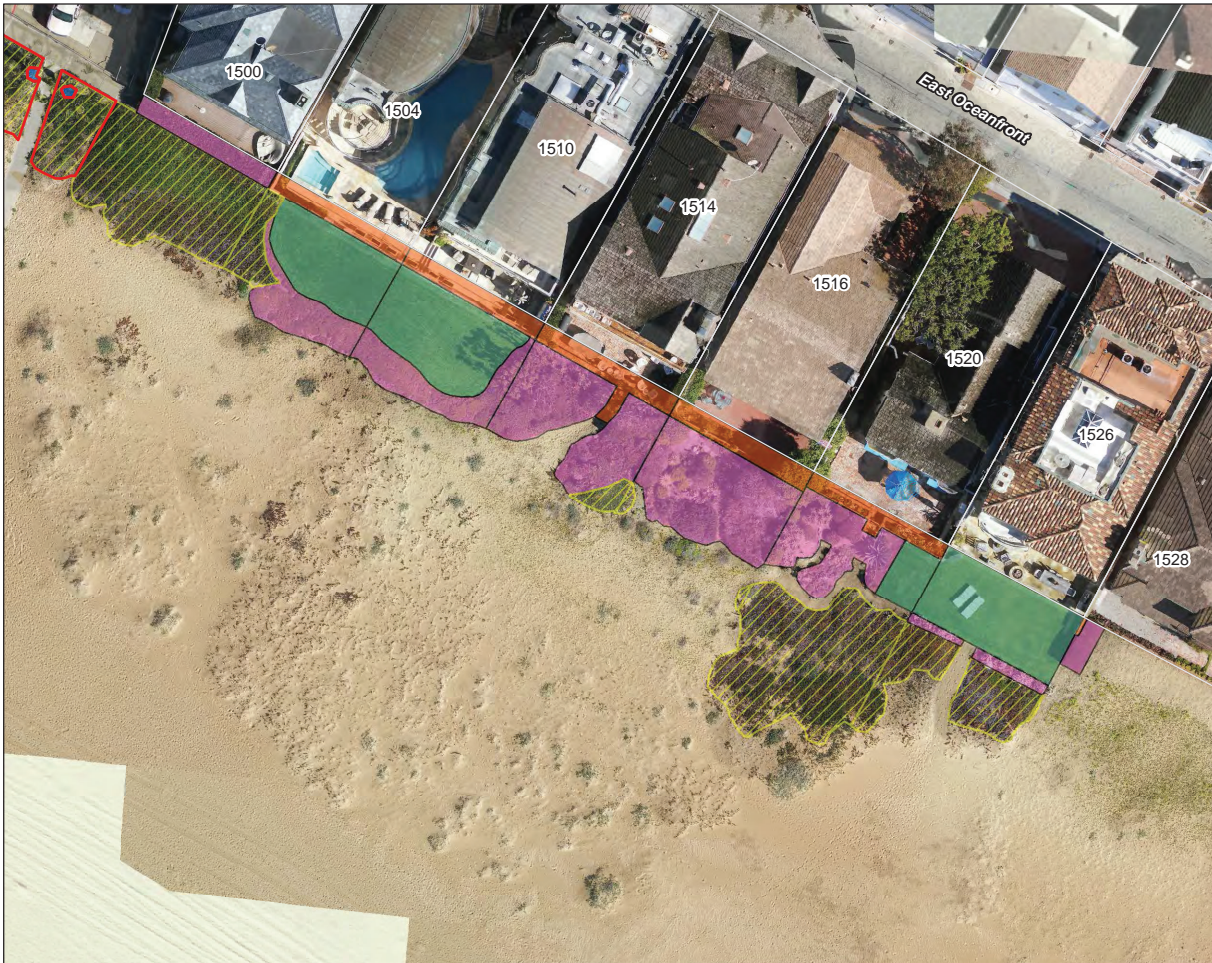
- Parcel Boundary
- Phase 1 - Encroachment Removal**
- Hardscape/Stepping Stones
- Lawn
- Ornamental Shrub/Groundcover
- Ornamental Tree
- Wildland Weeds/Escaped Ornamental
- City Restoration Area\*  
\*Areas labelled "City Restoration Area" are not associated with any private residence address, but will be subject to removal and restoration activity by the City
- Phase 2 - Iceplant Removal**
- Iceplant

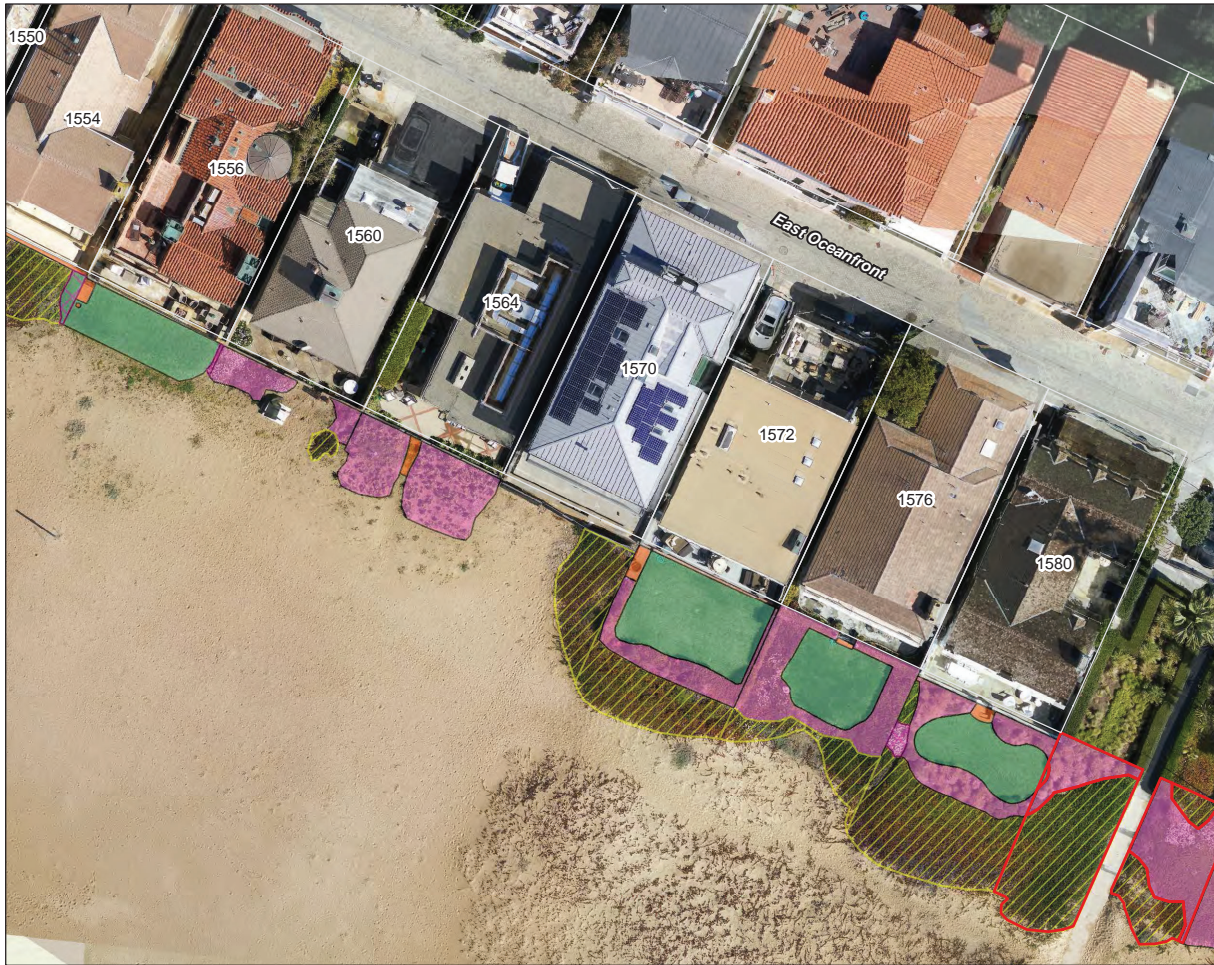
- Parcel Boundary
- Phase 1 - Encroachment Removal**
- Hardscape/Stepping Stones
- Lawn
- Ornamental Shrub/Groundcover
- Ornamental Tree
- Wildland Weeds/Escaped Ornamental
- City Restoration Area\*

\*Areas labelled "City Restoration Area" are not associated with any private residence address, but will be subject to removal and restoration activity by the City
- Phase 2 - Iceplant Removal**
- Iceplant

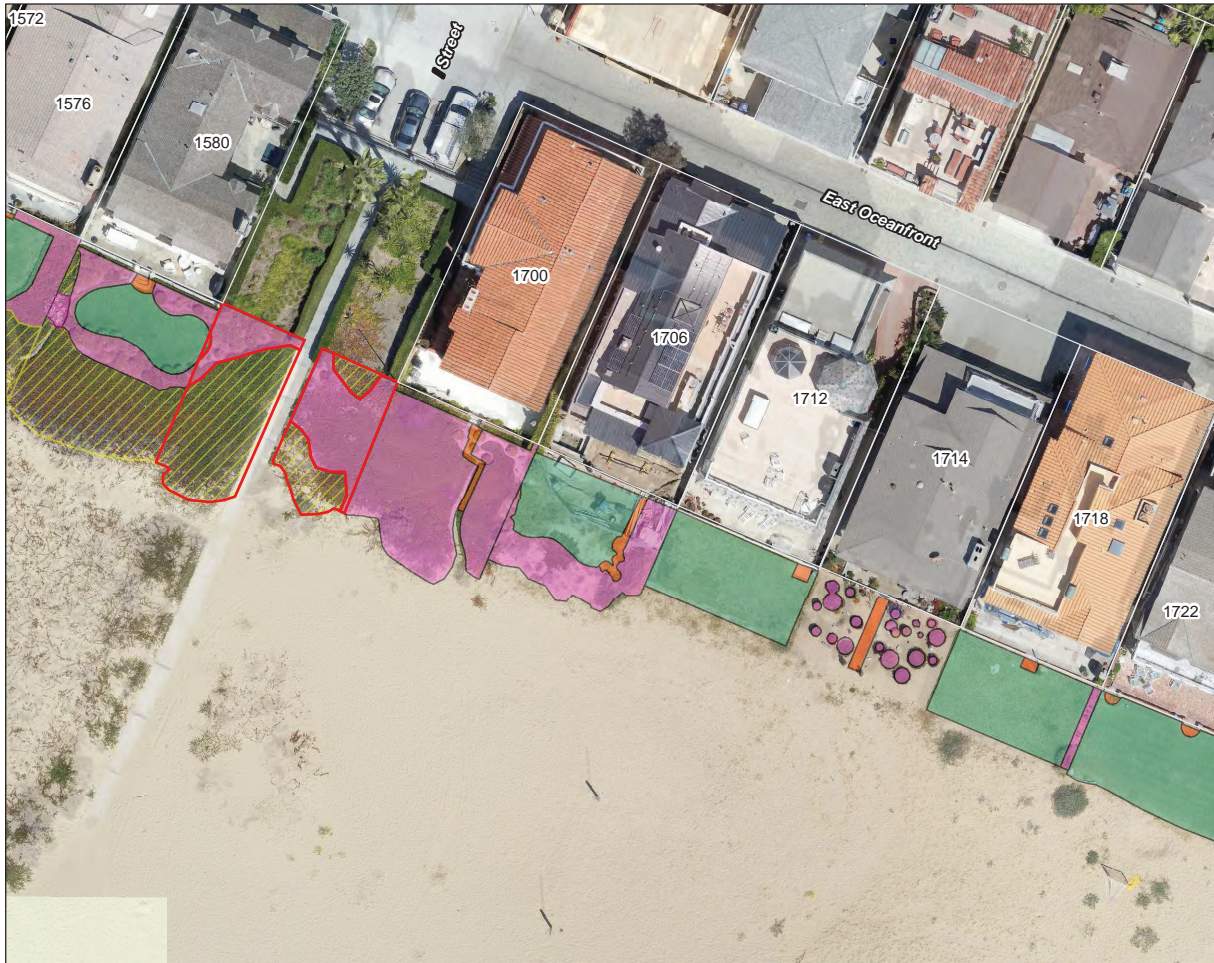
Exhibit 3 - Page 5

- Parcel Boundary
- Phase 1 - Encroachment Removal**
- Hardscape/Stepping Stones
- Lawn
- Ornamental Shrub/Groundcover
- Ornamental Tree
- Wildland Weeds/Escaped Ornamental
- City Restoration Area\*

\*Areas labelled "City Restoration Area" are not associated with any private residence address, but will be subject to removal and restoration activity by the City
- Phase 2 - Iceplant Removal**
- Iceplant

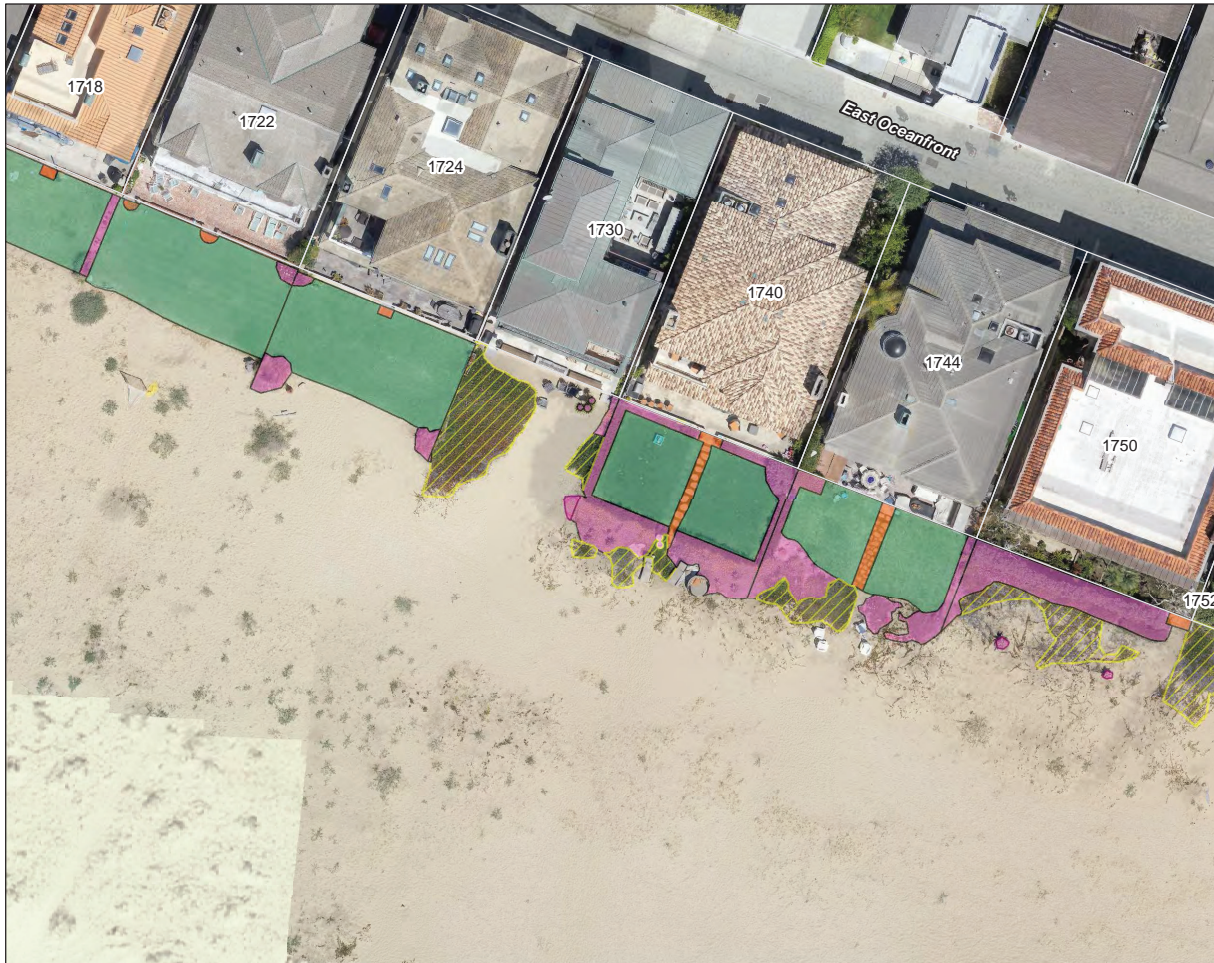
Exhibit 3 - Page 7

**PENINSULA POINT ENCROACHMENT  
REMOVAL AND REPLACEMENT PLAN**  
Between I Street and L Street

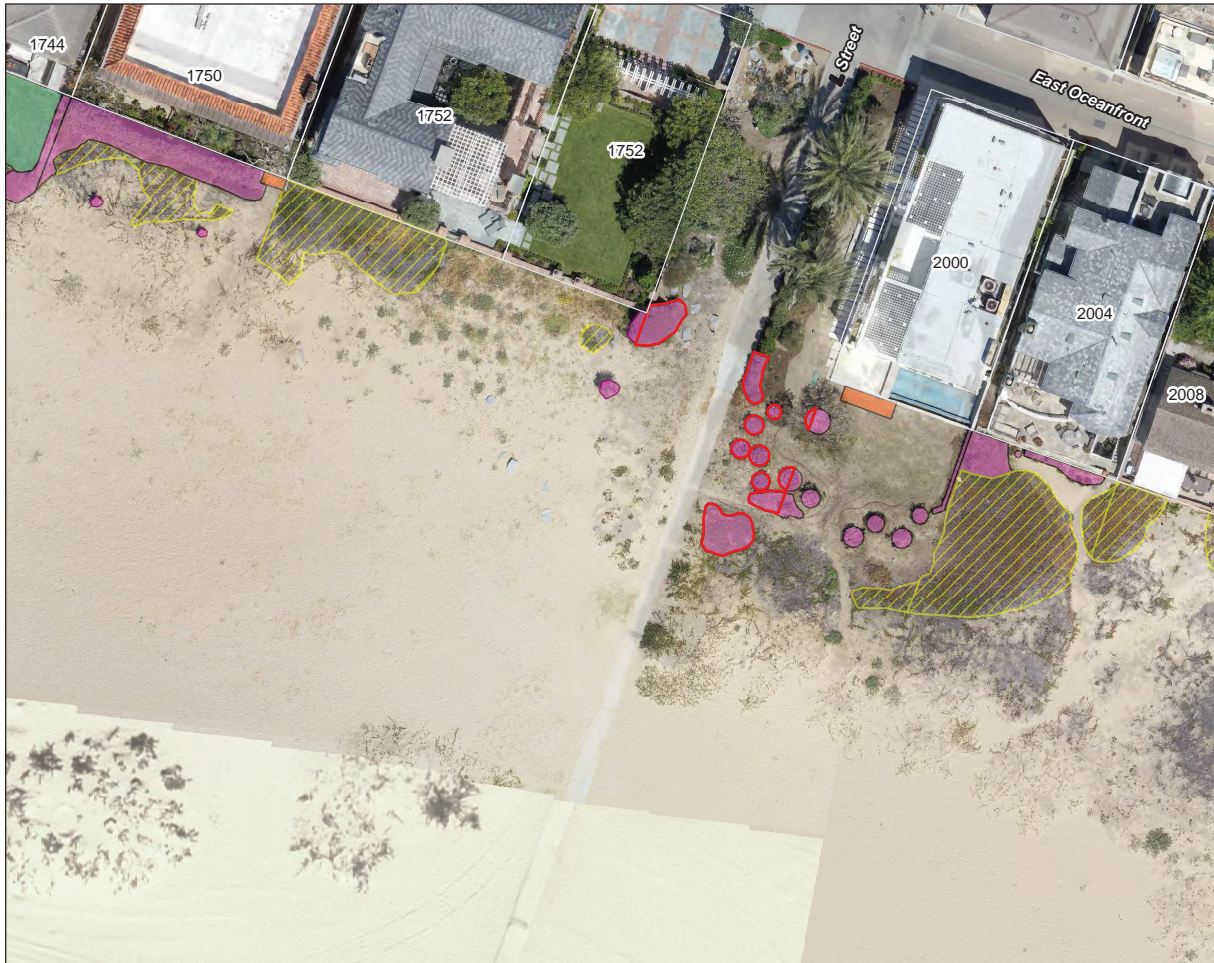
- Parcel Boundary
- Phase 1 - Encroachment Removal**
- Hardscape/Stepping Stones
- Lawn
- Ornamental Shrub/Groundcover
- Ornamental Tree
- Wildland Weeds/Escaped Ornamental
- City Restoration Area\*
- \*Areas labelled "City Restoration Area" are not associated with any private residence address, but will be subject to removal and restoration activity by the City
- Phase 2 - Iceplant Removal**
- Iceplant

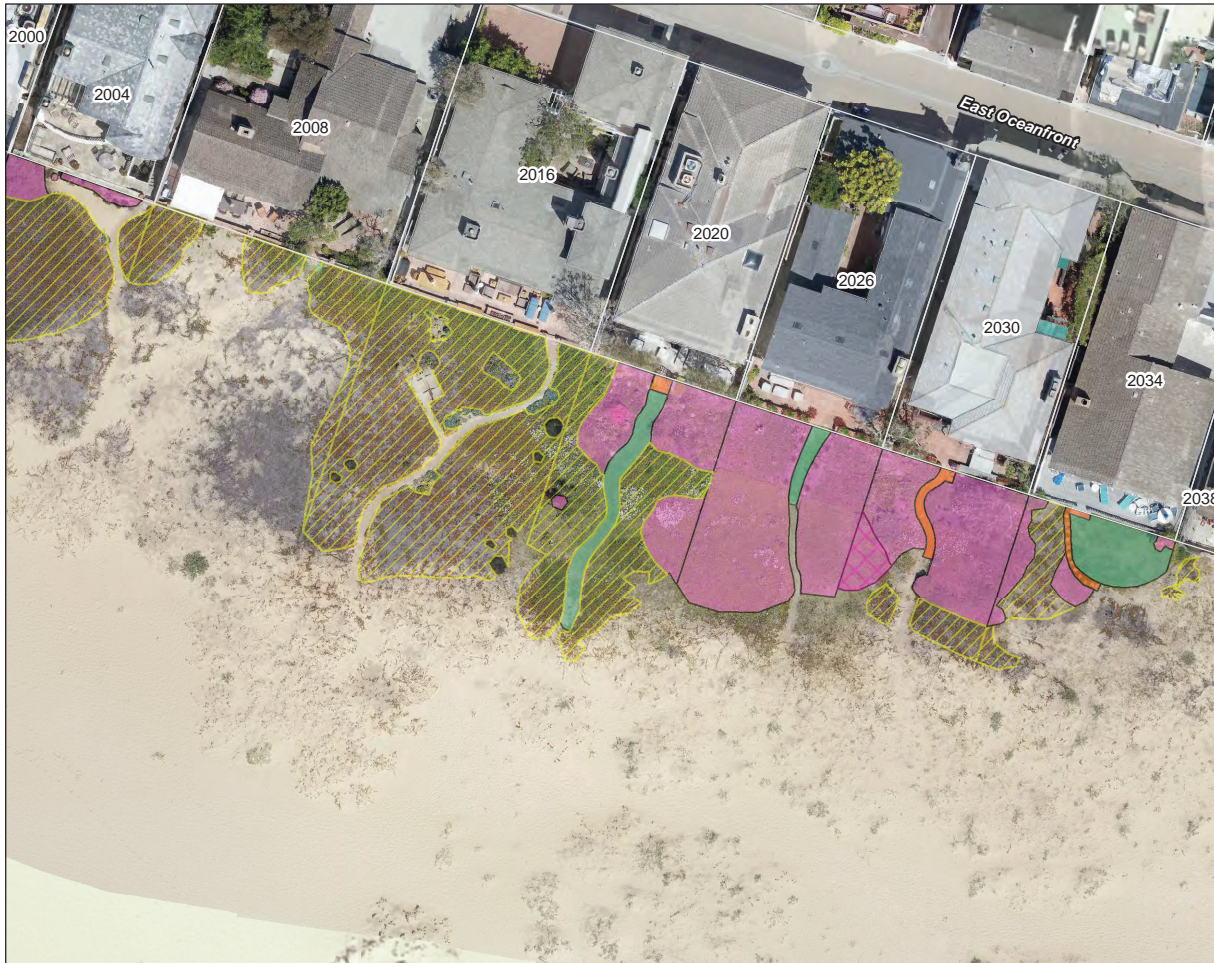
Exhibit 3 - Page 8

- Parcel Boundary
- Phase 1 - Encroachment Removal**
- Hardscape/Stepping Stones
- Lawn
- Ornamental Shrub/Groundcover
- Ornamental Tree
- Wildland Weeds/Escaped Ornamental
- City Restoration Area\*

\*Areas labelled "City Restoration Area" are not associated with any private residence address, but will be subject to removal and restoration activity by the City

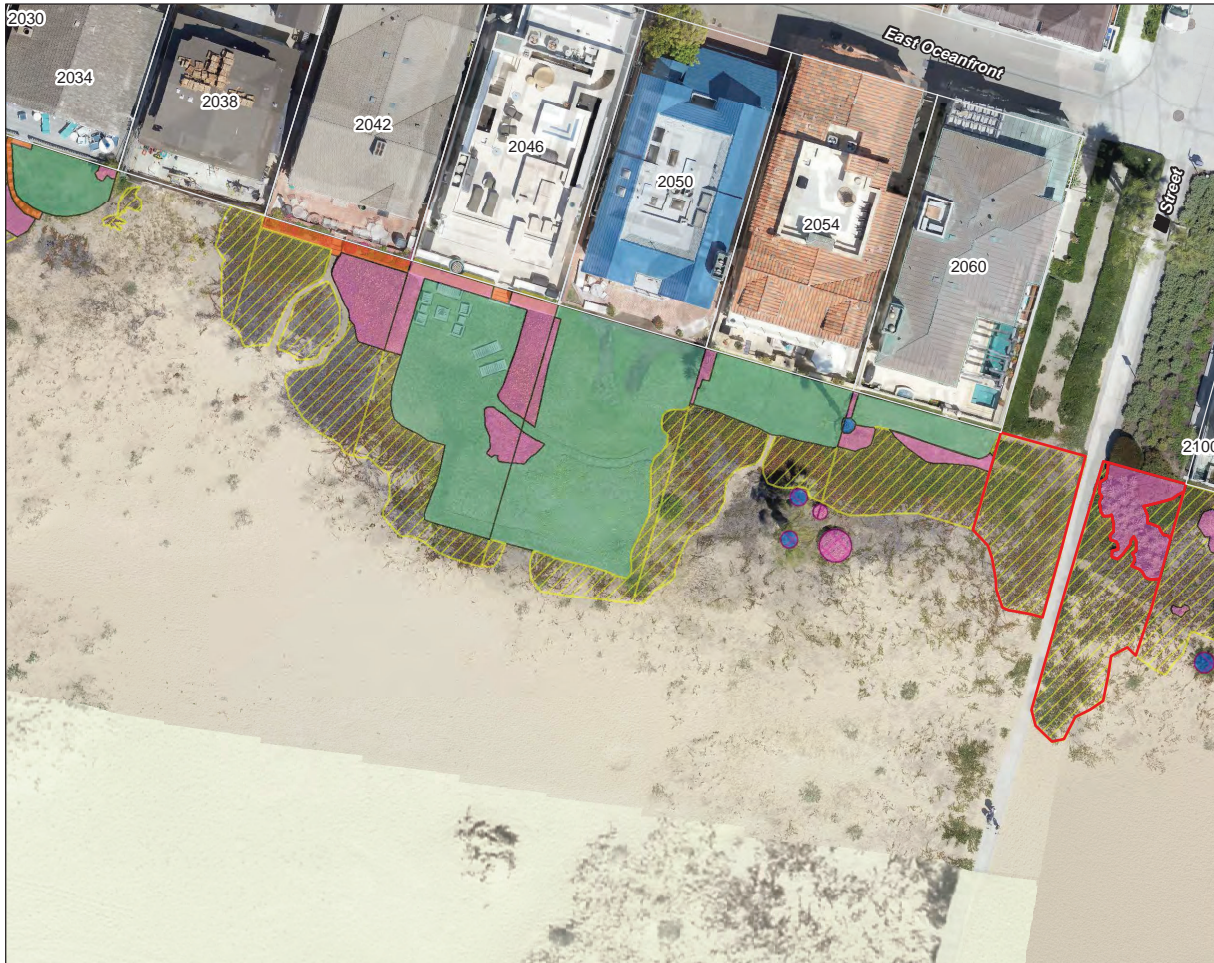
**PENINSULA POINT ENCROACHMENT  
REMOVAL AND REPLACEMENT PLAN**  
East o L Street

- Parcel Boundary
- Phase 1 - Encroachment Removal**
- Hardscape/Stepping Stones
- Lawn
- Ornamental Shrub/Groundcover
- Ornamental Tree
- Wildland Weeds/Escaped Ornamental
- City Restoration Area\*
- Phase 2 - Iceplant Removal**
- Iceplant

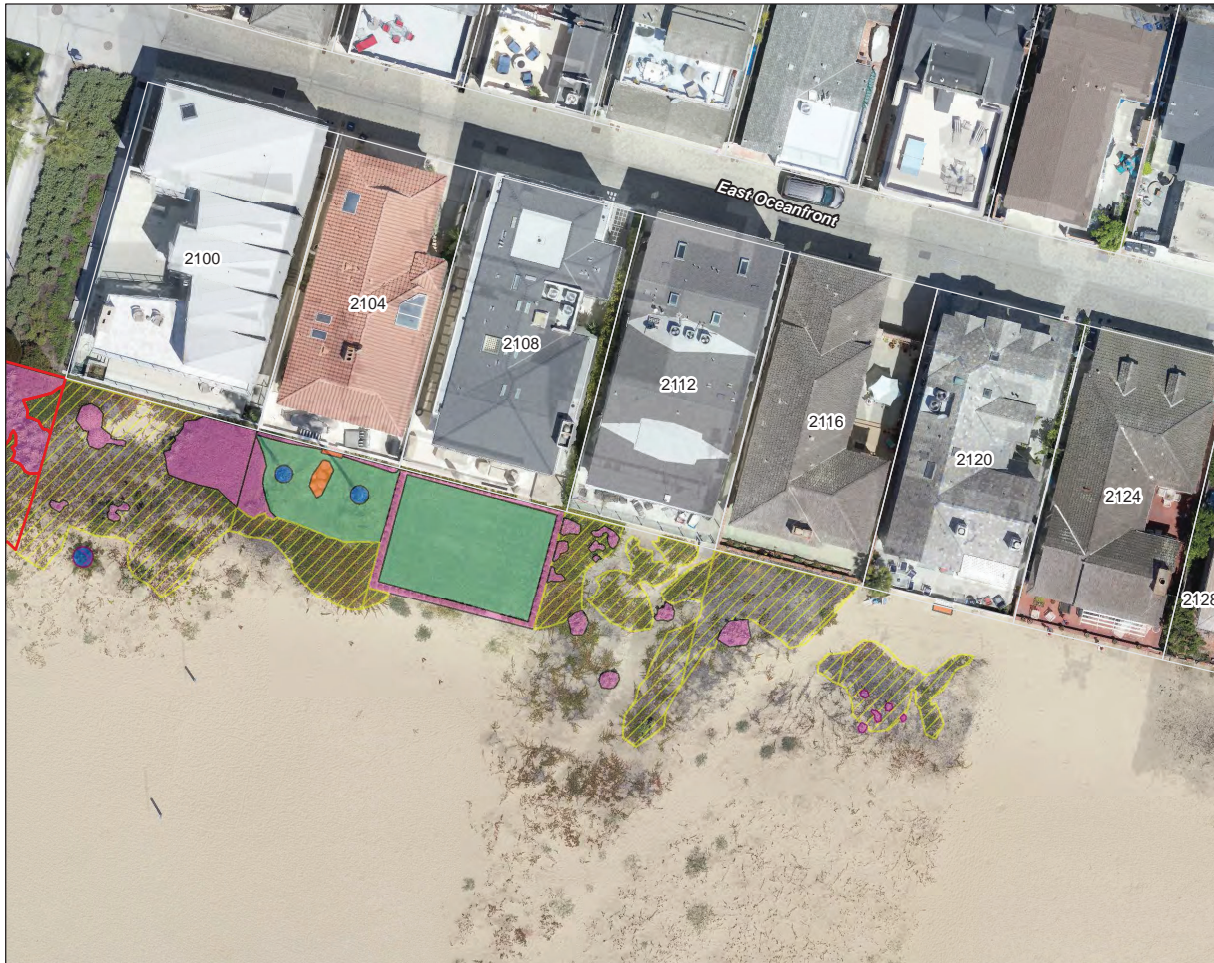
Exhibit 3 - Page 10

- Parcel Boundary
- Phase 1 - Encroachment Removal**
- Hardscape/Stepping Stones
- Lawn
- Ornamental Shrub/Groundcover
- Ornamental Tree
- Wildland Weeds/Escaped Ornamental
- City Restoration Area\*  
\*Areas labelled "City Restoration Area" are not associated with any private residence address, but will be subject to removal and restoration activity by the City
- Phase 2 - Iceplant Removal**
- Iceplant

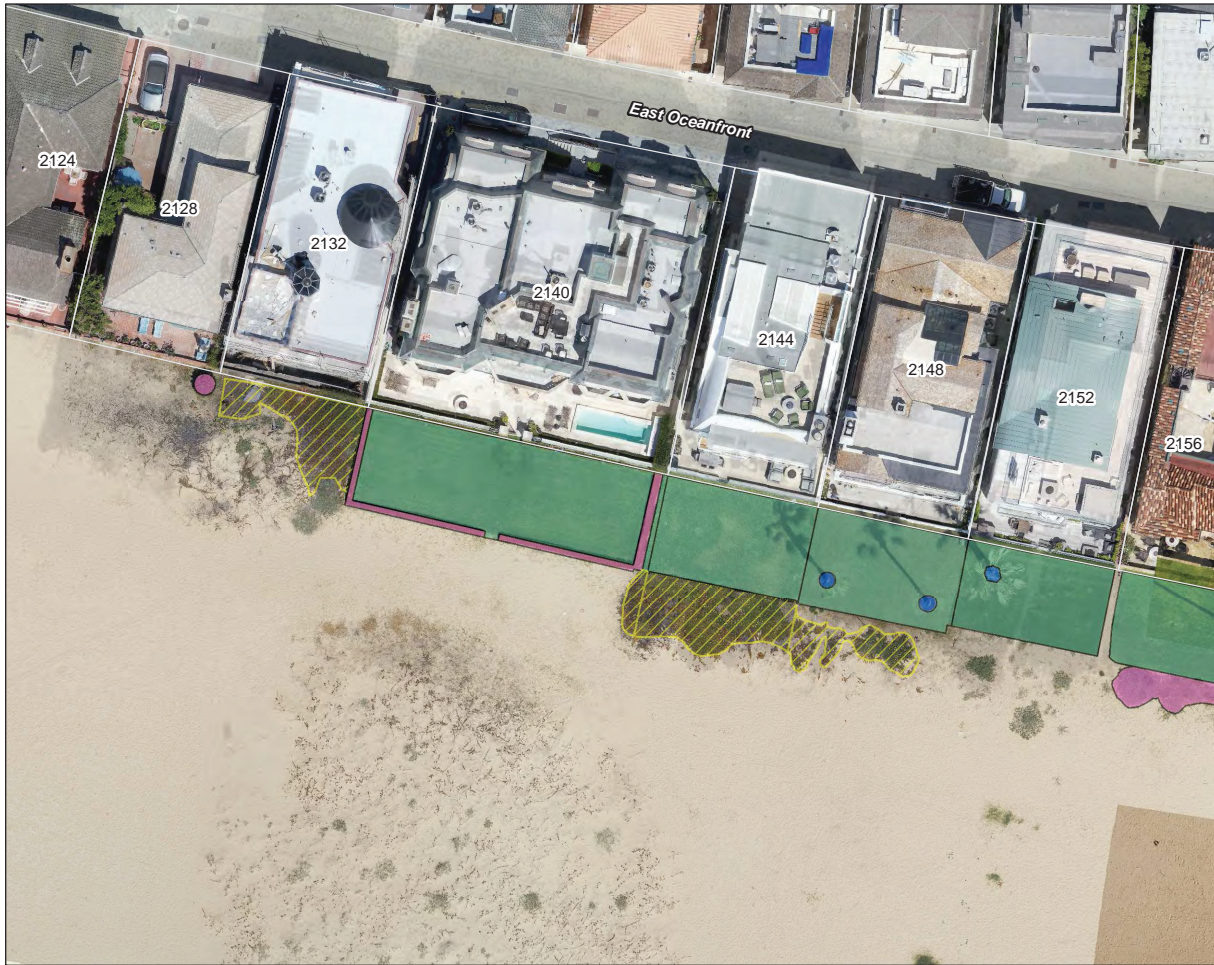
Exhibit 3 - Page 11

- Parcel Boundary
- Phase 1 - Encroachment Removal**
- Hardscape/Stepping Stones
- Lawn
- Ornamental Shrub/Groundcover
- Ornamental Tree
- Wildland Weeds/Escaped Ornamental
- City Restoration Area\*  
\*Areas labelled "City Restoration Area" are not associated with any private residence address, but will be subject to removal and restoration activity by the City
- Phase 2 - Iceplant Removal**
- Iceplant
