Appendix I
Eelgrass Survey

***MARINE BIOLOGICAL IMPACT ASSESSMENT
FOR A DOCK RENOVATION PROJECT
LOCATED IN CARNATION COVE, CORONA DEL MAR, CA 92625***

***May 12th, 2008
Revised March 4th, 2009***

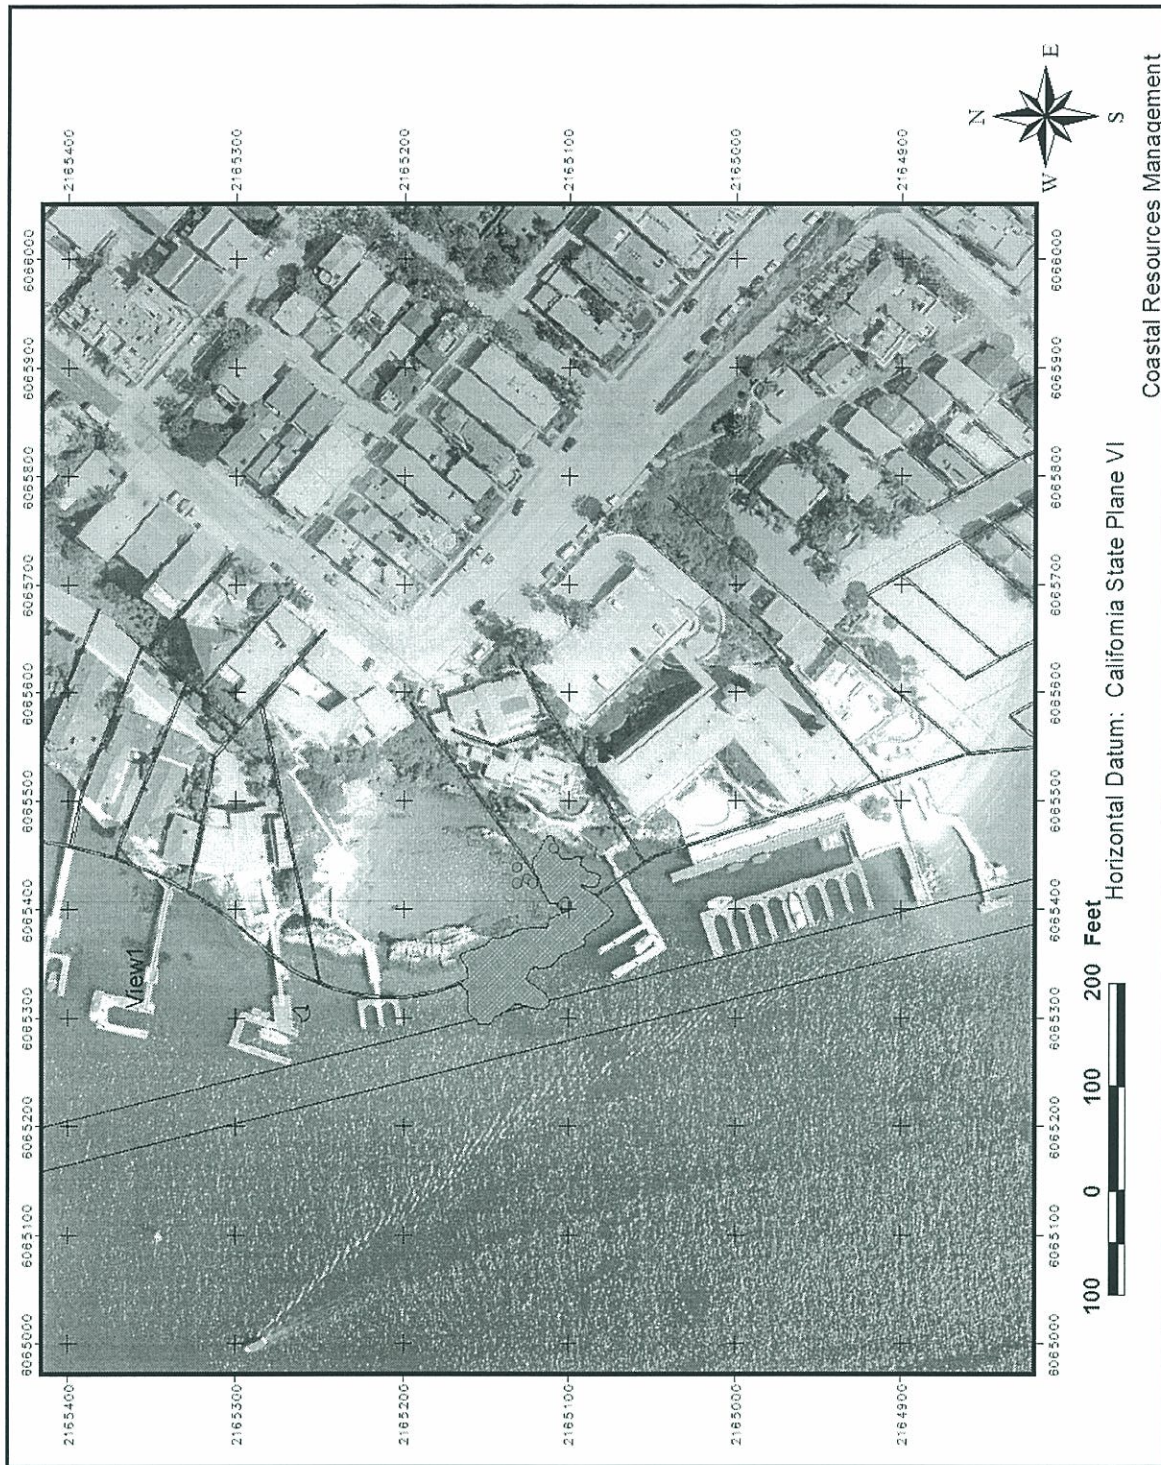
Figure 3. Location of Eelgrass in the Project Area, March, 2005

Eelgrass habitat maps for the 2005 and 2007 are shown in Figures 3 and 4, respectively. In 2005, a total of 10,155.4 square feet (0.233 acre) of eelgrass was mapped in the project vicinity. Of this total, 0.231 acre (99%) was mapped south of the existing boat dock. One small patch occurred outside the project boundary, 42 ft north of the project area dock. The remaining eelgrass bed began 62 ft south of the dock, and extended past the project area boundaries to the docks located at the Channel Reef apartment complex. The epifaunal snail

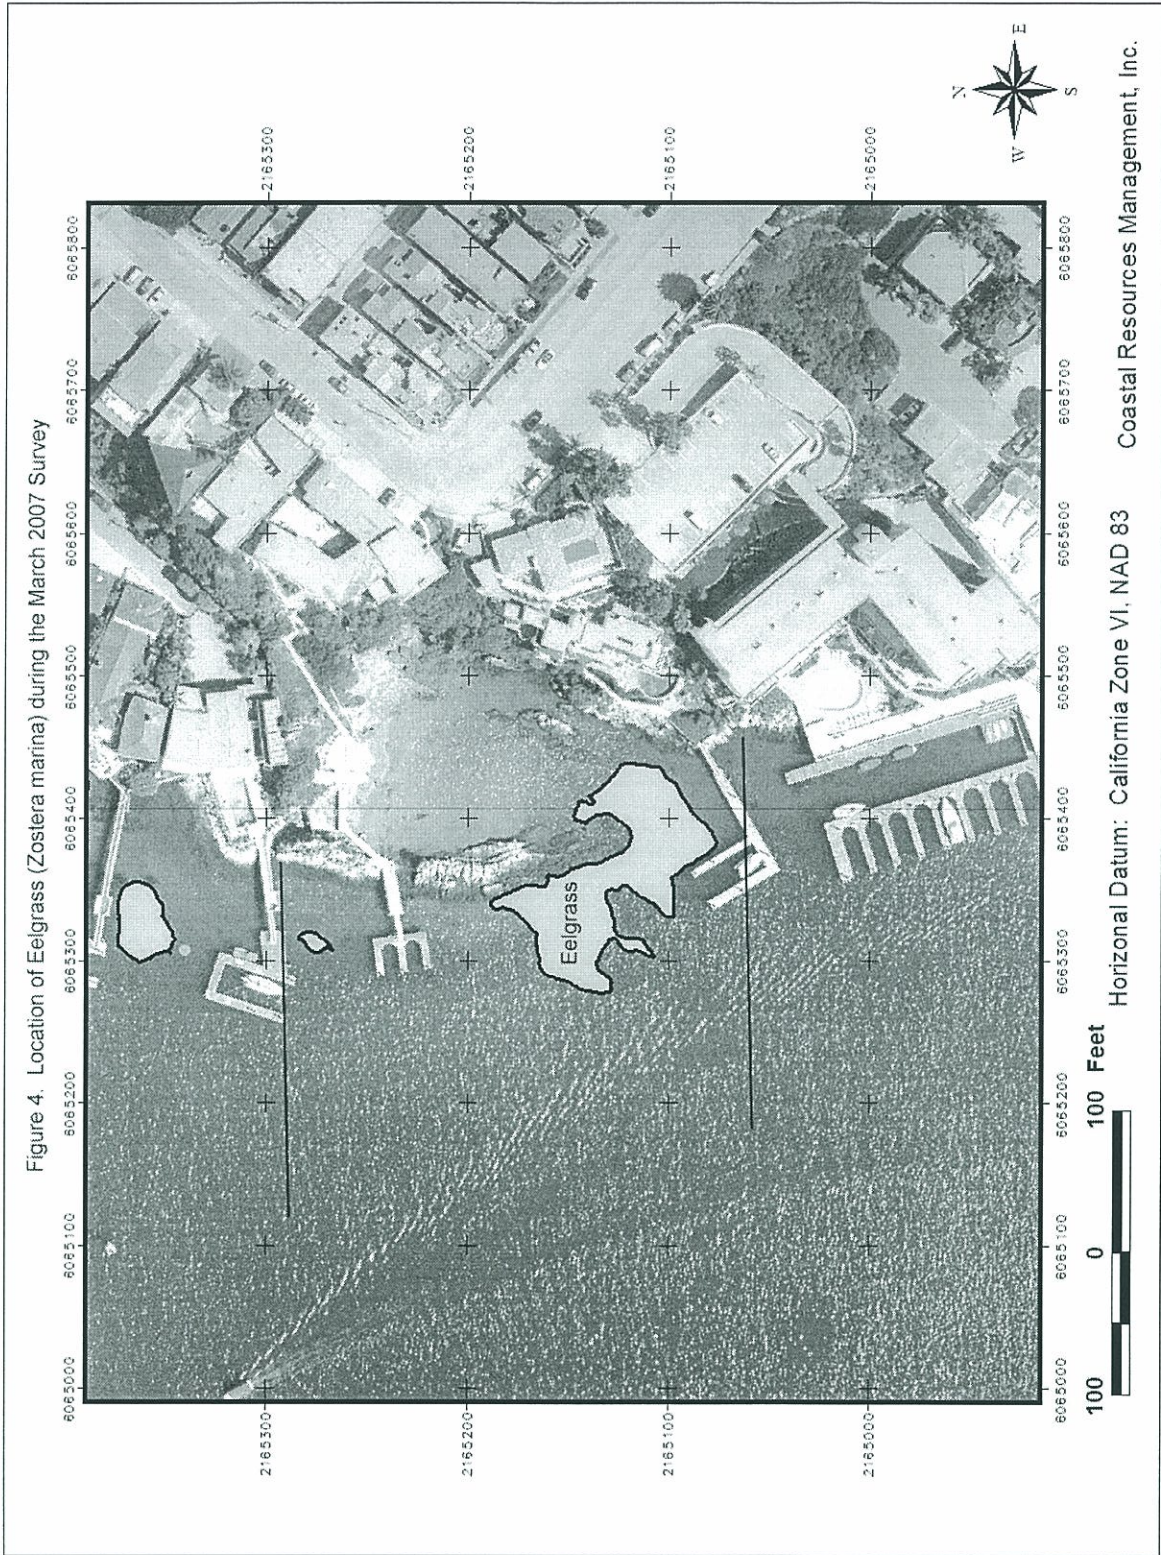
Eelgrass distribution in 2007 generally mimicked the distribution in 2005 with some slight boundary differences. The total amount of eelgrass in 2007 (10,062 sq ft; 0.231 acre) slightly declined compared to 2005 (Figure 3 and 4). A total of 9,888.12 square feet (0.227 acre) was mapped south of the project area dock, and another 0.04 acre was present north of the project area dock during the 2007 survey. The decline in eelgrass cover (0.02 acre), while small, was associated with bay-wide eelgrass habitat area reductions observed between 2005 and 2007 (CRM, in preparation).

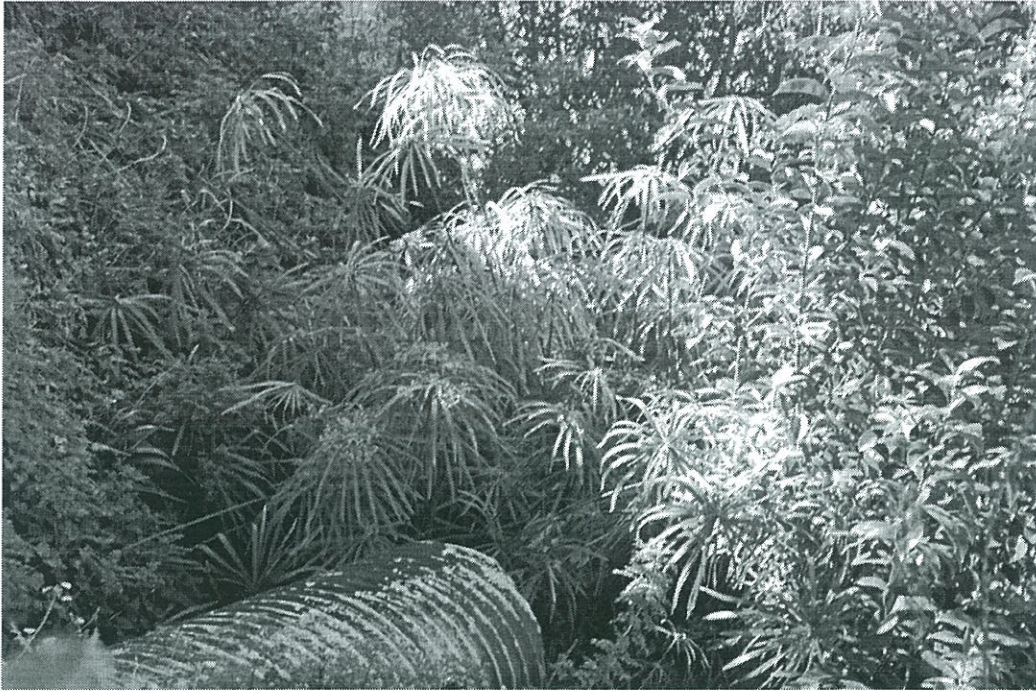
Photograph 1. View of discharge pipe with African umbrella sedge mixed with other ornamentals. Photograph taken on 12-10-2008.

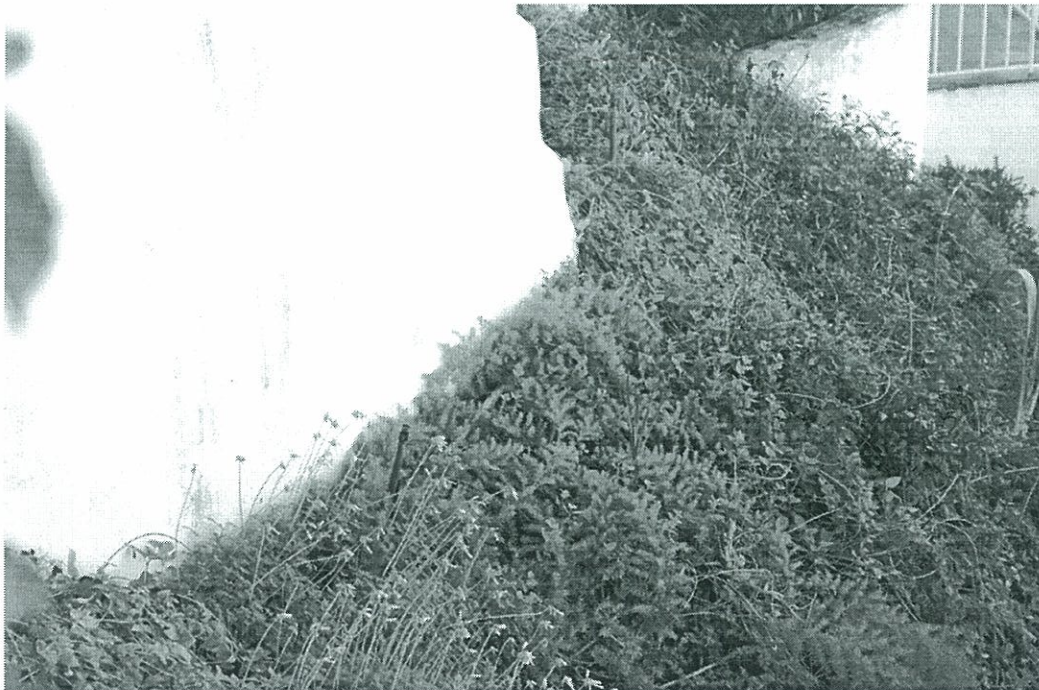
Photograph 2. This photograph depicts irrigation lines visible immediately above the area vegetated with African umbrella sedge. Photograph taken on 12-10-2008.
