PHASE I ENVIRONMENTAL SITE ASSESSMENT

Proposed Newport Beach City Hall

APNs 442-014-24, 442-014-25, 442-014-26, and 442-014-27

Newport Beach, California

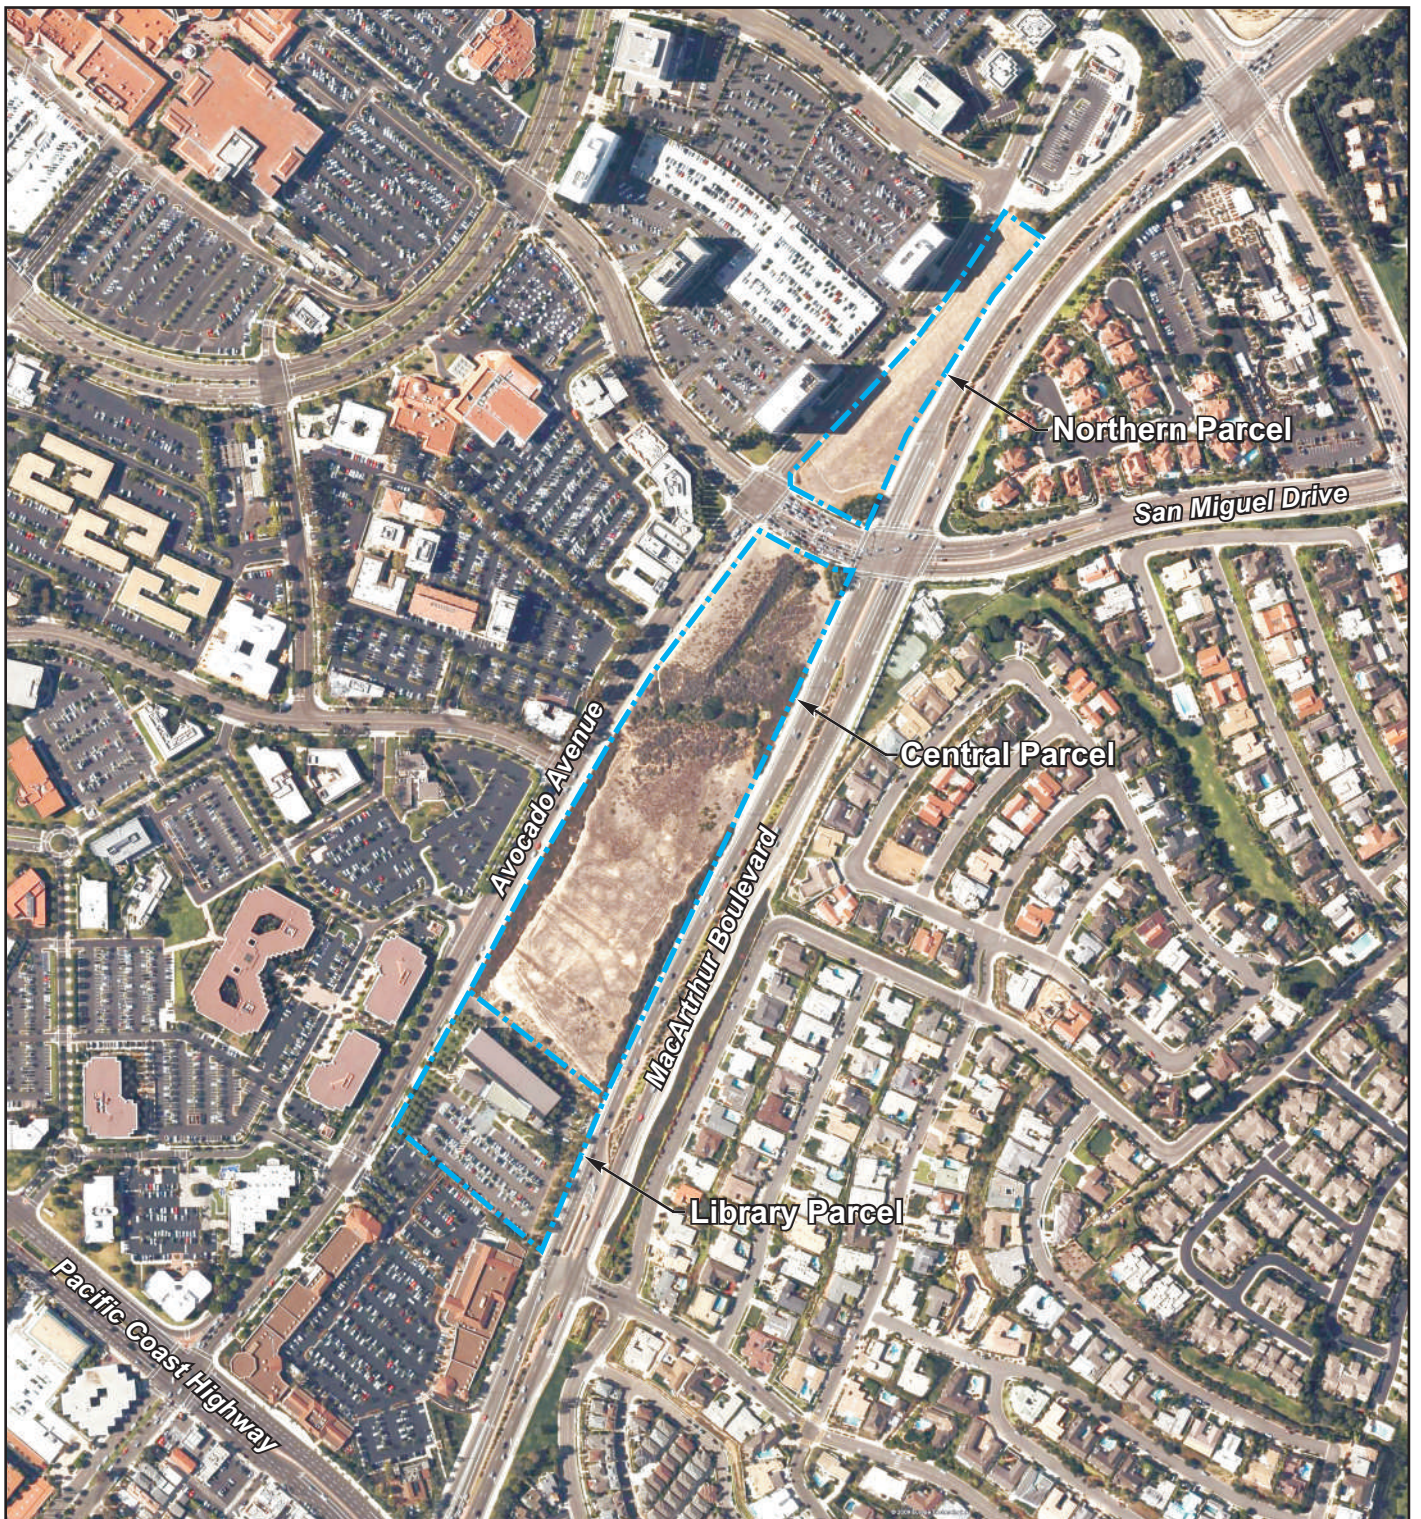
The Site is located east of Avocado Avenue, between the OCTA Newport Transportation Center to the north and the shopping center to the south, in Newport Beach, California (Figure 1, Site Location Map). The Site currently consists of the Library and two vacant parcels of land vegetated with grassland and bushes. The Site Plan is shown on Figure 2.
