Appendix D - Site Photographs

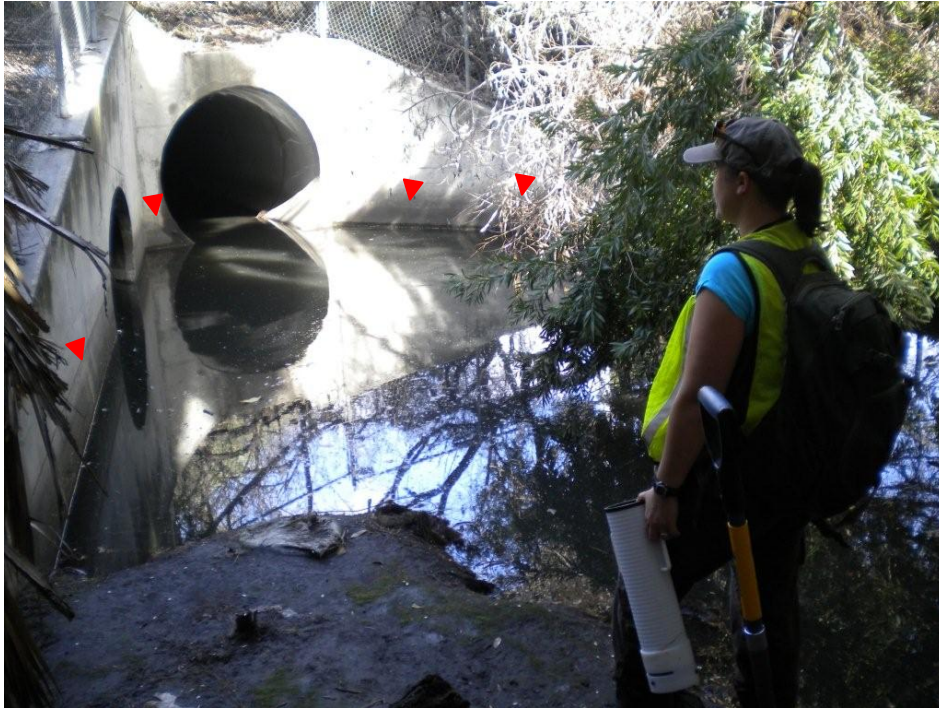
Photograph 1:

View of the drainage and Open Water as it water flows from two concrete culverts that pass beneath Jamboree Road. The current water level is approximately 18 inches below the ordinary high water mark. The ordinary high water mark can be seen by the water mark located on the concrete outlet structure (red arrows) and this represents the limits of USACE jurisdiction at this location. In addition to USACE jurisdiction, this Drainage is also subject to RWQCB, CDFG and CCC jurisdictions.

This drainage culvert and the ornamental vegetation have potential to support sensitive bat species that may be affected by surface grading and construction activities that may occur directly above the culvert. No sensitive aquatic species are expected to be affected by the Project.

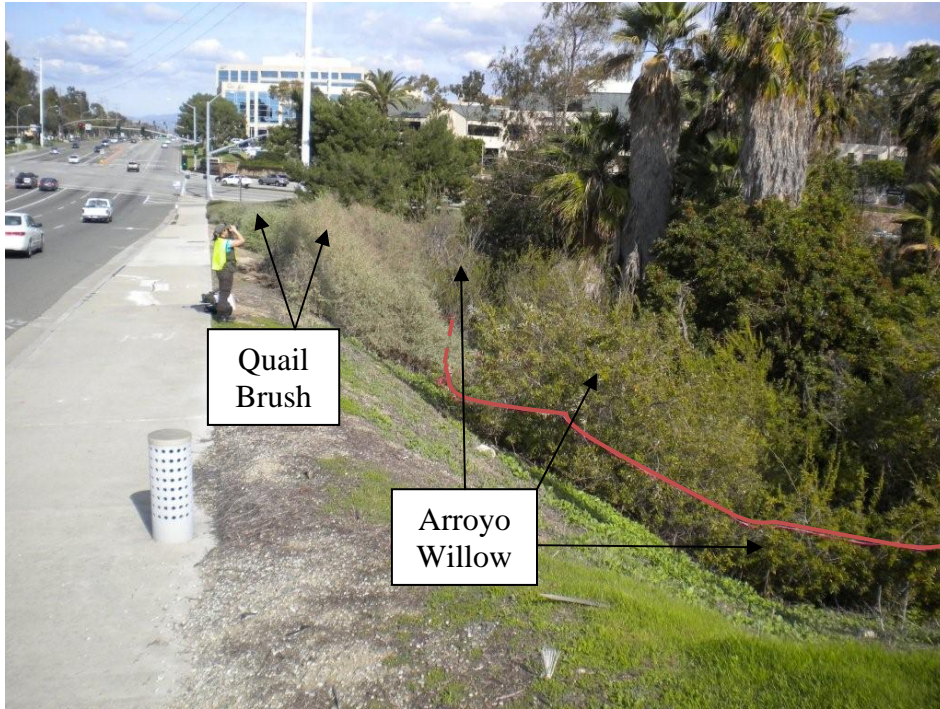
Photograph 2:

View of the limits of CDFG and CCC jurisdiction and Riparian Scrub vegetation. The red flagging tape indicates the most upslope extent of CDFG riparian habitat and CCC-defined wetland. The vegetation flagged by red tape is Arroyo Willow, which is commonly associated with streams and wetlands. Quail Brush (located immediately upslope of the Arroyo Willow and adjacent to the sidewalk) and turf grass (foreground) is not considered to be a CCC-defined wetland or CDFG riparian habitat.

The upland scrub vegetation (Quail Brush Scrub) has a low potential to support the sensitive terrestrial species such as the Two-strip Garter Snake. Nesting birds may be present during nesting season February 15 to August 31. The Riparian Scrub (Arroyo Willows) down slope of the Quail Brush Scrub has potential to support a variety of sensitive nesting birds during nesting season as well.

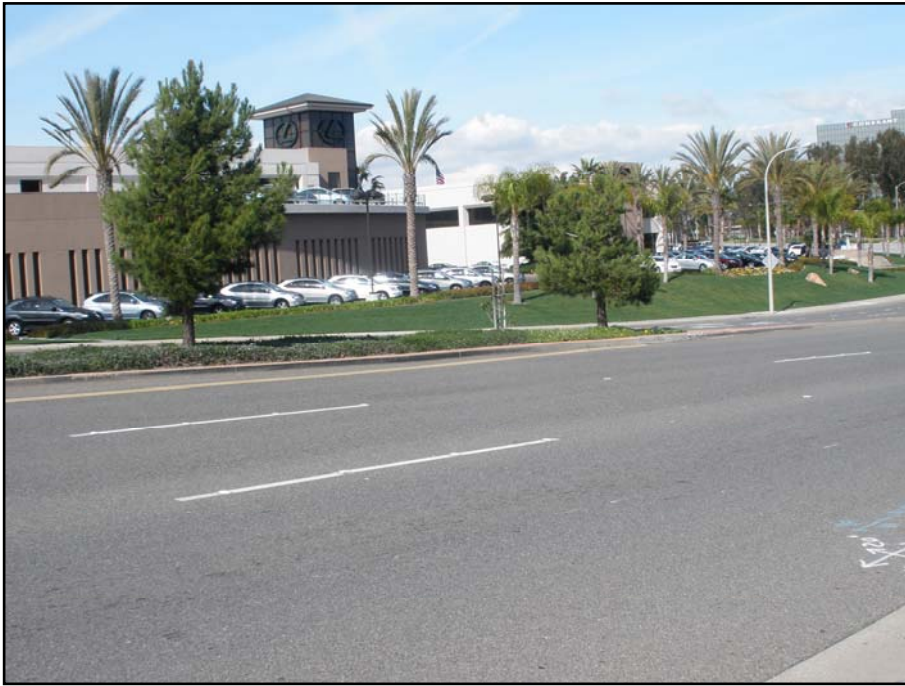
Photograph 4:

Representative photograph of “Developed Lands/Ornamental Landscaping.” Developed areas within the Project limits of construction are subject to high volumes of vehicle and pedestrian traffic and noise. Ornamental trees could serve as nest sites for CDFG and MBTA nesting birds. There is potential, although low, for roosting bats within the buildings and ornamental trees (e.g. Palm Trees).

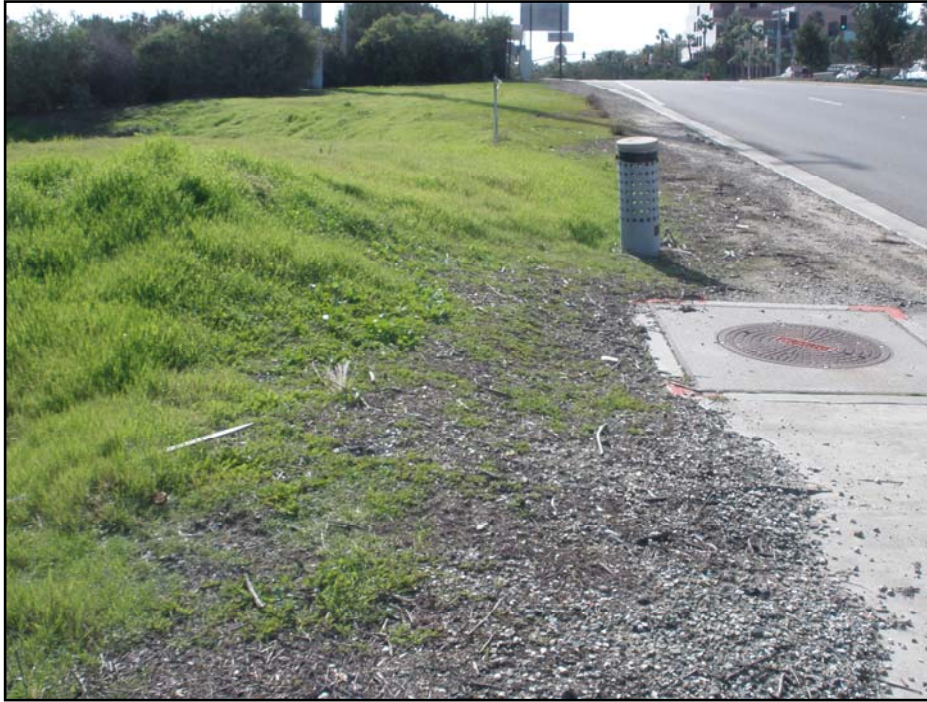
Photograph 5:

Representative example of "Disturbed" areas located within the BSA. These areas have low biological diversity and are degraded by human activity by trash, debris, and regular maintenance/vegetation clearing. They may serve as foraging habitats for raptors.
