RISK Assessment® Report

**1 Newport Beach Pier
Newport Beach, CA 92663**

**Confidential Inspection Report
1 Newport Beach Pier
Newport Beach, CA 92663**

Prepared for: City of Newport Beach

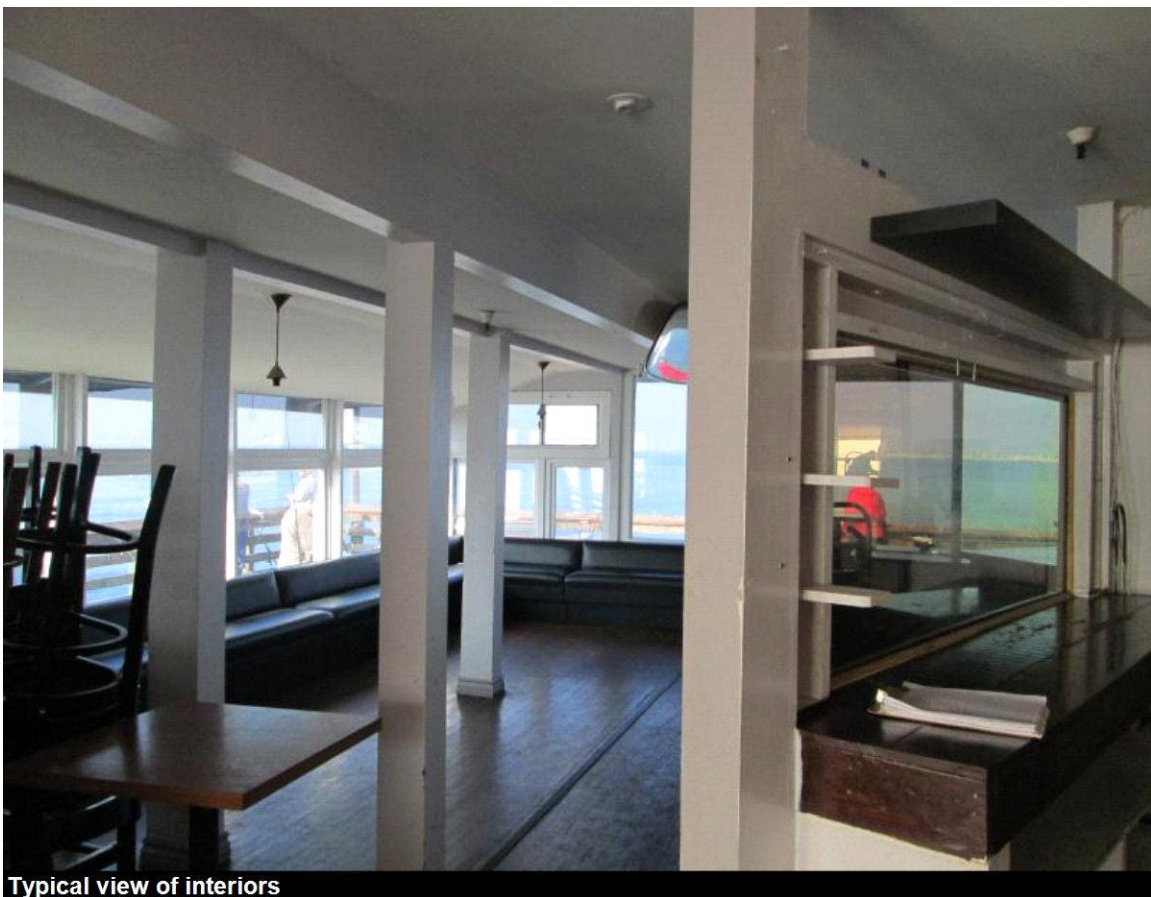
The restaurant has sloping or uneven wooden or tile floors. Walls and ceilings are aged and worn. Wires are hanging and equipment is very aged and corroded such as the exhaust system and walk-in coolers. Much interior upgrade would need to be done to make the restaurant occupiable.

Typical view of interiors

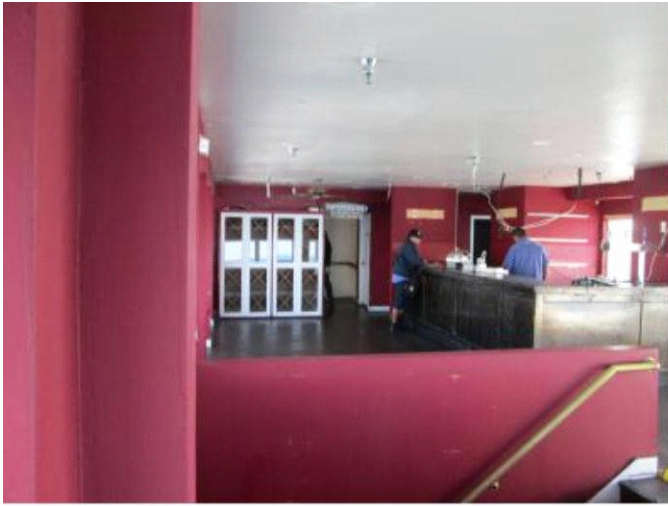
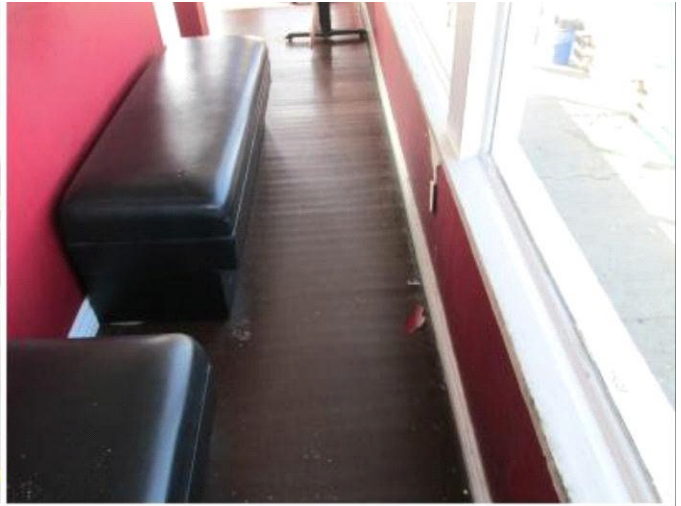
Serviceable overall.

2nd floor interiors
