**Subject: City of Newport Beach Balboa Island Coping Repair Project (C-7066-1)**

**PROPOSED PROJECT:** Balboa Island Seawall Coping Repair Project

Repair and maintenance of existing seawalls, and increase  
height of seawalls by 9 inches.

# Bulkhead Condition Report for Portions of the Balboa Island Seawall

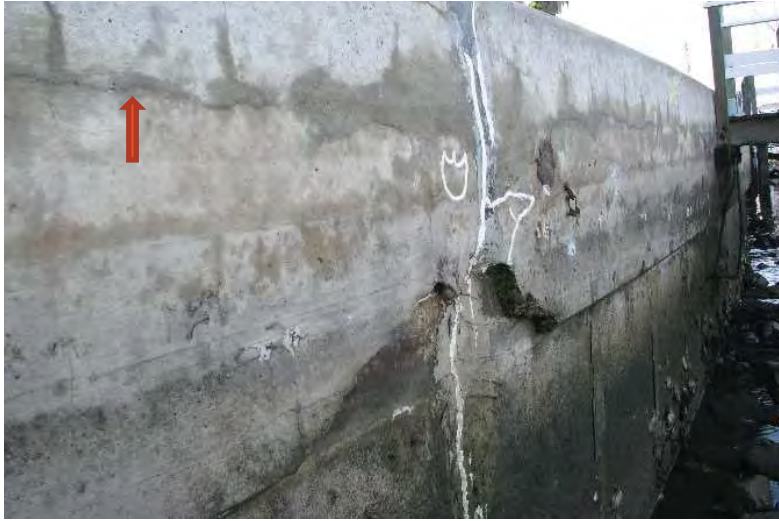
Figure 4 - Cold joint visible along Coping Type D

The connection between the previous and modified is simply two pins extending across the cold joint, each pin embedded 3 in. on either side of the joint. The connections appears to have held over the years, but the joint is visible from the outside as shown in Figure 4.

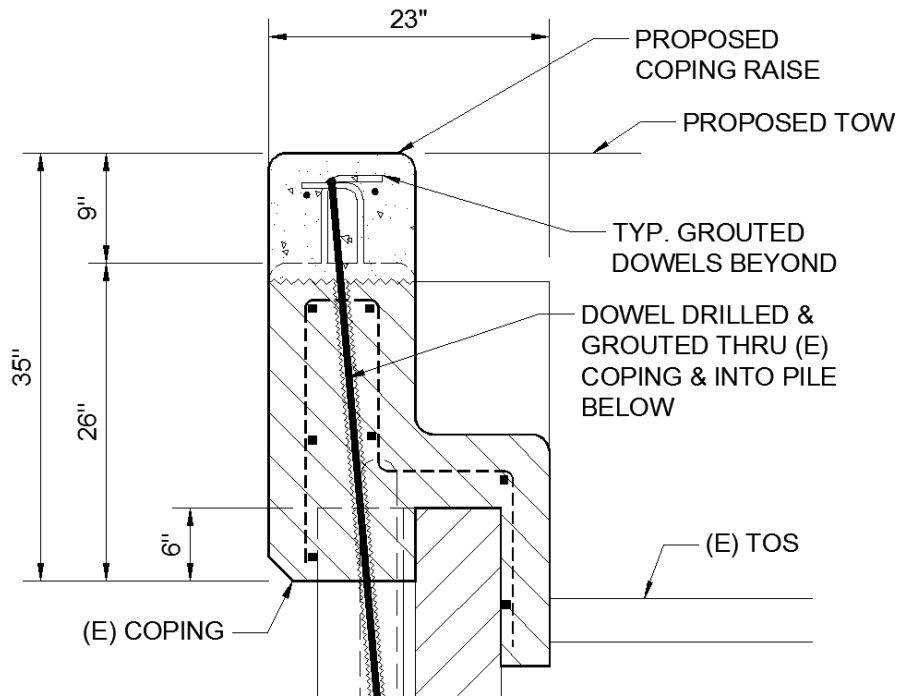
Figure 7 - Detail of Proposed Connection between (E) Coping and (E) Pile

Because of the lack of a positive connection between the existing coping and the wall and piles below, and because the added height will add some extra lateral load to the wall, a positive connection is desirable. This can be easily accomplished by extending one of the dowel holes shown in Figure 6 that falls over each pile an additional 2 ft or so, through the cap and into the pile underneath. A singular, larger and longer dowel is grouted in place. See Figure 7.

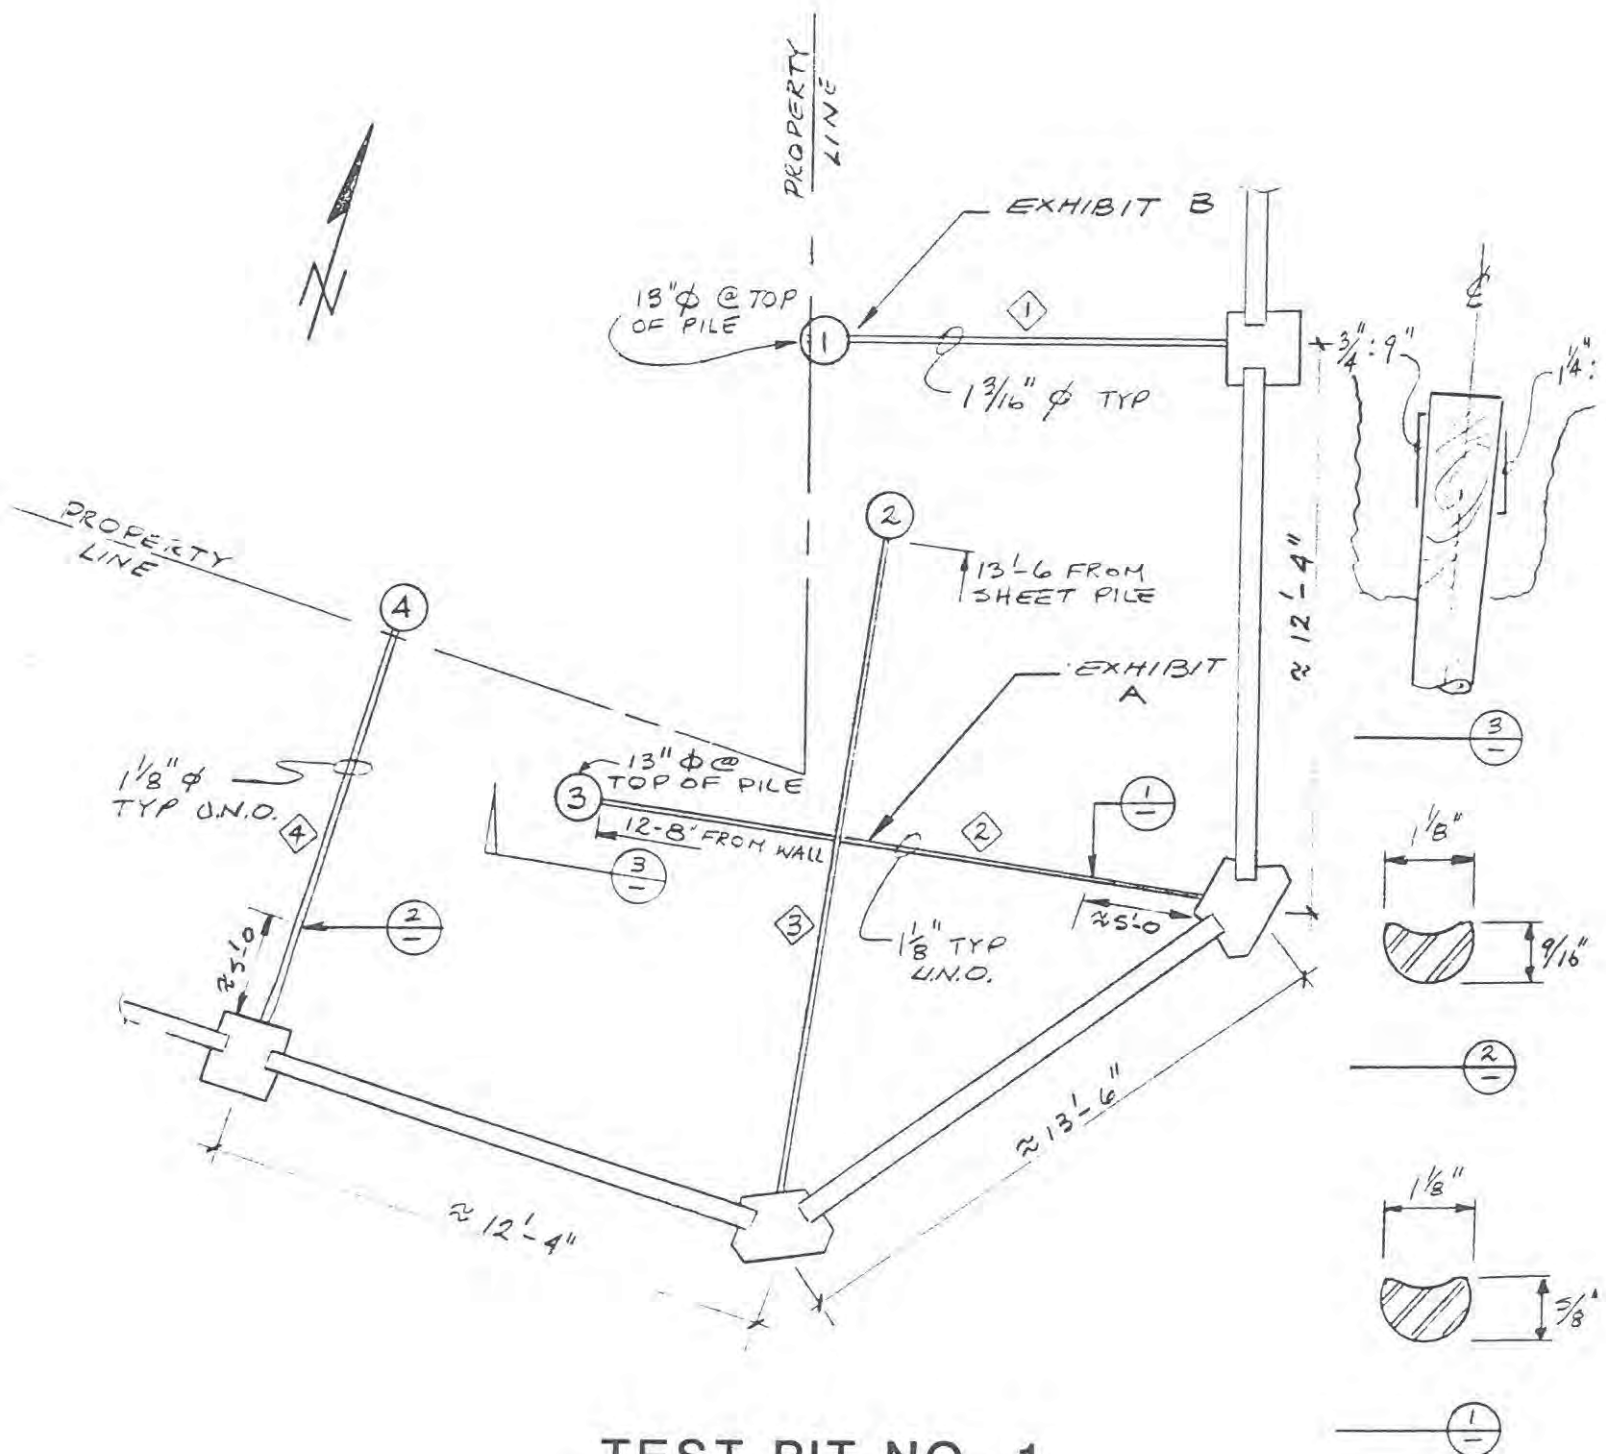
FIGURE NO. 4

It should also be noted that the conditions observed do not coincide with the existing drawing information. Drawings indicated that a common timber pile existed at the intersection of rod numbers 2 and 3. The condition which exists is that shown in Figure No. 4. The as-built geometry has greater lateral resistance than that shown on Dwg. No. R-5457-S sheet 10.

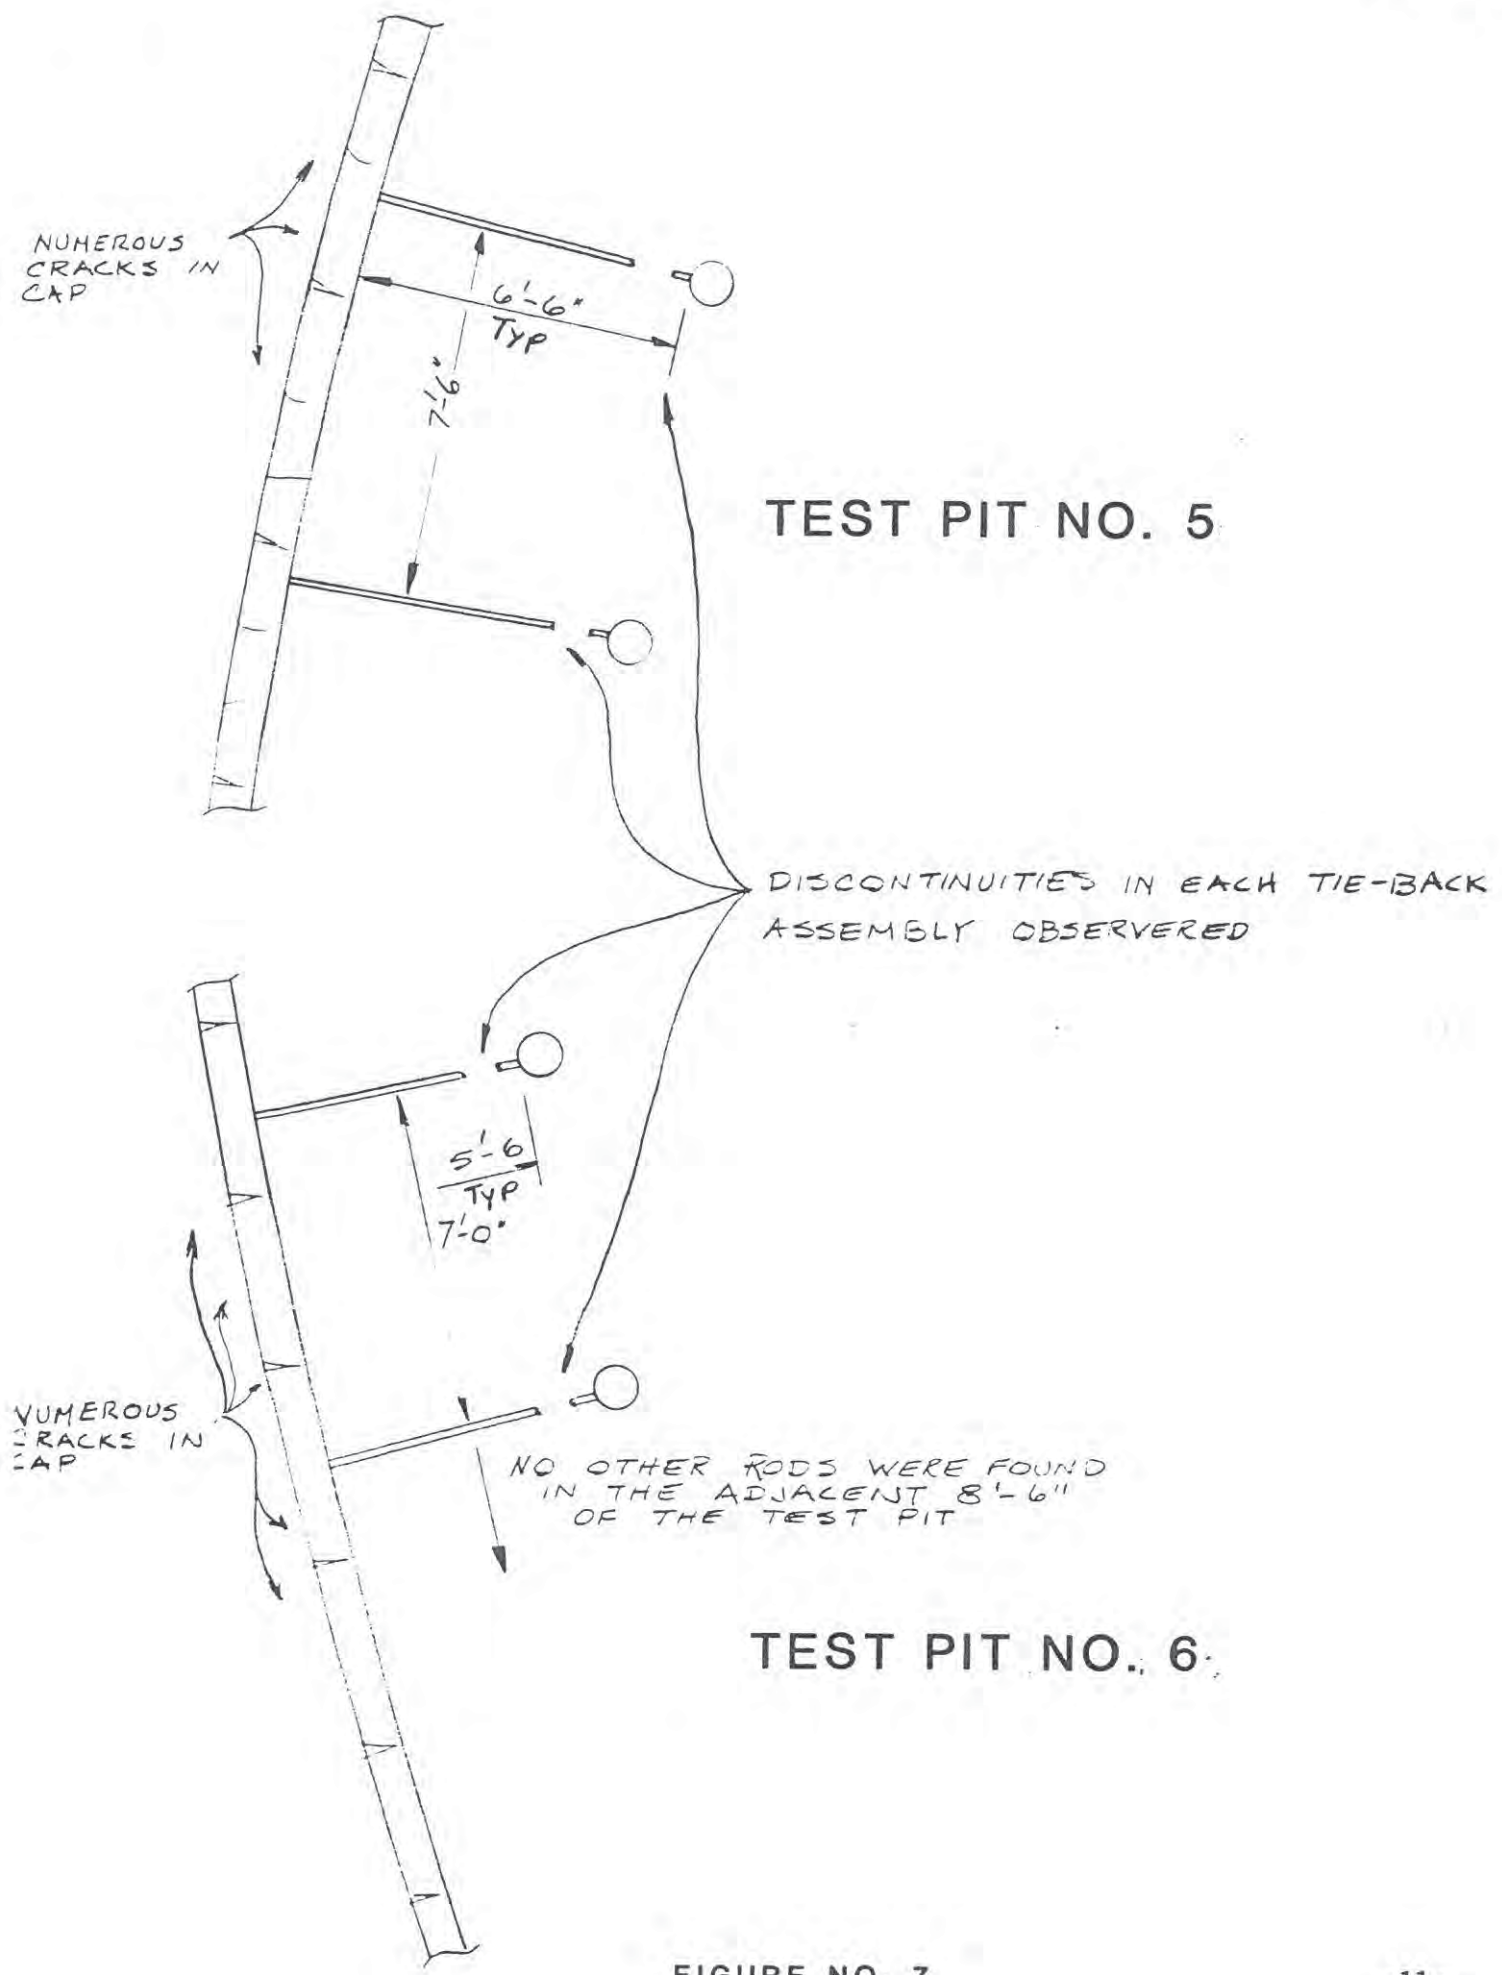
FIGURE NO. 7

1. Two rods in both Pits No. 5 and 6 were uncovered.
2. All rods were severely corroded and severed within 2'-0" of the timber pile.
3. Based on the existing spacing of the rods uncovered, one rod was missing in Test Pit No. 6.

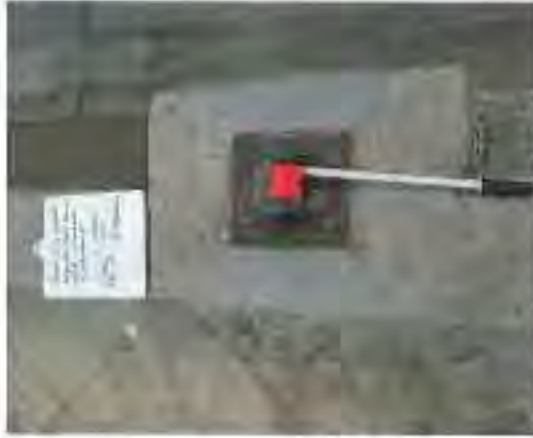
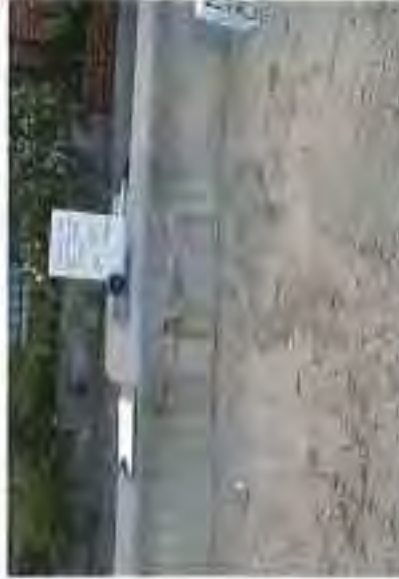
| Item Location | Description |
|---|---|
| 3 125' East of Emerald Avenue | Pullbox, landside cracks, waterside cracks through previous repair |

North Bay Front, 125' East of Emerald

| Item | Description | QUANTITY | | MATERIAL COST | | LABOR COST | | ENGINEERING ESTIMATE | |
|---|---|---|---|---|---|---|---|---|---|
| 3 | 125' East of Emerald Avenue, crack injection | 6 | LF | | | | | \$70.00 | \$420.00 |

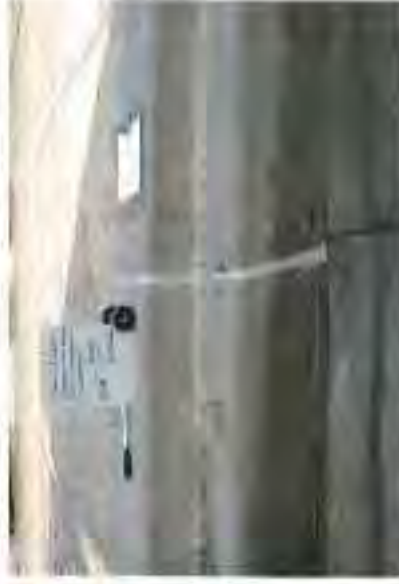
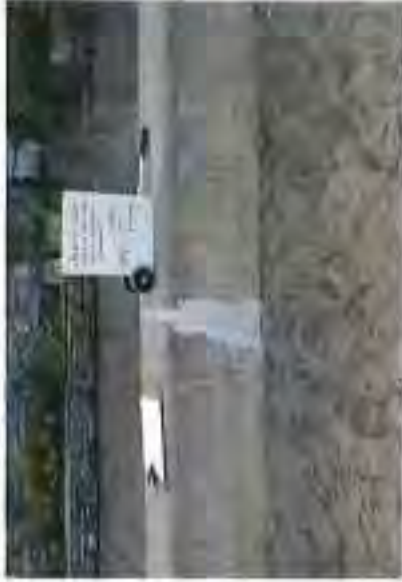
| Item Location | Description |
|---|---|
| 4 154' East of Emerald Avenue | Construction joint, sealant waterside in good condition, landside cracked and split |

North Bay Front, 154' East of Emerald

| Item | Description | QUANTITY | | MATERIAL COST | | LABOR COST | | ENGINEERING ESTIMATE | |
|---|---|---|---|---|---|---|---|---|---|
| 4 | 154' East of Emerald Avenue, sealant repair | 3 | LF | | | | | \$25.00 | \$75.00 |

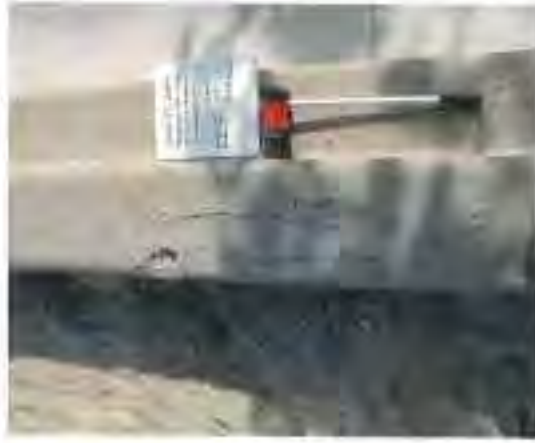
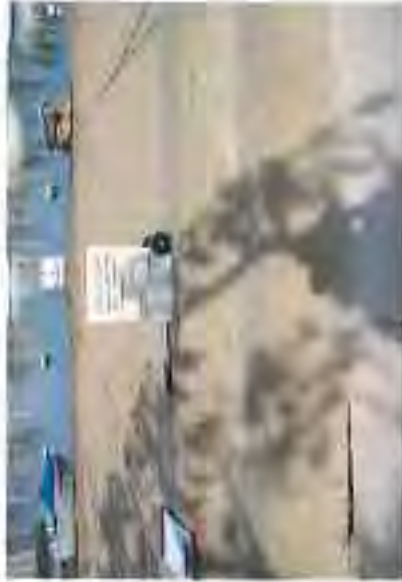
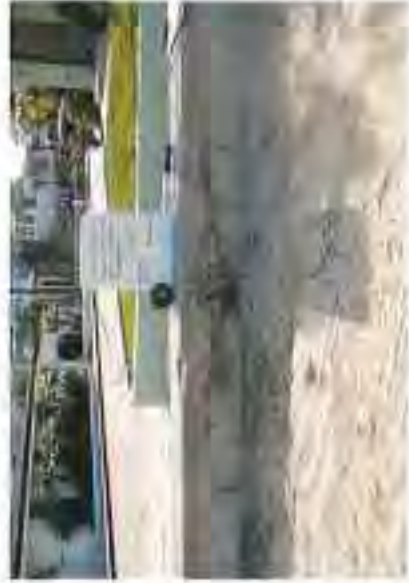
| Item Location | Description |
|---|---|
| 5 223' East of Emerald Avenue | Top of cap cracked, spill repair 4 SQ FT |

North Bay Front, 223' East of Emerald

| Item | Description | QUANTITY | | MATERIAL COST | | LABOR COST | | ENGINEERING ESTIMATE | |
|---|---|---|---|---|---|---|---|---|---|
| 5 | 223' East of Emerald Avenue, spall repair | 4 | SF | | | | | \$70.00 | \$280.00 |

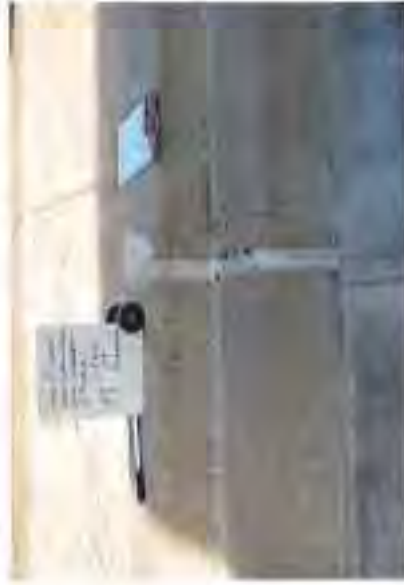
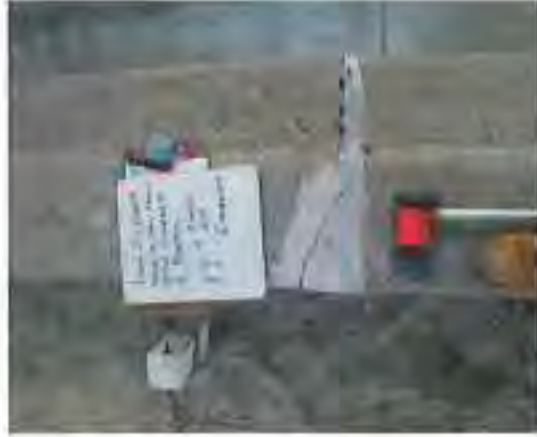
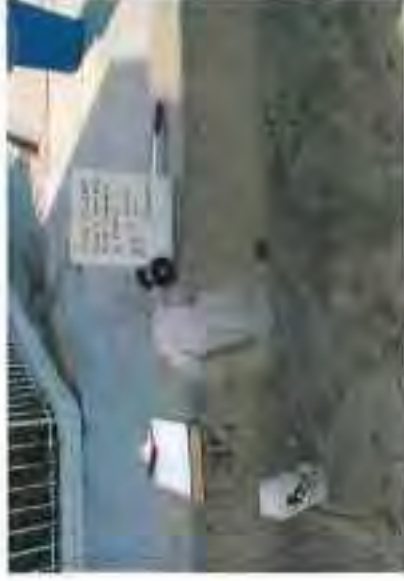
| Item | Location | Description |
|---|---|---|
| 4 | 17' East of Garnet Avenue | Waterside, crack through previous spall. |

17 feet East of Garnet

| Item | Description | QUANTITY | | MATERIAL COST | | LABOR COST | | ENGINEERING ESTIMATE | |
|---|---|---|---|---|---|---|---|---|---|
| 4 | 17' East of Garnet Avenue, crack injection | 3 | LF | | | | | \$70.00 | \$210 |

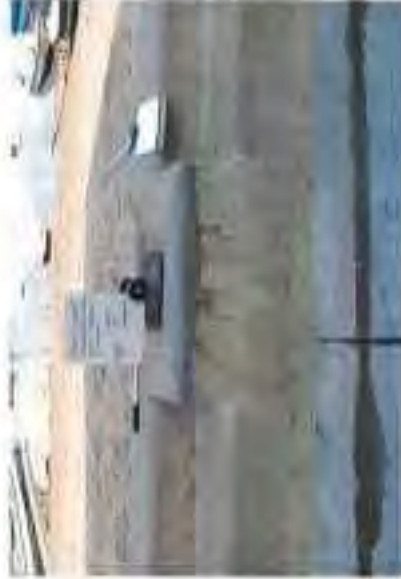
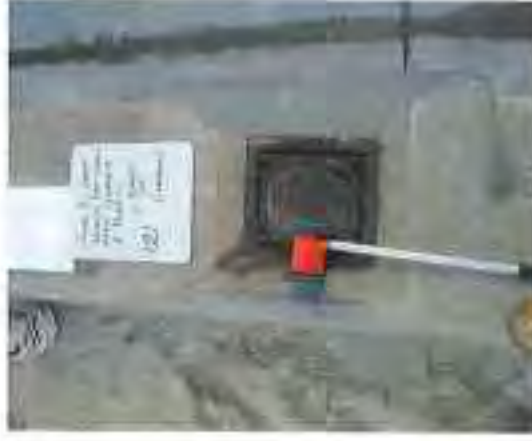
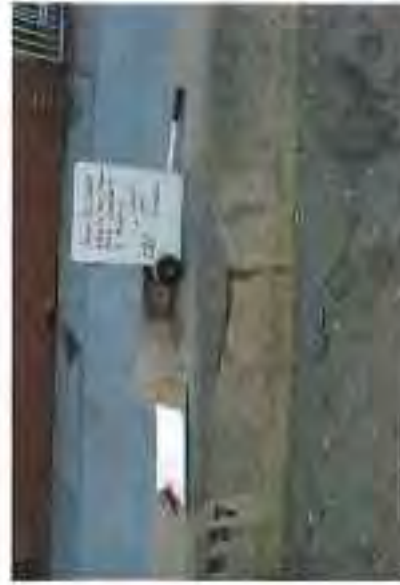
| Item | Location | Description |
|---|---|---|
| 6 | 121' East of Garnet Avenue | Pullbox, crack repair through previous spalls |

121 feet East of Garnet

| Item | Description | QUANTITY | | MATERIAL COST | | LABOR COST | | ENGINEERING ESTIMATE | |
|---|---|---|---|---|---|---|---|---|---|
| 6 | 121' East of Garnet Avenue, crack injection | 6 | LF | | | | | \$70.00 | \$420 |

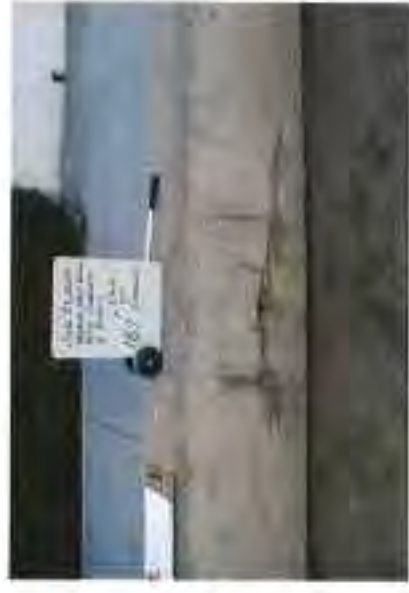
| Item | Location | Description |
|---|---|---|
| 9 | 187' East of Garnet Avenue | Waterside, crack at bottom of cap, 36" long |

187 feet East of Garnet

| Item | Description | QUANTITY | | MATERIAL COST | | LABOR COST | | ENGINEERING ESTIMATE | |
|---|---|---|---|---|---|---|---|---|---|
| 9 | 187' East of Garnet Avenue, crack injection | 3 | LF | | | | | \$70.00 | \$210 |

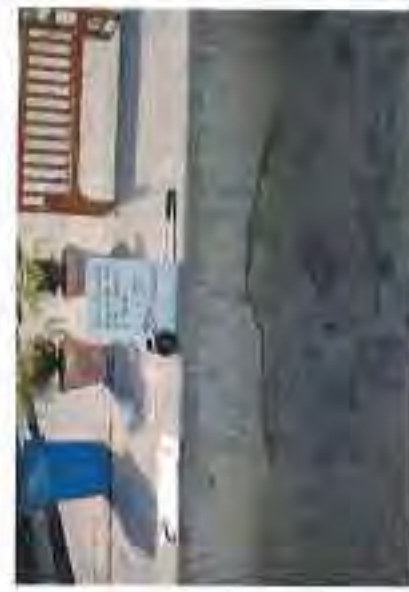
| Item | Location | Description |
|---|---|---|
| 11 | 230' East of Garnet Avenue | Waterside, crack at bottom of cap, 60" long |

230 feet East of Garnet

| Item | Description | QUANTITY | | MATERIAL COST | | LABOR COST | | ENGINEERING ESTIMATE | |
|---|---|---|---|---|---|---|---|---|---|
| 11 | 230' East of Garnet Avenue, crack injection | 5 | LF | | | | | \$70.00 | \$350 |

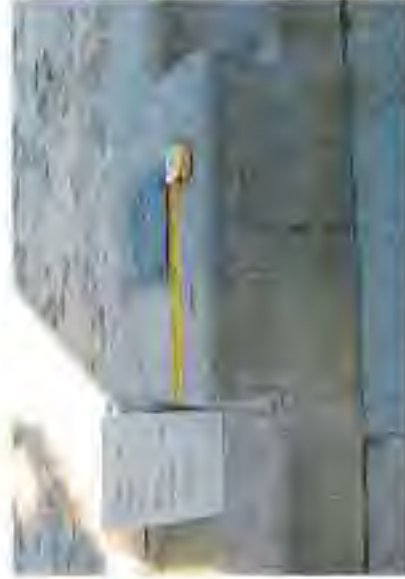
| Item Location | Description |
|---|---|
| 3 110' East of Pearl Avenue | Pullbox, waterside west and landside west corners are cracked 12" long |

North Bay Front, 110' East of Pearl

| Item | Description | QUANTITY | | MATERIAL COST | | LABOR COST | | ENGINEERING ESTIMATE | |
|---|---|---|---|---|---|---|---|---|---|
| 3 | 110' East of Pearl Avenue, crack injection | 6 | LF | | | | | \$70.00 | \$420 |

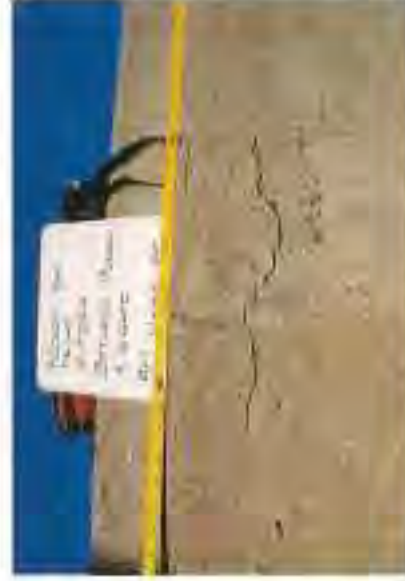
| Item Location | Description |
|---|---|
| 4 90' West of Agate Avenue | Landside, spall on lower step 24" long x 5" x 5" |

North Bay Front, 90' West of Agate

| Item | Description | QUANTITY | | MATERIAL COST | | LABOR COST | | ENGINEERING ESTIMATE | |
|---|---|---|---|---|---|---|---|---|---|
| 4 | 90' West of Agate Avenue, crack injection | 2 | LF | | | | | \$70.00 | \$140 |

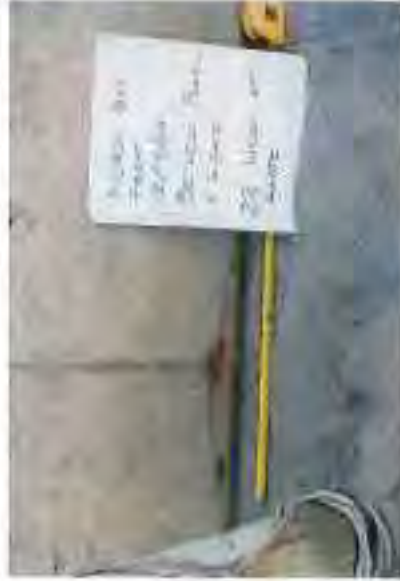
| Item Location | Description |
|---|---|
| 6 22' West of Agate Avenue | Waterside, crack at bottom of cap 18" long, rust present |

North Bay Front, 22' West of Agate

| Item | Description | QUANTITY | | MATERIAL COST | | LABOR COST | | ENGINEERING ESTIMATE | |
|---|---|---|---|---|---|---|---|---|---|
| 6 | 22' West of Agate Avenue, crack injection | 2 | LF | | | | | \$70.00 | \$140 |

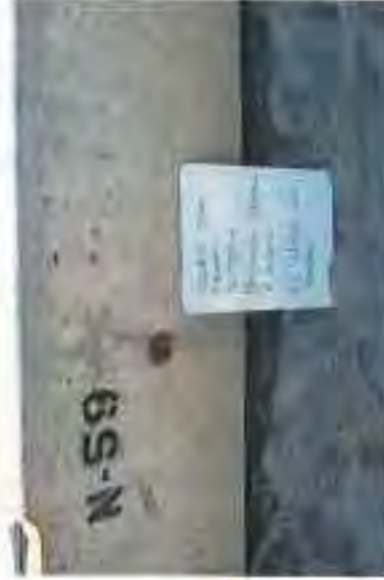
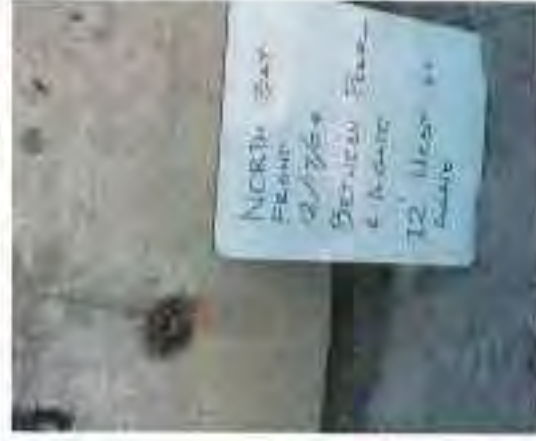
| Item Location | Description |
|---|---|
| 7 12' West of Agate Avenue | Waterside, mooring anchor insert, rust present |

North Bay Front, 12' West of Agate

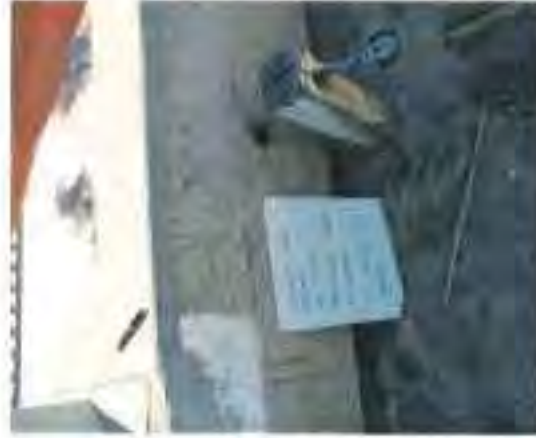
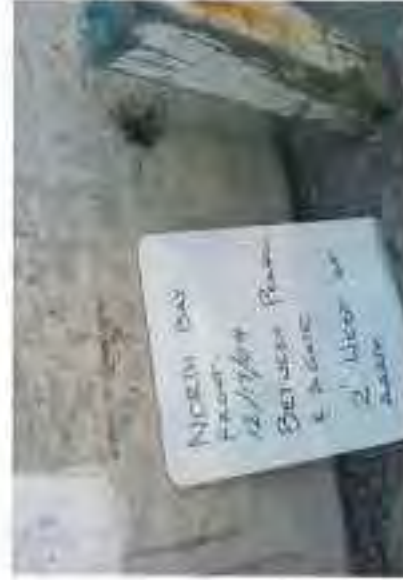
| Item Location | Description |
|---|---|
| 8 2' West of Agate Avenue | Waterside, mooring anchor insert, rust present |

North Bay Front, 2' West of Agate

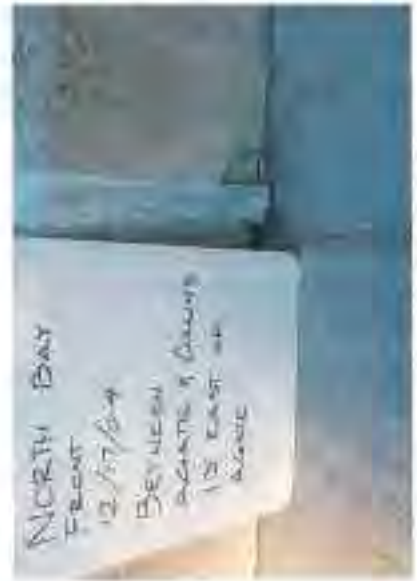
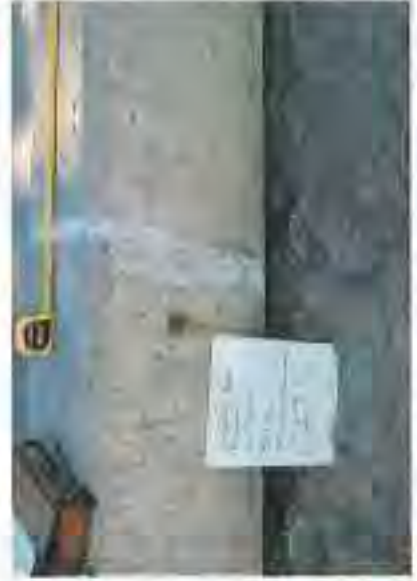
| Item | Location | Description |
|---|---|---|
| 1 | 13' East of Agate Avenue | Waterside, mooring anchor, rust present |
| 3 | 13' East of Agate Avenue | Landside, spall at sidewalk 2" x 3" x 1" |

North Bay Front, 13' East of Agate

| Item | Description | QUANTITY | | MATERIAL COST | | LABOR COST | | ENGINEERING ESTIMATE | |
|---|---|---|---|---|---|---|---|---|---|
| 3 | 13' East of Agate Avenue, spall repair | 0.25 | SF | | | | | \$70.00 | \$18 |

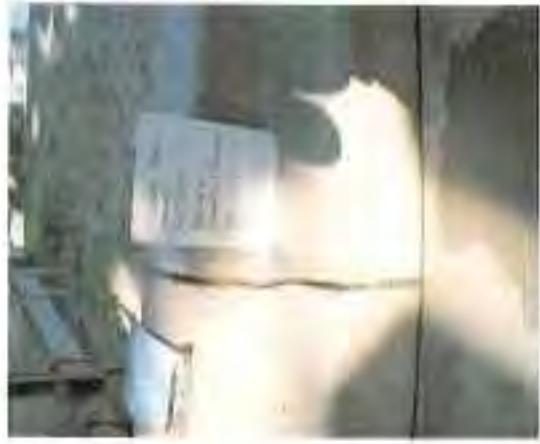
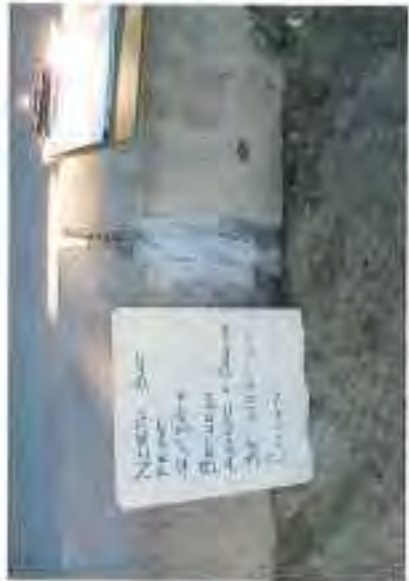
| Item | Location | Description |
|---|---|---|
| 4 | 32' West of Collins Avenue | Construction joint, sealant cracked and split on waterside, sealant missing on landside and top |

North Bay Front, 32' West of Collins

| Item | Description | QUANTITY | | MATERIAL COST | | LABOR COST | | ENGINEERING ESTIMATE | |
|---|---|---|---|---|---|---|---|---|---|
| 4 | 32' West of Collins Avenue, sealant repair | 6 | LF | | | | | \$25.00 | \$150 |

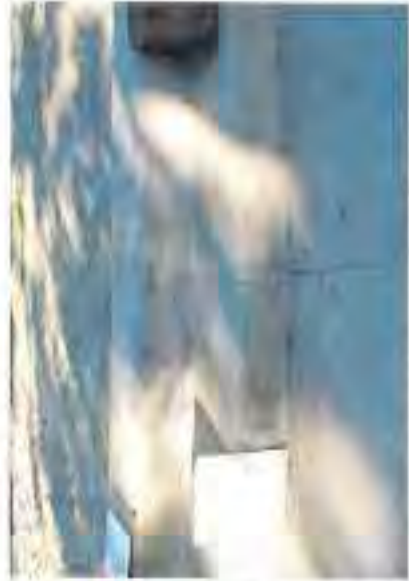
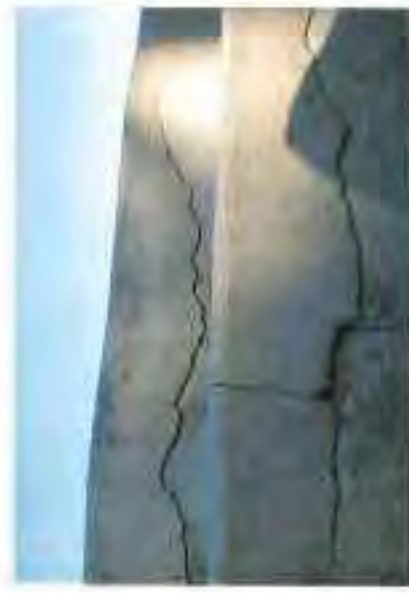
| Item | Location | Description |
|---|---|---|
| 5 | 8' West of Collins Avenue | Spall repair 60" long at top x 6" x 9"; Spall repair at bottom 48" long x 3" x 7" |

North Bay Front, 8' West of Collins

| Item | Description | QUANTITY | | MATERIAL COST | | LABOR COST | | ENGINEERING ESTIMATE | |
|---|---|---|---|---|---|---|---|---|---|
| 5 | 8' West of Collins Avenue, spall repair, steps | 20 | SF | | | | | \$70.00 | \$1,400 |

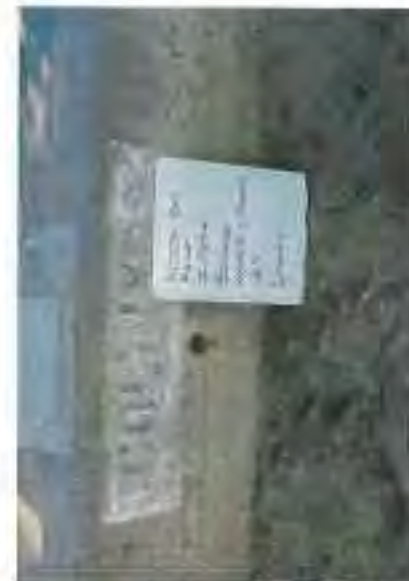
| Item | Location | Description |
|---|---|---|
| 6 | At Collins Avenue | Mooring anchor insert, rust present |

North Bay Front, at Collins

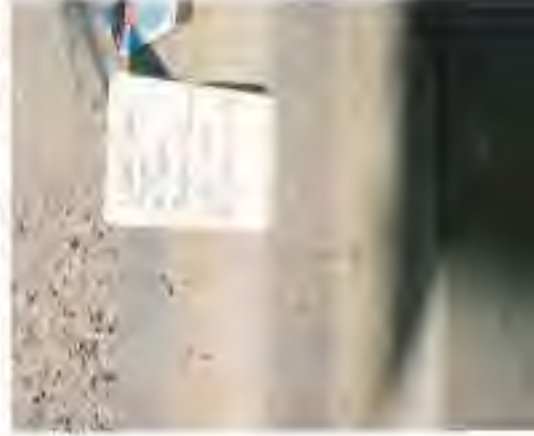
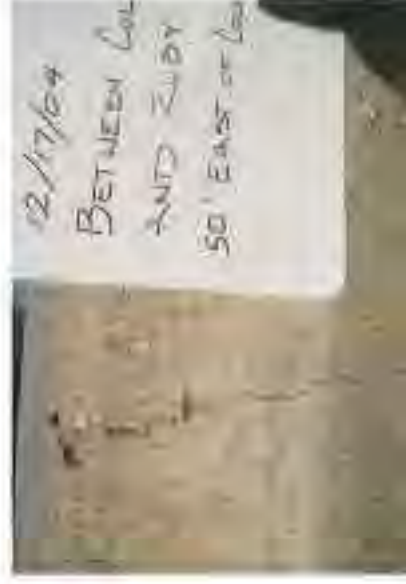
| Item | Location | Description |
|---|---|---|
| 2 | 50' East of Collins Avenue | Landside, transverse shrinkage crack across cap |

North Bay Front, 50' East of Collins

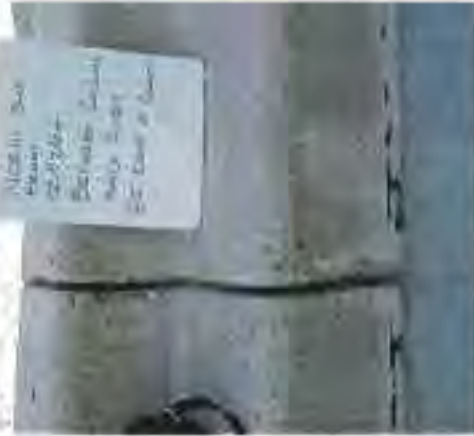
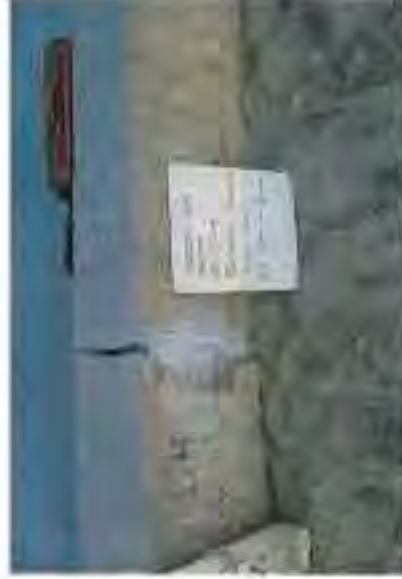
| Item | Location | Description |
|---|---|---|
| 3 | 85' East of Collins Avenue | Construction joint, sealant cracked and split on waterside, sealant missing on landside and top |

North Bay Front, 85' East of Collins

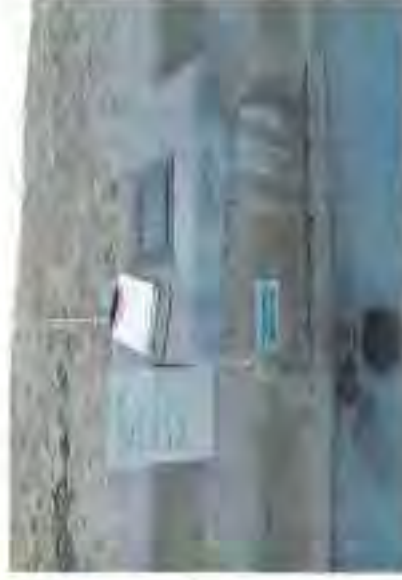
| Item | Location | Description |
|---|---|---|
| 4 | 110' East of Collins Avenue | Pullbox, landside spill through previous repair 30" long x 6" x 5" |

North Bay Front, 110' East of Collins

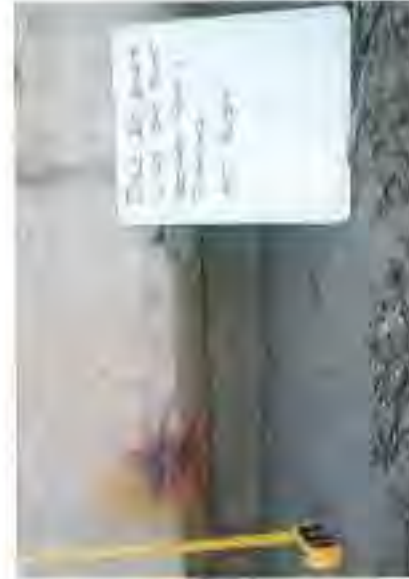
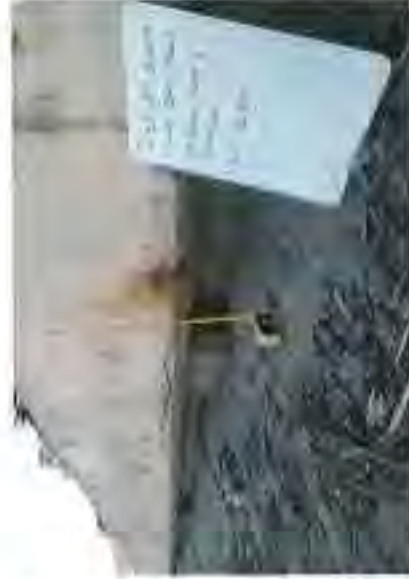
North Bay Front, at Ruby

| Item | Location | Description |
|---|---|---|
| 1 | At Ruby Avenue lightpole | Waterside, mooring anchor insert, rust present |
| 2 | At Ruby Avenue lightpole | Waterside, 84" long crack at bottom of cap |

| Item | Description | QUANTITY | | MATERIAL COST | | LABOR COST | | ENGINEERING ESTIMATE | |
|---|---|---|---|---|---|---|---|---|---|
| 2 | At Ruby Avenue lightpole, crack injection | 7 | LF | | | | | \$70.00 | \$490 |

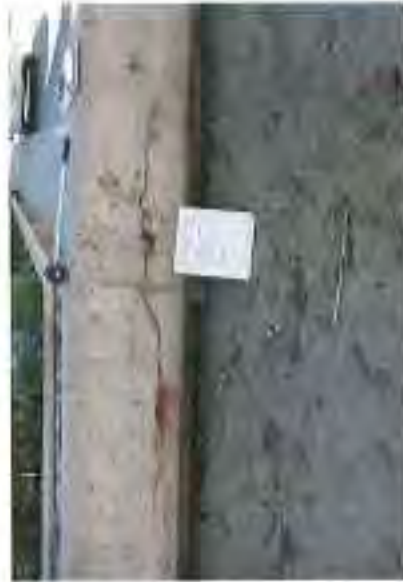
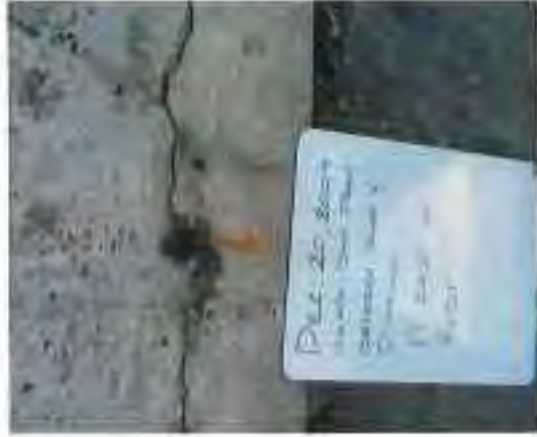
North Bay Front, 17' East of Ruby

| Item | Location | Description |
|---|---|---|
| 3 | 17' East of Ruby Avenue | Waterside, crack at middle of cap 84" long |

| Item | Description | QUANTITY | | MATERIAL COST | | LABOR COST | | ENGINEERING ESTIMATE | |
|---|---|---|---|---|---|---|---|---|---|
| 3 | 17' East of Ruby Avenue, crack injection | 7 | LF | | | | | \$70.00 | \$490 |

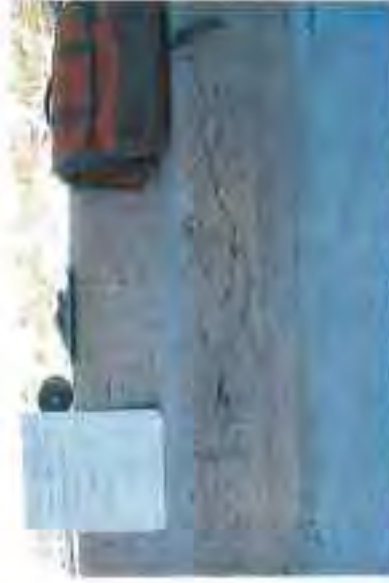
North Bay Front, 22' East of Ruby

| Item | Location | Description |
|---|---|---|
| 4 | 22' East of Ruby Avenue | Waterside, spill and crack landside lower steep 36" long |

| Item | Description | QUANTITY | | MATERIAL COST | | LABOR COST | | ENGINEERING ESTIMATE | |
|---|---|---|---|---|---|---|---|---|---|
| 4 | 22' East of Ruby Avenue, spall repair | 7 | SF | | | | | \$70.00 | \$490 |

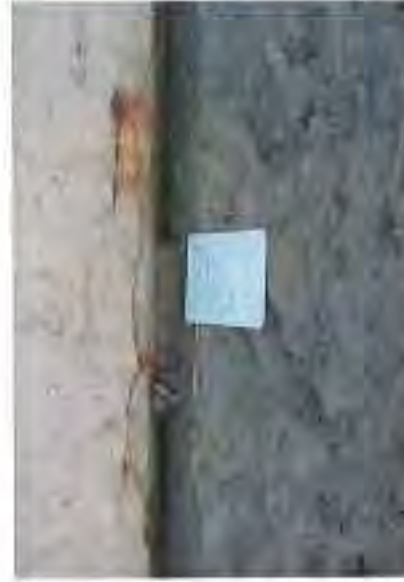
North Bay Front, 28' East of Ruby

| Item | Location | Description |
|---|---|---|
| 5 | 28' East of Ruby Avenue | Waterside, 60" long crack with rust present |

| Item | Description | QUANTITY | | MATERIAL COST | | LABOR COST | | ENGINEERING ESTIMATE | |
|---|---|---|---|---|---|---|---|---|---|
| 5 | 28' East of Ruby Avenue, crack injection | 5 | LF | | | | | \$70.00 | \$350 |

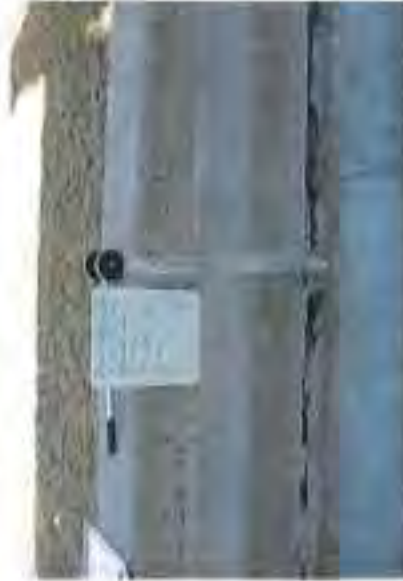
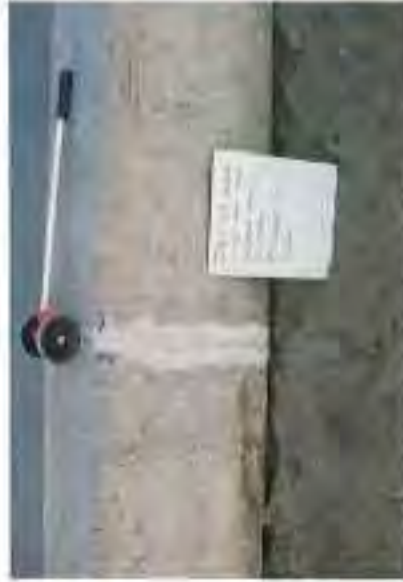
North Bay Front, 97' East of Ruby

| Item | Location | Description |
|---|---|---|
| 7 | 97' East of Ruby Avenue | Construction joint, sealant in good condition both sides |

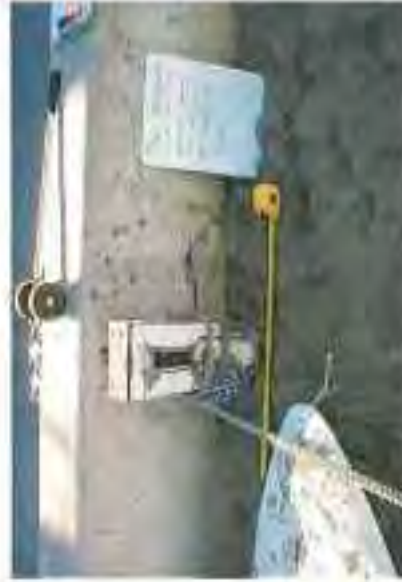
North Bay Front, 134' East of Ruby

| Item | Location | Description |
|---|---|---|
| 9 | 134' East of Ruby Avenue | Waterside, crack bottom of cap 24" long |

| Item | Description | QUANTITY | | MATERIAL COST | | LABOR COST | | ENGINEERING ESTIMATE | |
|---|---|---|---|---|---|---|---|---|---|
| 9 | 134' East of Ruby Avenue, crack injection | 2 | LF | | | | | \$70.00 | \$140 |

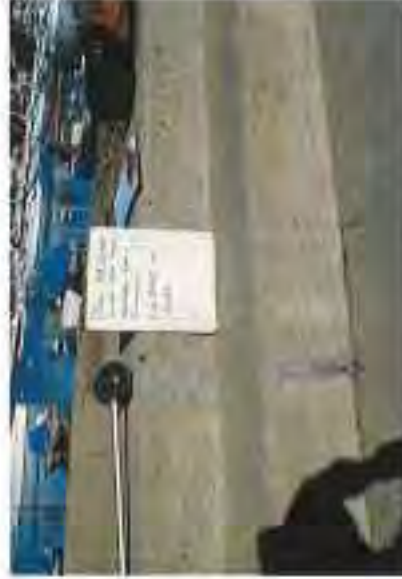
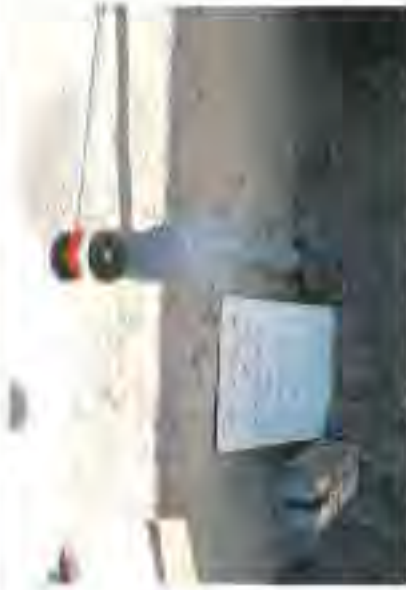
North Bay Front, 215' East of Ruby

| Item | Location | Description |
|---|---|---|
| 10 | 215' East of Ruby Avenue at Diamond Avenue | Construction joint, waterside sealant needs repair |

| Item | Description | QUANTITY | | MATERIAL COST | | LABOR COST | | ENGINEERING ESTIMATE | |
|---|---|---|---|---|---|---|---|---|---|
| 10 | 215' East of Ruby Avenue, sealant repair | 6 | LF | | | | | \$25.00 | \$150 |

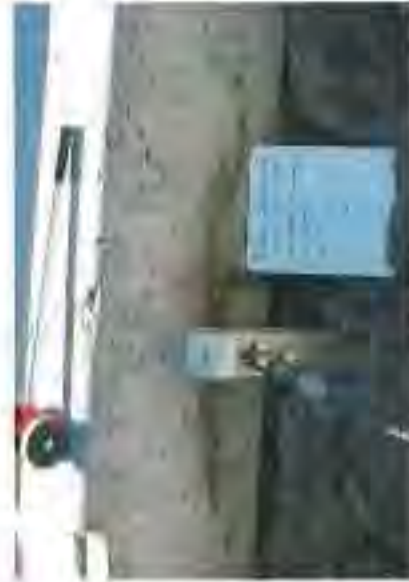
North Bay Front, 28' East of Diamond

| Item | Location | Description |
|---|---|---|
| 2 | 28' East of Diamond Avenue | Waterside, crack at middle of cap, 36" long |

| Item | Description | QUANTITY | | MATERIAL COST | | LABOR COST | | ENGINEERING ESTIMATE | |
|---|---|---|---|---|---|---|---|---|---|
| 2 | 28' East of Diamond Avenue, crack injection | 3 | LF | | | | | \$70.00 | \$210 |

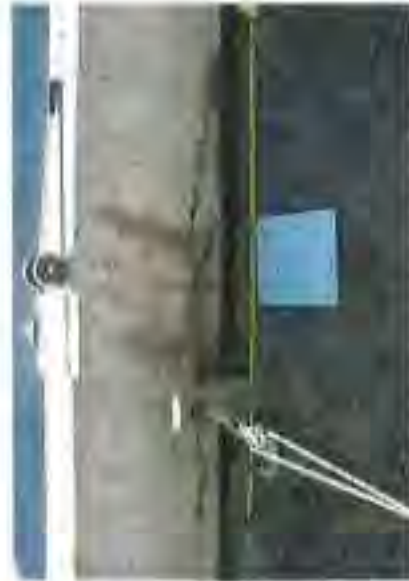
North Bay Front, 38' East of Diamond

| Item | Location | Description |
|---|---|---|
| 3 | 38' East of Diamond Avenue | Waterside, crack at bottom of cap, 72" long |

| Item | Description | QUANTITY | | MATERIAL COST | | LABOR COST | | ENGINEERING ESTIMATE | |
|---|---|---|---|---|---|---|---|---|---|
| 3 | 38' East of Diamond Avenue, crack injection | 6 | LF | | | | | \$70.00 | \$420 |

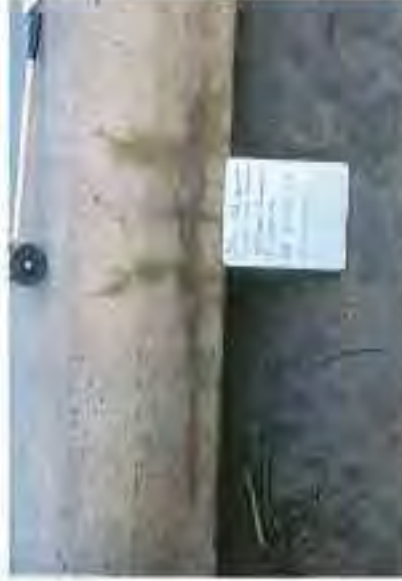
North Bay Front, 62' East of Diamond

| Item | Location | Description |
|---|---|---|
| 4 | 62' East of Diamond Avenue | Waterside, crack at bottom of cap, 60" long |

| Item | Description | QUANTITY | | MATERIAL COST | | LABOR COST | | ENGINEERING ESTIMATE | |
|---|---|---|---|---|---|---|---|---|---|
| 4 | 62' East of Diamond Avenue, crack injection | 5 | LF | | | | | \$70.00 | \$350 |

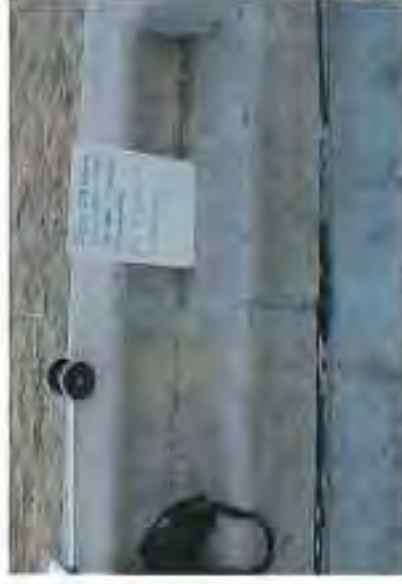
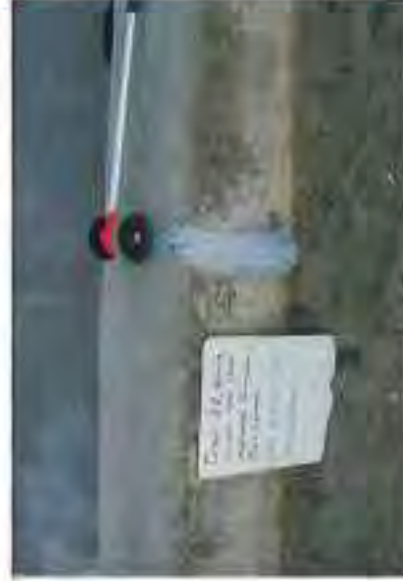
North Bay Front, 108' East of Diamond

| Item | Location | Description |
|---|---|---|
| 6 | 108' East of Diamond Avenue | Construction joint, sealant cracked and split land and water side |

| Item | Description | QUANTITY | | MATERIAL COST | | LABOR COST | | ENGINEERING ESTIMATE | |
|---|---|---|---|---|---|---|---|---|---|
| 6 | 108' East of Diamond Avenue, sealant repair | 6 | LF | | | | | \$25.00 | \$150 |

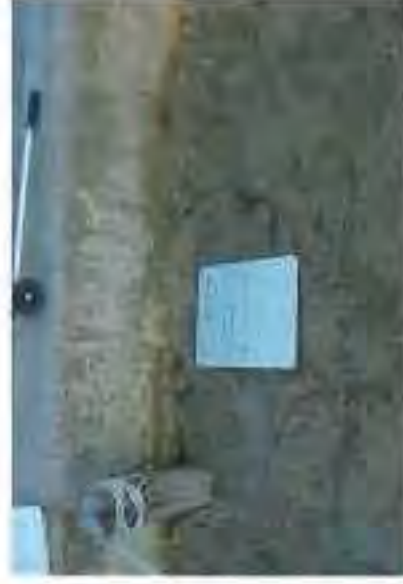
North Bay Front, 132' East of Diamond

| Item | Location | Description |
|---|---|---|
| 8 | 132' East of Diamond Avenue | Waterside, crack at bottom of cap 72" long |

| Item | Description | QUANTITY | | MATERIAL COST | | LABOR COST | | ENGINEERING ESTIMATE | |
|---|---|---|---|---|---|---|---|---|---|
| 8 | 132' East of Diamond Avenue, crack injection | 6 | LF | | | | | \$70.00 | \$420 |

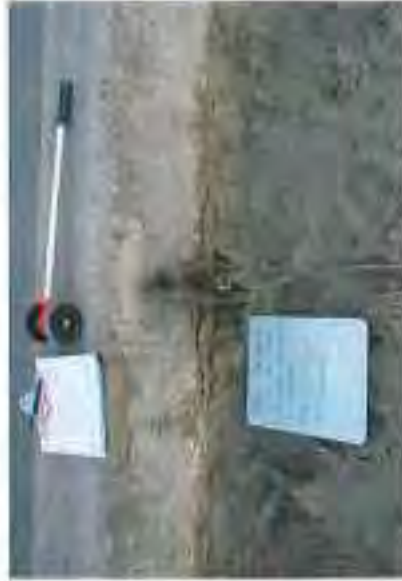
North Bay Front, 144' East of Diamond

| Item | Location | Description |
|---|---|---|
| 9 | 144' East of Diamond Avenue | Waterside, crack at bottom of cap 36" long |

| Item | Description | QUANTITY | | MATERIAL COST | | LABOR COST | | ENGINEERING ESTIMATE | |
|---|---|---|---|---|---|---|---|---|---|
| 9 | 144' East of Diamond Avenue, crack injection | 3 | LF | | | | | \$70.00 | \$210 |

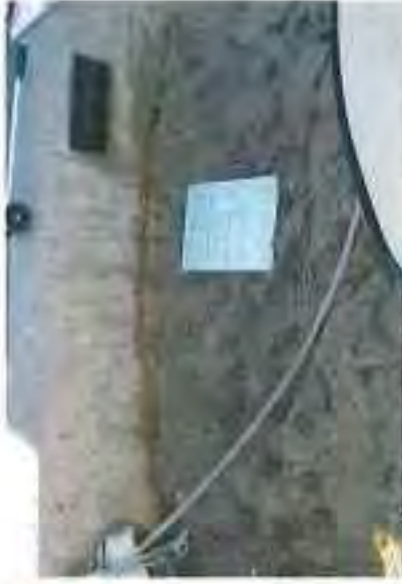
North Bay Front, 167' East of Diamond

| Item | Location | Description |
|---|---|---|
| 11 | 167' East of Diamond Avenue | Waterside, crack at bottom of cap, 72" long |

| Item | Description | QUANTITY | | MATERIAL COST | | LABOR COST | | ENGINEERING ESTIMATE | |
|---|---|---|---|---|---|---|---|---|---|
| 11 | 167' East of Diamond Avenue, crack injection | 6 | LF | | | | | \$70.00 | \$420 |
