**Subject: City of Newport Beach Balboa Island Coping Repair Project (C-7066-1)**

**PROPOSED PROJECT:** Balboa Island Seawall Coping Repair Project

Repair and maintenance of existing seawalls, and increase  
height of seawalls by 9 inches.

# Bulkhead Condition Report for Portions of the Balboa Island Seawall

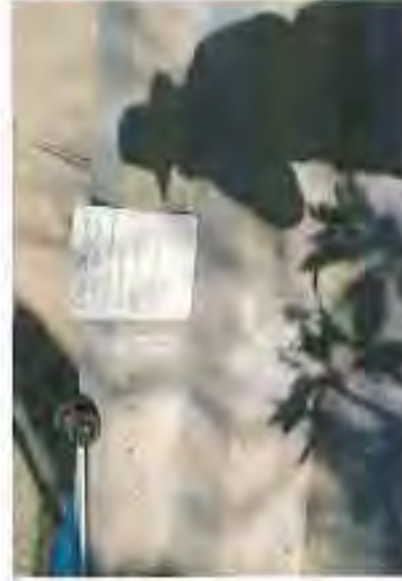
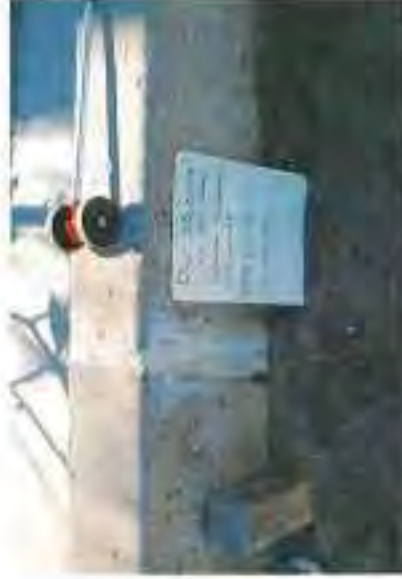
North Bay Front, 202' East of Diamond

| Item | Location | Description |
|---|---|---|
| 12 | 202' East of Diamond Avenue | Construction joint, sealant needs repair on landside |

| Item | Description | QUANTITY | | MATERIAL COST | | LABOR COST | | ENGINEERING ESTIMATE | |
|---|---|---|---|---|---|---|---|---|---|
| 12 | 202' East of Diamond Avenue, sealant repair | 6 | LF | | | | | \$70.00 | \$420 |
| 13 | 202' East of Diamond Avenue, spall repair | 1 | SF | | | | | \$70.00 | \$70 |

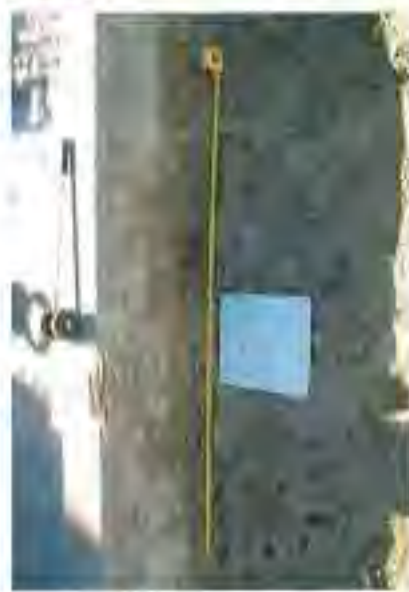
North Bay Front, 52' East of Sapphire

| Item | Location | Description |
|---|---|---|
| 3 | 52' East of Sapphire Avenue | Waterside, spall along cap, 60" long and 24" high |

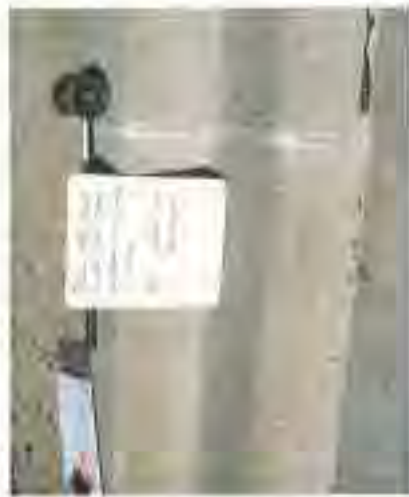
North Bay Front, 90' East of Sapphire

| Item | Location | Description |
|---|---|---|
| 4 | 90' East of Sapphire Avenue | Construction Joint, sealant on land and water side in good condition |

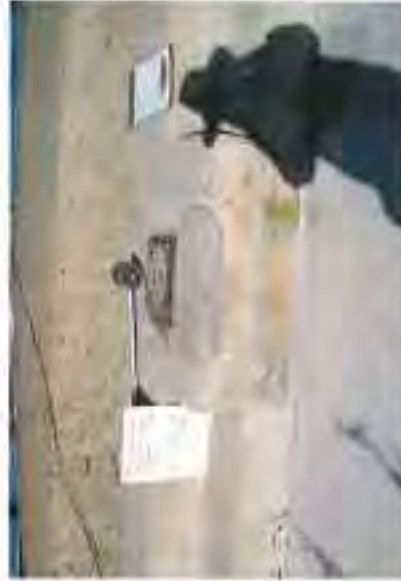
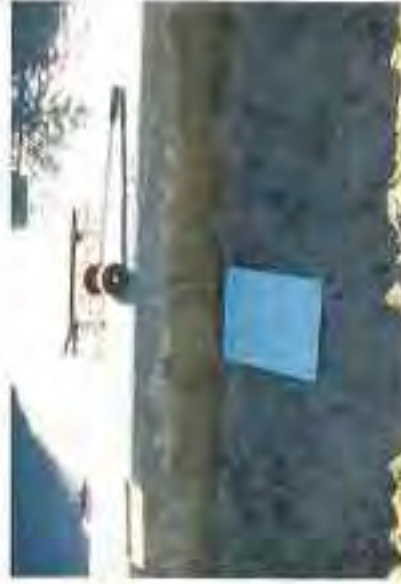
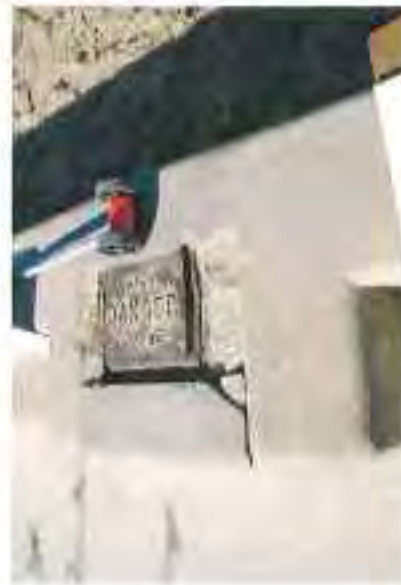
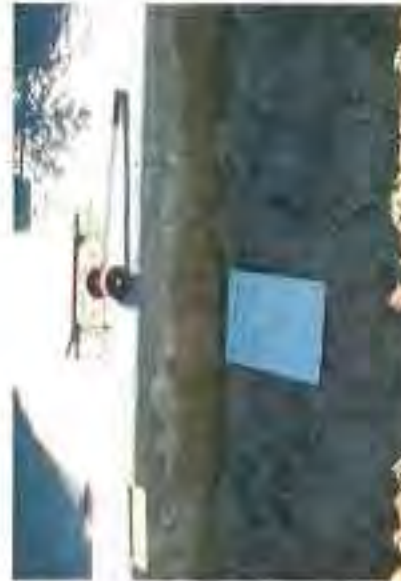
North Bay Front, 105' East of Sapphire

| Item | Location | Description |
|---|---|---|
| 5 | 105' East of Sapphire Avenue | Pullbox, top cap spalled land and water side 24" long x 8" high x 6" deep |

| 5 | 105' East of Sapphire Avenue, spall repair | 4 | SF | | | | | \$70.00 | \$280 |

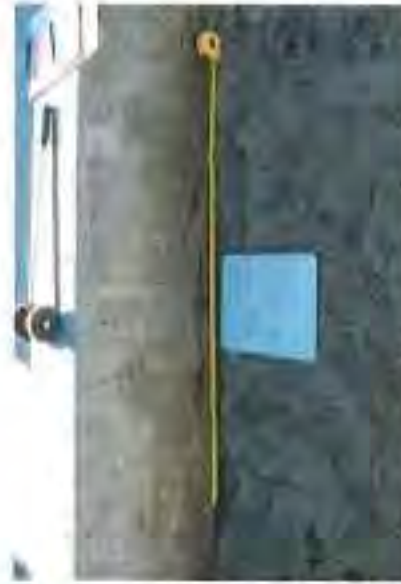
North Bay Front, 125' East of Sapphire

| Item | Location | Description |
|---|---|---|
| 6 | 125' East of Sapphire Avenue | Waterside, crack at bottom of cap 60" long (adjacent to pier) |

| 6 | 125' East of Sapphire Avenue, crack injection | 5 | LF | | | | | \$70.00 | \$350 |

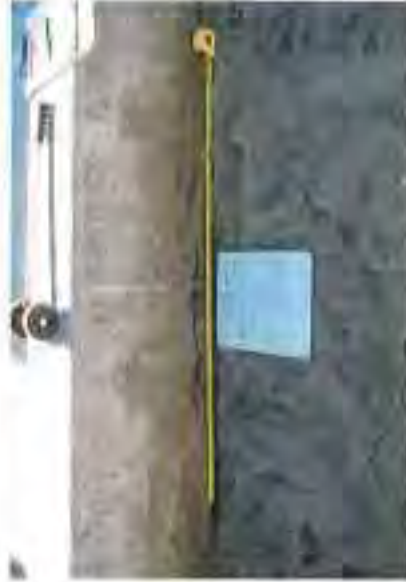
North Bay Front, 135' East of Sapphire

| Item | Location | Description |
|---|---|---|
| 7 | 135' East of Sapphire Avenue | Waterside, crack at bottom of cap 60" long (adjacent to pier) |

| 7 | 135' East of Sapphire Avenue, crack injection | 5 | LF | | | | | \$70.00 | \$350 |

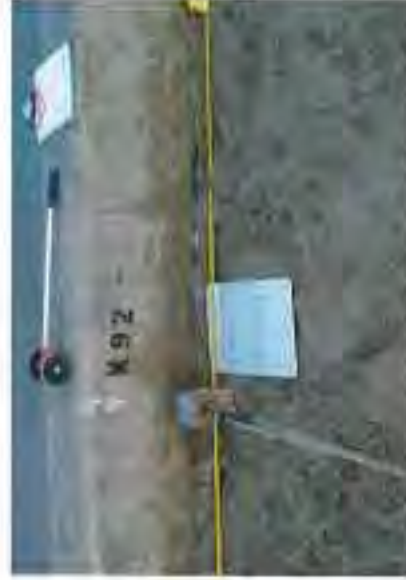
North Bay Front, 148' East of Sapphire

| Item | Location | Description |
|---|---|---|
| 8 | 148' East of Sapphire Avenue | Waterside, crack at bottom of cap, 72" long |

| 8 | 148' East of Sapphire Avenue, crack injection | 6 | LF | | | | | \$70.00 | \$420 |

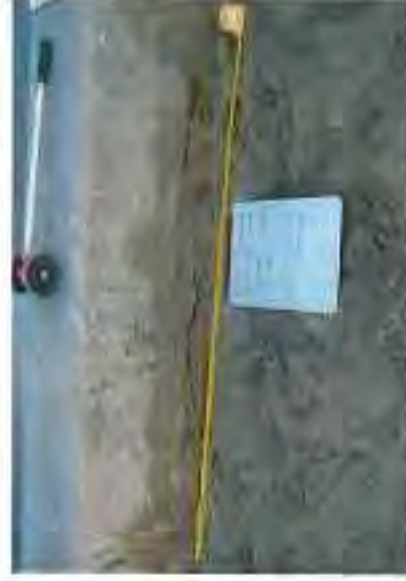
North Bay Front, 158' East of Sapphire

| Item | Location | Description |
|---|---|---|
| 9 | 158' East of Sapphire Avenue | Waterside, spall at bottom of cap, 60" long x 12" high |

| 9 | 158' East of Sapphire Avenue, spall repair | 5 | SF | | | | | \$70.00 | \$350 |

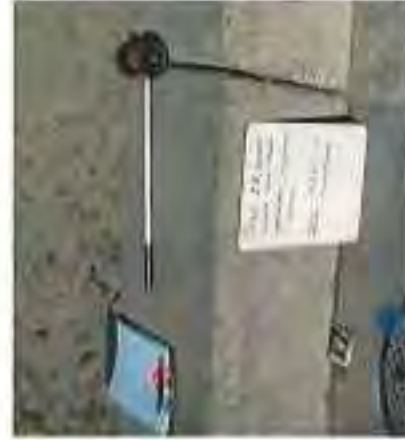
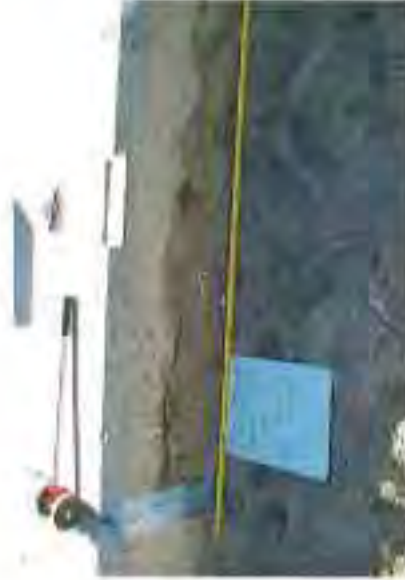
North Bay Front, 206' East of Sapphire

| Item | Location | Description |
|---|---|---|
| 10 | 206' East of Sapphire Avenue | Waterside, spall 48" long x 12" x 1" |
| 11 | 206' East of Sapphire Avenue | Construction joint, waterside sealant cracked and split, top and landside missing sealant |

| 10 | 206' East of Sapphire Avenue, spall repair | 4 | SF | | | | | \$70.00 | \$280 |
| 11 | 206' East of Sapphire Avenue, sealant repair | 6 | LF | | | | | \$25.00 | \$150 |

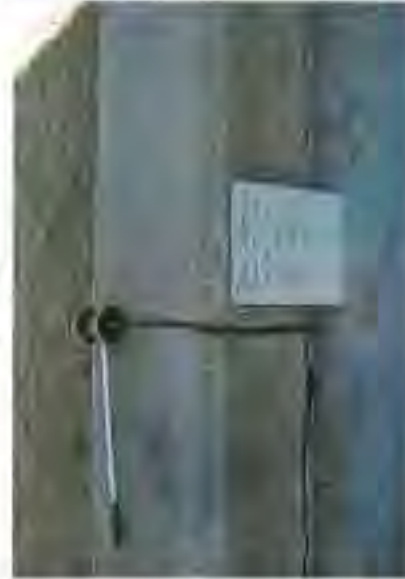
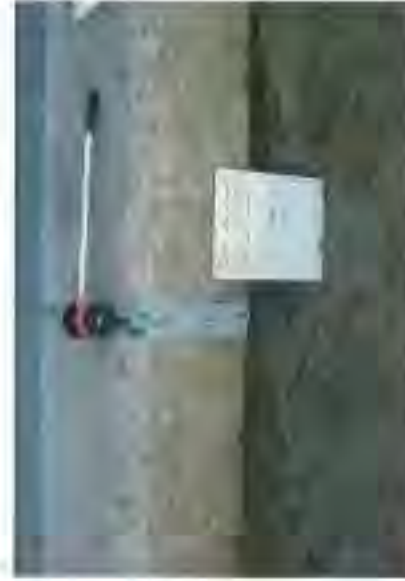
North Bay Front, 47' East of Coral

| Item | Location | Description |
|---|---|---|
| 2 | 47' East of Coral Avenue | Construction joint, waterside sealant split and cracked, landside and top sealant missing |

| Item | Description | QUANTITY | | MATERIAL COST | | LABOR COST | | ENGINEERING ESTIMATE | |
|---|---|---|---|---|---|---|---|---|---|
| 2 | 47' East of Coral Avenue, sealant repair | 6 | LF | | | | | \$40.00 | \$240 |

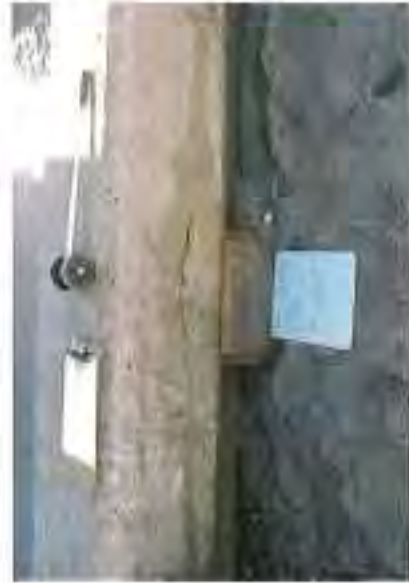
North Bay Front, 58' East of Coral

| Item | Location | Description |
|---|---|---|
| 3 | 58' East of Coral Avenue | Waterside, crack at bottom of cap 48" long |

| Item | Description | QUANTITY | | MATERIAL COST | | LABOR COST | | ENGINEERING ESTIMATE | |
|---|---|---|---|---|---|---|---|---|---|
| 3 | 58' East of Coral Avenue, crack injection | 4 | LF | | | | | \$70.00 | \$280 |

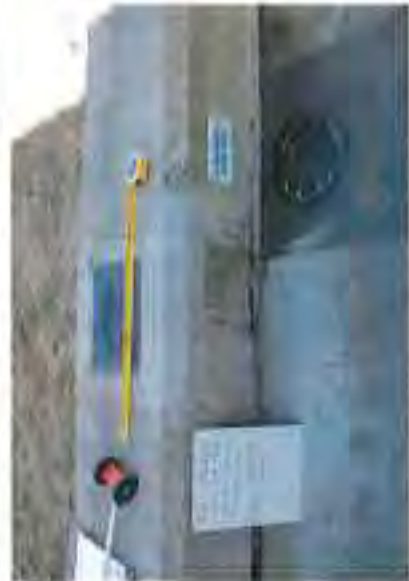
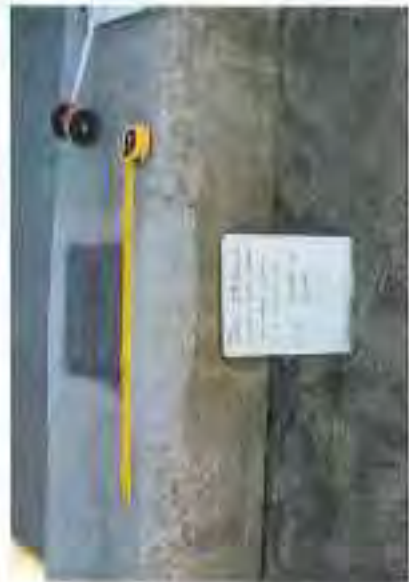
North Bay Front, 108' East of Coral

| Item | Location | Description |
|---|---|---|
| 4 | 108' East of Coral Avenue | Pullbox spall both sides of box, 24" x 9" x 6" |

| Item | Description | QUANTITY | | MATERIAL COST | | LABOR COST | | ENGINEERING ESTIMATE | |
|---|---|---|---|---|---|---|---|---|---|
| 4 | 108' East of Coral Avenue, spall repair | 6 | SF | | | | | \$70.00 | \$420 |

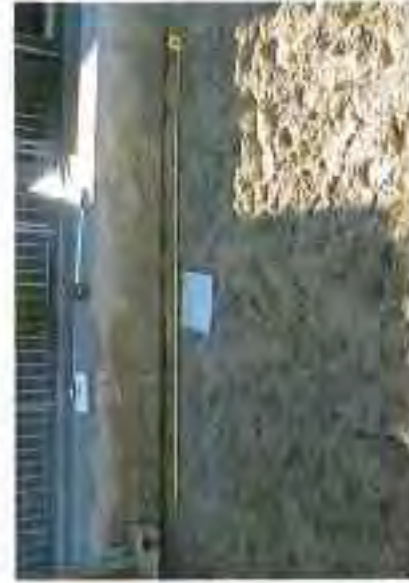
North Bay Front, 116' East of Coral

| Item | Location | Description |
|---|---|---|
| 5 | 116' East of Coral Avenue | Waterside, crack at bottom of cap 96" long |

| Item | Description | QUANTITY | | MATERIAL COST | | LABOR COST | | ENGINEERING ESTIMATE | |
|---|---|---|---|---|---|---|---|---|---|
| 5 | 116' East of Coral Avenue, crack injection | 8 | LF | | | | | \$70.00 | \$560 |

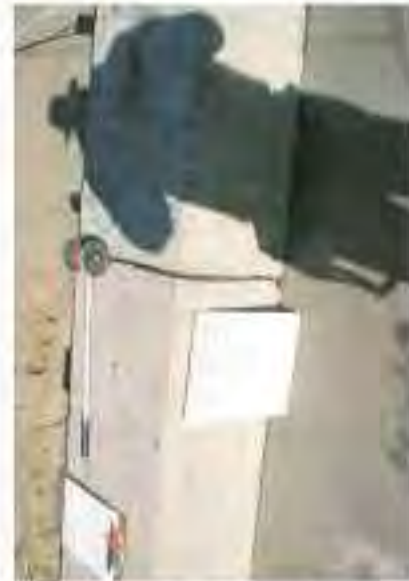
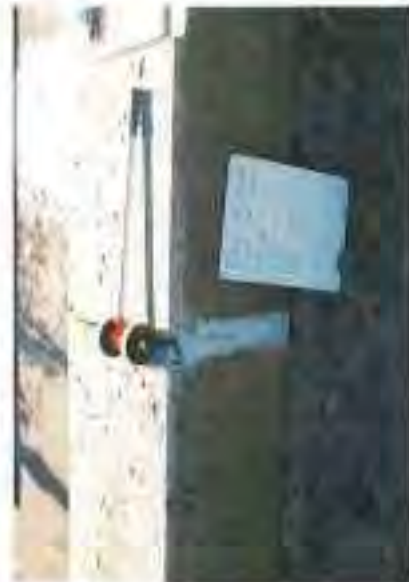
North Bay Front, 162' East of Coral

| Item | Location | Description |
|---|---|---|
| 6 | 162' East of Coral Avenue | Construction joint, waterside sealant split and cracked, landside and top sealant missing |

| Item | Description | QUANTITY | | MATERIAL COST | | LABOR COST | | ENGINEERING ESTIMATE | |
|---|---|---|---|---|---|---|---|---|---|
| 6 | 162' East of Coral Avenue, sealant repair | 6 | LF | | | | | \$40.00 | \$240 |

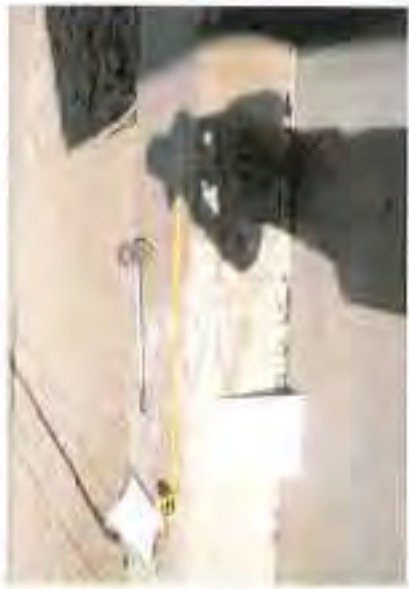
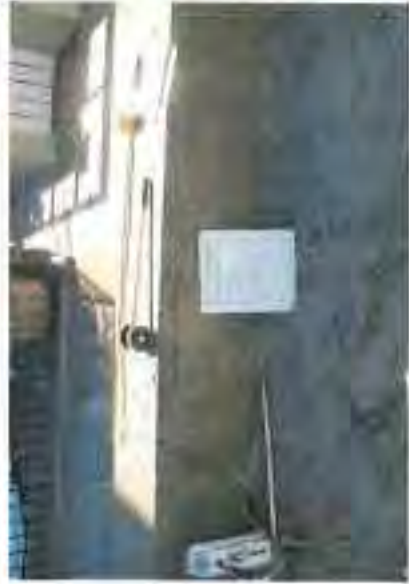
North Bay Front, 172' East of Coral

| Item | Location | Description |
|---|---|---|
| 7 | 172' East of Coral Avenue | Top of cap spalled 48" long x 2' wide x 3" deep |

| Item | Description | QUANTITY | | MATERIAL COST | | LABOR COST | | ENGINEERING ESTIMATE | |
|---|---|---|---|---|---|---|---|---|---|
| 7 | 172' East of Coral Avenue, spall repair | 8 | SF | | | | | \$70.00 | \$560 |

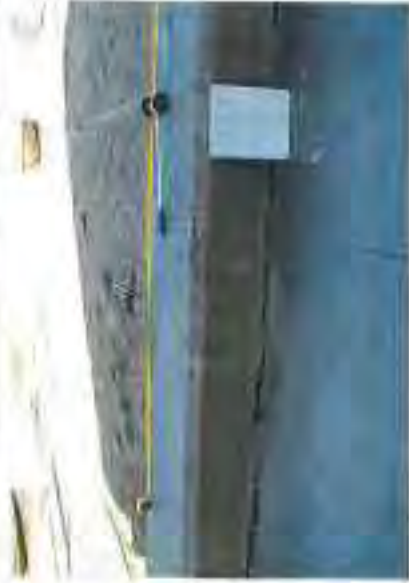
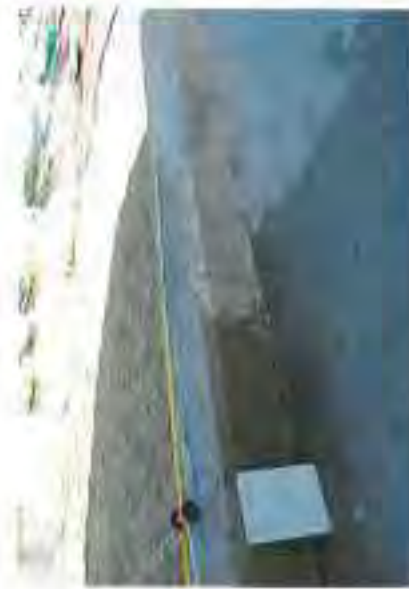
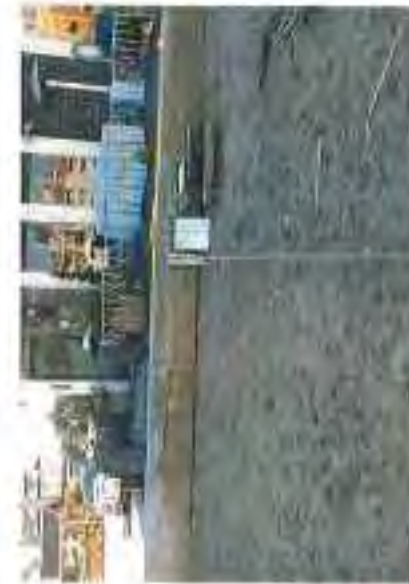
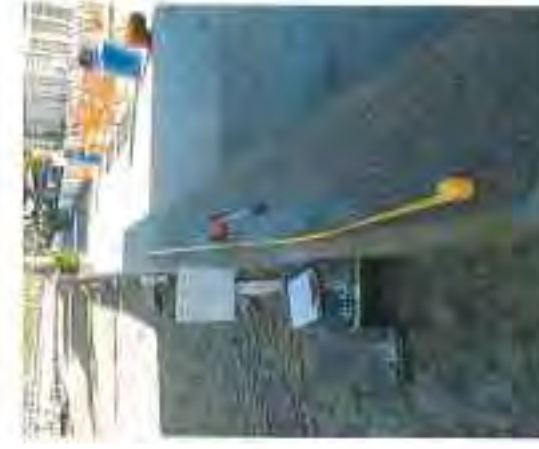
North Bay Front, 187' East of Coral

| Item | Location | Description |
|---|---|---|
| 8 | 187' East of Coral Avenue | Waterside top corner of cap spalled and previously repaired, spalling 168" long x 24" high x 12" deep |

| Item | Description | QUANTITY | | MATERIAL COST | | LABOR COST | | ENGINEERING ESTIMATE | |
|---|---|---|---|---|---|---|---|---|---|
| 8 | 187' East of Coral Avenue, Spall repair | 24 | SF | | | | | \$70.00 | \$1,680 |

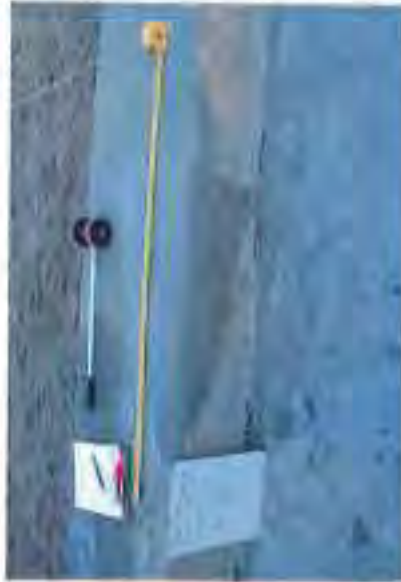
North Bay Front, 196' East of Coral

| Item | Location | Description |
|---|---|---|
| 9 | 196' East of Coral Avenue | Landside, spall, 48" long x 12" high x 12" deep |

| Item | Description | QUANTITY | | MATERIAL COST | | LABOR COST | | ENGINEERING ESTIMATE | |
|---|---|---|---|---|---|---|---|---|---|
| 9 | 196' East of Coral Avenue, spall repair | 4 | SF | | | | | \$70.00 | \$280 |

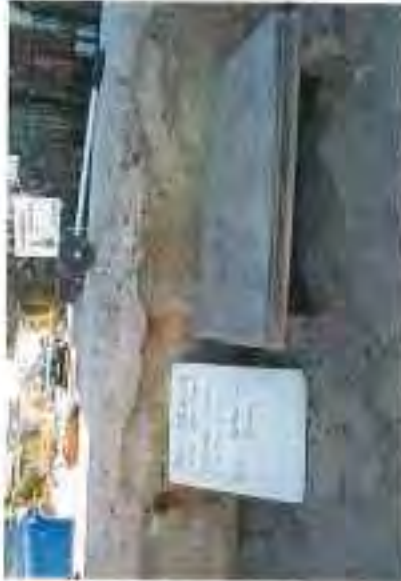
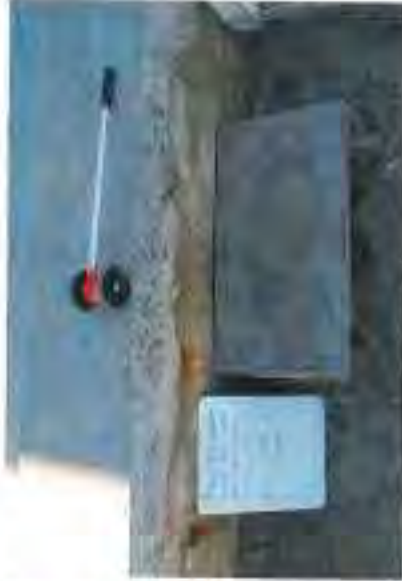
North Bay Front, 202' East of Coral

| Item | Location | Description |
|---|---|---|
| 10 | 202' East of Coral Avenue | Waterside, spall 48" long at top of cap |

| Item | Description | QUANTITY | | MATERIAL COST | | LABOR COST | | ENGINEERING ESTIMATE | |
|---|---|---|---|---|---|---|---|---|---|
| 10 | 202' East of Coral Avenue, Spall repair | 4 | SF | | | | | \$70.00 | \$280 |

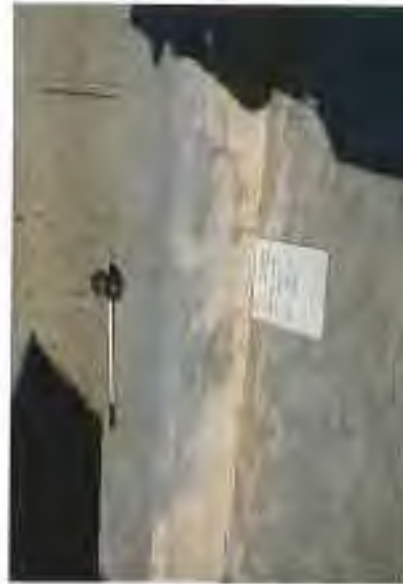
North Bay Front, 207' East of Coral

| Item | Location | Description |
|---|---|---|
| 11 | 207' East of Coral Avenue | Landside, spall at top of cap, 48" long x 18" wide, 9" deep |

| Item | Description | QUANTITY | | MATERIAL COST | | LABOR COST | | ENGINEERING ESTIMATE | |
|---|---|---|---|---|---|---|---|---|---|
| 11 | 207' East of Coral Avenue, spall repair | 6 | SF | | | | | \$70.00 | \$420 |

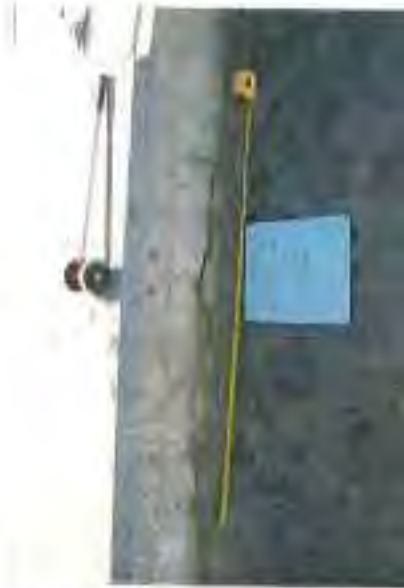
North Bay Front, 213' East of Coral

| Item | Location | Description |
|---|---|---|
| 12 | 213' East of Coral Avenue | Waterside, crack at bottom of cap 48" long |

| Item | Description | QUANTITY | | MATERIAL COST | | LABOR COST | | ENGINEERING ESTIMATE | |
|---|---|---|---|---|---|---|---|---|---|
| 12 | 213 East of Coral Avenue, crack injection | 4 | LF | | | | | \$70.00 | \$280 |

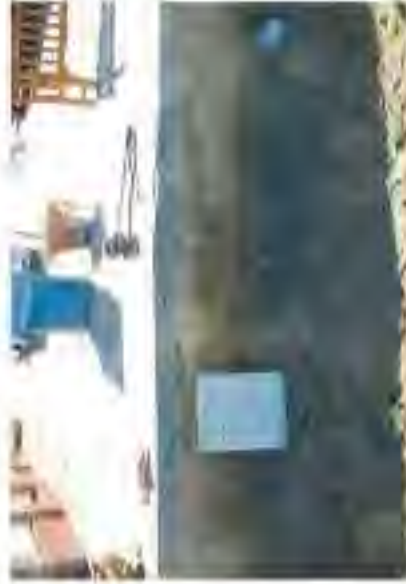
North Bay Front, 13' East of Apolena

| Item | Location | Description |
|---|---|---|
| 1 | 13' East of Apolena Avenue | Top of cap spalled 60" x 24" x 6" |

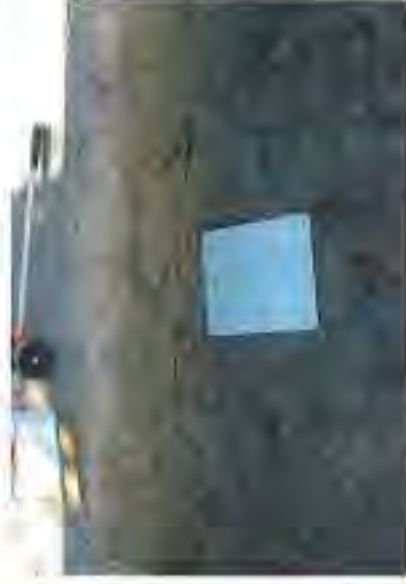
North Bay Front, 26' East of Apolena

| Item | Location | Description |
|---|---|---|
| 2 | 26' East of Apolena Avenue | Waterside, crack at bottom of cap 72" long |

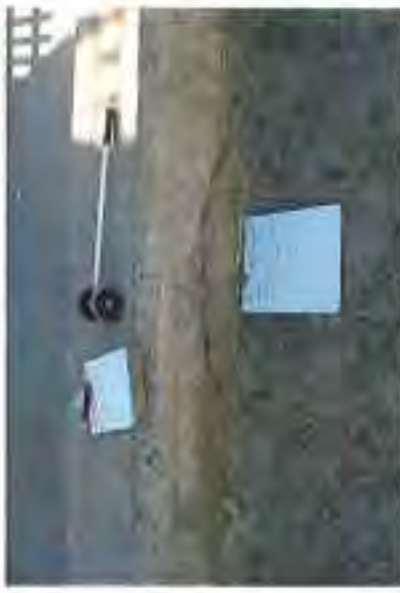
North Bay Front, 32' East of Apolena

| Item | Location | Description |
|---|---|---|
| 3 | 32' East of Apolena Avenue | Waterside, crack at bottom of cap 72" long |

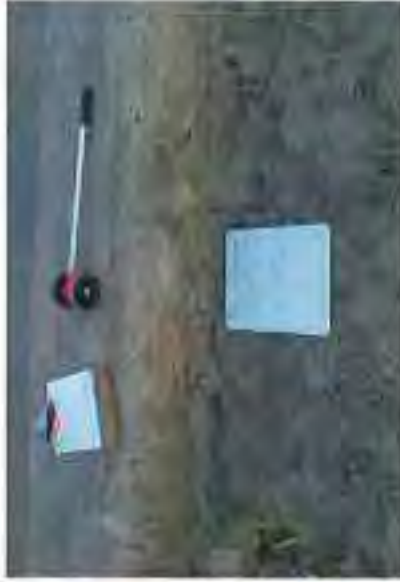
North Bay Front, 38' East of Apolena

| Item | Location | Description |
|---|---|---|
| 4 | 38' East of Apolena Avenue | Waterside, crack at bottom of cap 72" long |

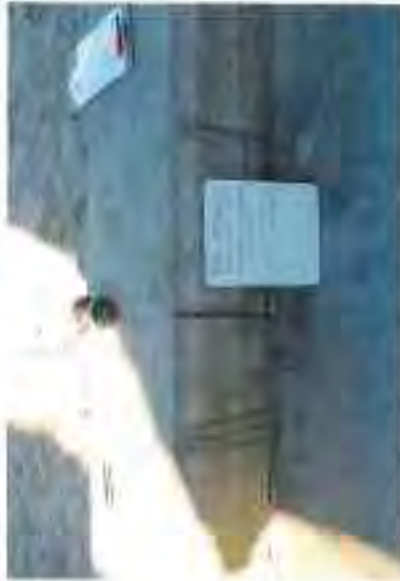
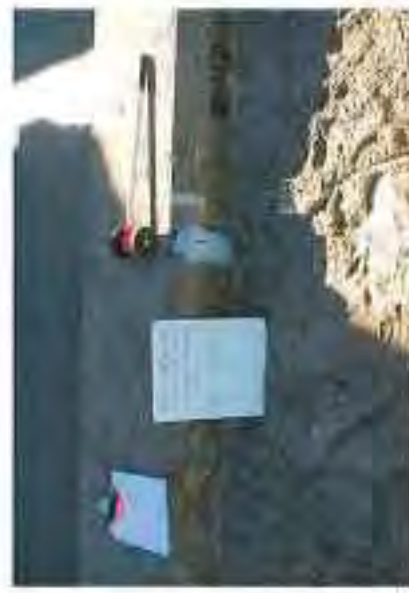
North Bay Front, 60' East of Apolena

| Item | Location | Description |
|---|---|---|
| 5 | 60' East of Apolena Avenue | Construction joint, waterside sealant cracked and split, landside and top missing sealant |

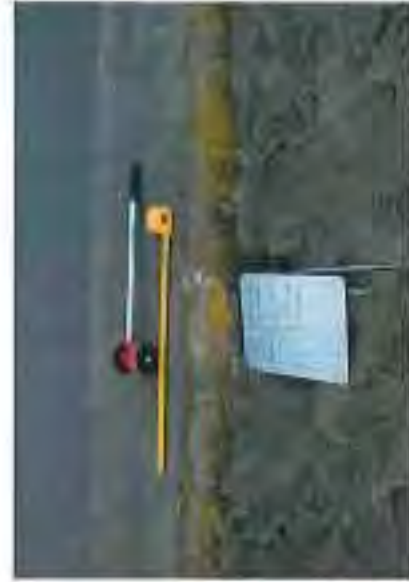
North Bay Front, 94' East of Apolena

| Item | Location | Description |
|---|---|---|
| 6 | 94' East of Apolena Avenue | Waterside and top of cap spalled 24" long x 12" high x 2" deep |

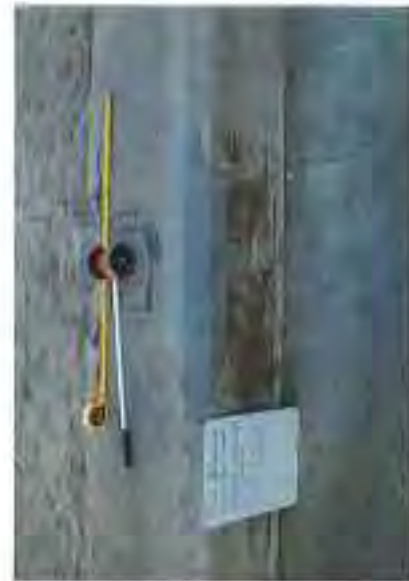
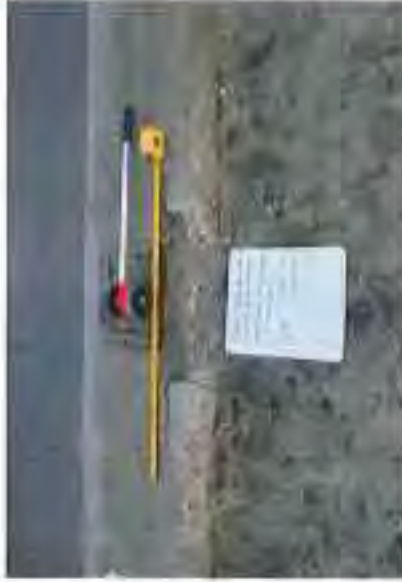
North Bay Front, 109' East of Apolena

| Item | Location | Description |
|---|---|---|
| 7 | 109' East of Apolena Avenue | Pull box, spalls both sides 24" long x 8" high x 3" deep |

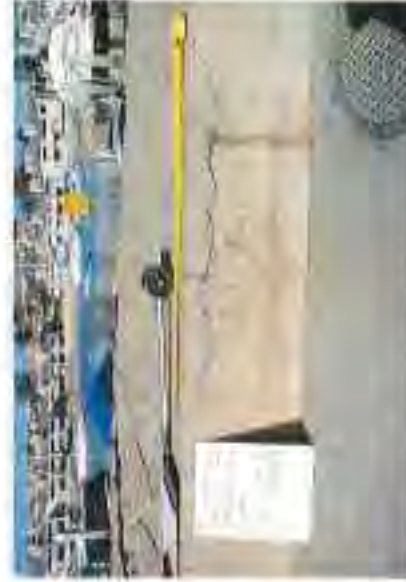
North Bay Front, 11' East of Amethyst

| Item | Location | Description |
|---|---|---|
| 2 | 11' East of Amethyst Avenue | Top of cap, crack, 3' long |

| Item | Description | QUANTITY | | MATERIAL COST | | LABOR COST | | ENGINEERING ESTIMATE | |
|---|---|---|---|---|---|---|---|---|---|
| 2 | 11' East of Amethyst Avenue, spall repair | 6 | SF | | | | | \$70.00 | \$420 |

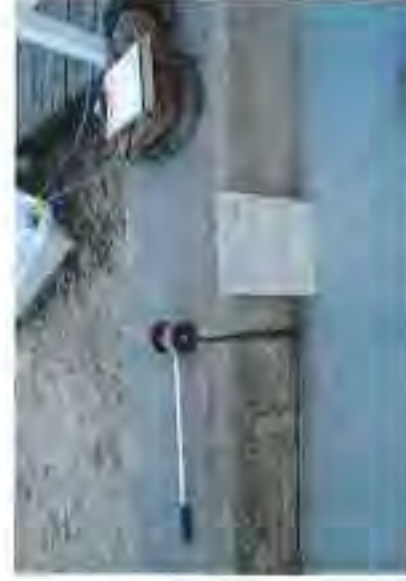
North Bay Front, 74' East of Amethyst

| Item | Location | Description |
|---|---|---|
| 3 | 74' East of Amethyst Avenue | Construction joint, waterside sealant cracked and split, landside and top sealant missing |

| Item | Description | QUANTITY | | MATERIAL COST | | LABOR COST | | ENGINEERING ESTIMATE | |
|---|---|---|---|---|---|---|---|---|---|
| 3 | 74' East of Amethyst Avenue, sealant repair | 6 | LF | | | | | \$25.00 | \$150 |

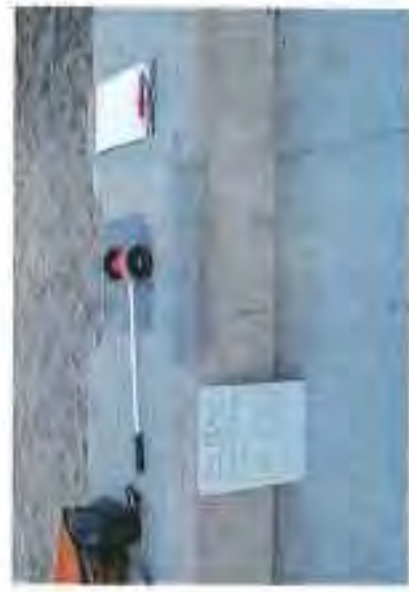
North Bay Front, 110' East of Amethyst

| Item | Location | Description |
|---|---|---|
| 4 | 110' East of Amethyst Avenue | Pull box, spall 24" long x 3" high x 9" deep |

| Item | Description | QUANTITY | | MATERIAL COST | | LABOR COST | | ENGINEERING ESTIMATE | |
|---|---|---|---|---|---|---|---|---|---|
| 4 | 110' East of Amethyst Avenue, spall repair | 4 | SF | | | | | \$70.00 | \$280 |

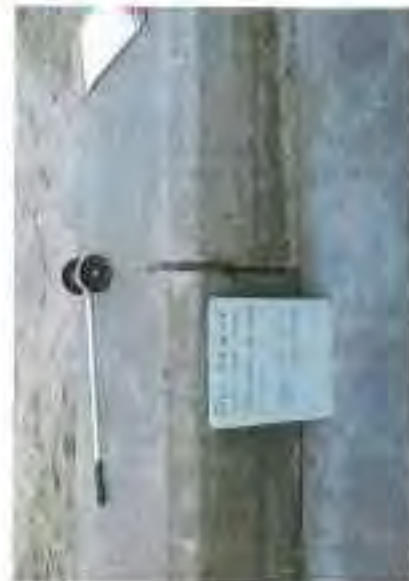
North Bay Front, 190' East of Amethyst

| Item | Location | Description |
|---|---|---|
| 5 | 190' East of Amethyst Avenue | Construction joint, waterside sealant cracked and split, landside and top sealant missing |

| Item | Description | QUANTITY | | MATERIAL COST | | LABOR COST | | ENGINEERING ESTIMATE | |
|---|---|---|---|---|---|---|---|---|---|
| 5 | 190' East of Amethyst Avenue, sealant repair | 6 | LF | | | | | \$25.00 | \$150 |

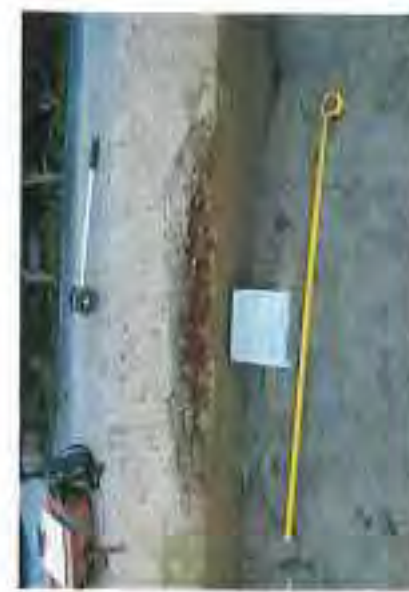
North Bay Front, 195' East of Amethyst

| Item | Location | Description |
|---|---|---|
| 6 | 195' East of Amethyst Avenue | Waterside, spall at bottom of cap 72" long x 12" high x 12" deep |

| Item | Description | QUANTITY | | MATERIAL COST | | LABOR COST | | ENGINEERING ESTIMATE | |
|---|---|---|---|---|---|---|---|---|---|
| 6 | 195' East of Amethyst Avenue, spall repair | 6 | SF | | | | | \$70.00 | \$420 |

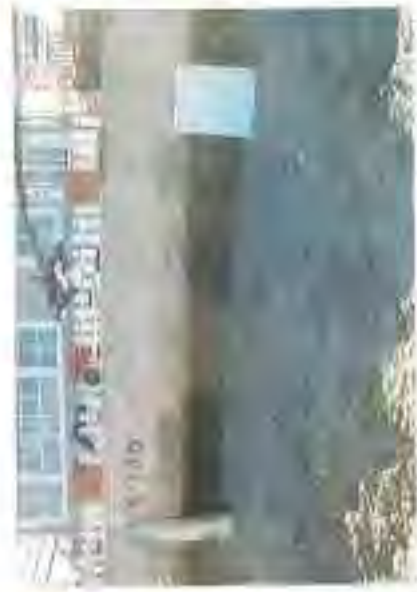
North Bay Front, 32' East of Onyx

| Item | Location | Description |
|---|---|---|
| 2 | 32' East of Onyx Avenue | Waterside, crack at bottom of cap 144" long |

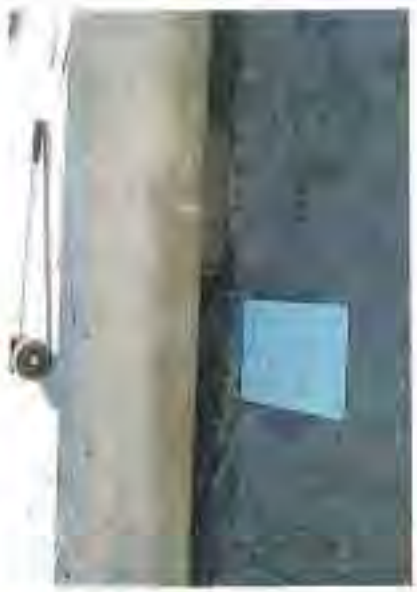
North Bay Front, 42' East of Onyx

| Item | Location | Description |
|---|---|---|
| 3 | 42' East of Onyx Avenue | Waterside, crack at bottom of cap, 24" long |

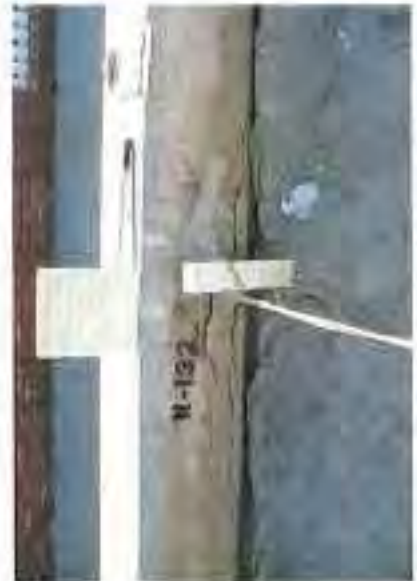
North Bay Front, 53' East of Onyx

| Item | Location | Description |
|---|---|---|
| 4 | 53' East of Onyx Avenue | Waterside, spall at bottom of cap 60" long x 12" high x 6" deep |

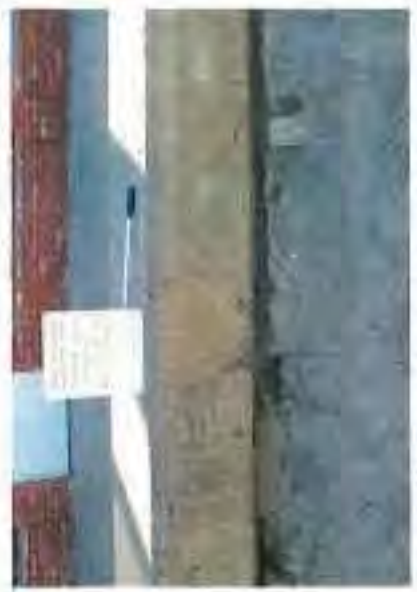
North Bay Front, 62' East of Onyx

| Item | Location | Description |
|---|---|---|
| 5 | 62' East of Onyx Avenue | Waterside, crack at bottom of cap, 60" long |

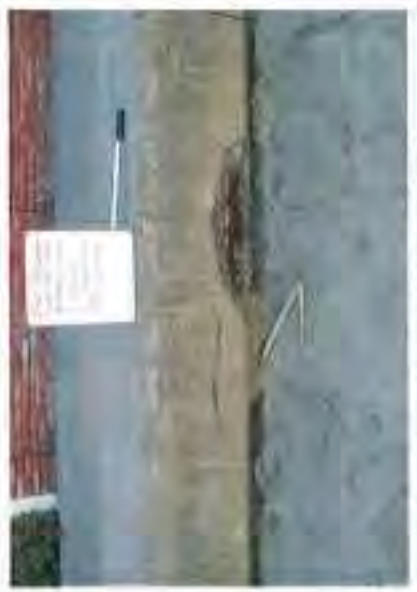
North Bay Front, 74' East of Onyx

| Item | Location | Description |
|---|---|---|
| 6 | 74' East of Onyx Avenue | Waterside, spall at bottom of cap, 60" long x 12" high x 6" deep |

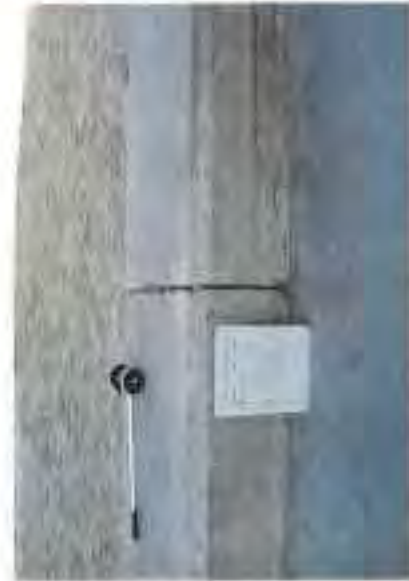
North Bay Front, 87' East of Onyx

| Item | Location | Description |
|---|---|---|
| 7 | 87' East of Onyx Avenue | Construction joint, waterside sealant cracked and split, landside and top sealant missing |

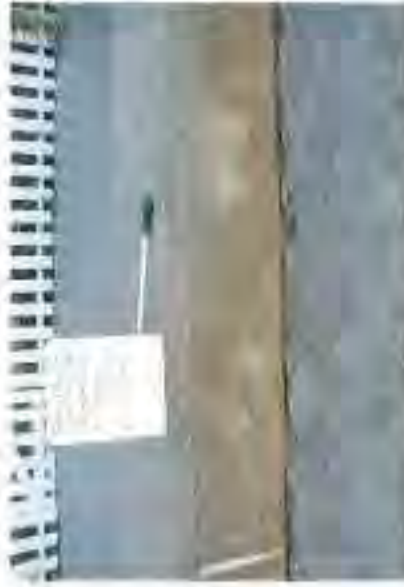
North Bay Front, 122' East of Onyx

| Item | Location | Description |
|---|---|---|
| 9 | 122' East of Onyx Avenue | Waterside, crack at bottom of cap, 36" long |

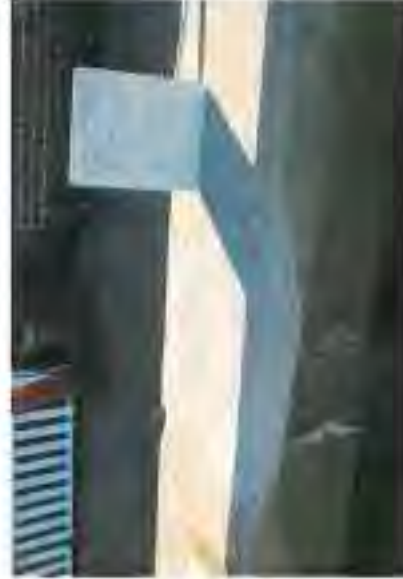
North Bay Front, 95' East of Marine

| Item | Location | Description |
|---|---|---|
| 2 | 95' East of Marine Avenue | Waterside, spall at top of cap, 24" square x 2" deep |

| Item | Description | QUANTITY | | MATERIAL COST | | LABOR COST | | ENGINEERING ESTIMATE | |
|---|---|---|---|---|---|---|---|---|---|
| 2 | 95' East of Marine Avenue, spall repair | 4 | SF | | | | | \$70.00 | \$280 |

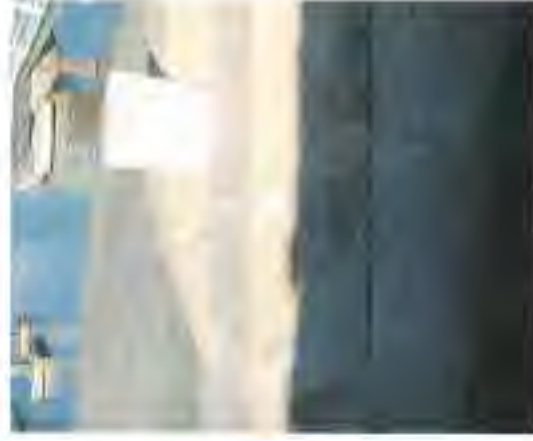
North Bay Front, 166' East of Marine

| Item | Location | Description |
|---|---|---|
| 3 | 166' East of Marine Avenue | Waterside, cracked above pile, longitudinal crack 60" long |

| Item | Description | QUANTITY | | MATERIAL COST | | LABOR COST | | ENGINEERING ESTIMATE | |
|---|---|---|---|---|---|---|---|---|---|
| 3 | 166' East of Marine Avenue, crack injection | 5 | LF | | | | | \$70.00 | \$350 |

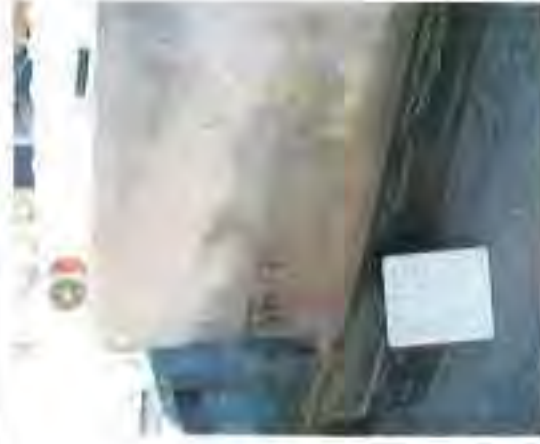
North Bay Front, 173' East of Marine

| Item | Location | Description |
|---|---|---|
| 4 | 173' East of Marine Avenue | Waterside, crack with rust at center of cap, 36" long |

| Item | Description | QUANTITY | | MATERIAL COST | | LABOR COST | | ENGINEERING ESTIMATE | |
|---|---|---|---|---|---|---|---|---|---|
| 4 | 173' East of Marine Avenue, crack injection | 3 | LF | | | | | \$70.00 | \$210 |

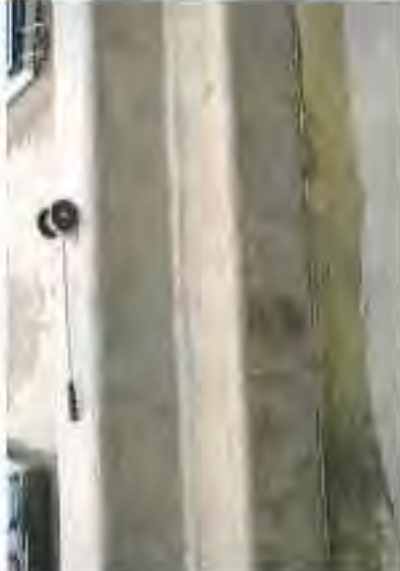
South Bay Front, 86' West of Emerald

| Item | Location | Description |
|---|---|---|
| 1 | 86' West of Emerald Avenue | Landside, cracking at lower step 72" |

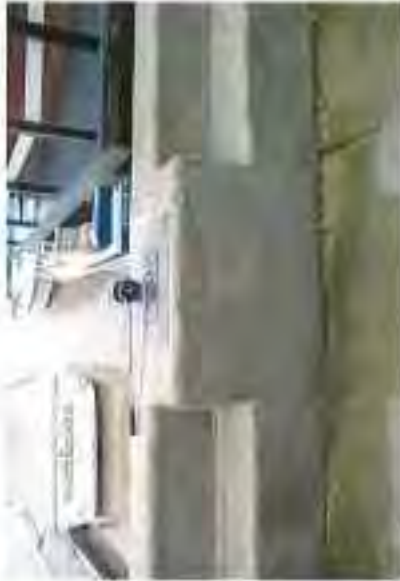
South Bay Front, 95' West of Emerald

| Item | Location | Description |
|---|---|---|
| 2 | 95' West of Emerald Avenue | Pullbox, cracked on landside, 30", waterside repaired and in good shape |

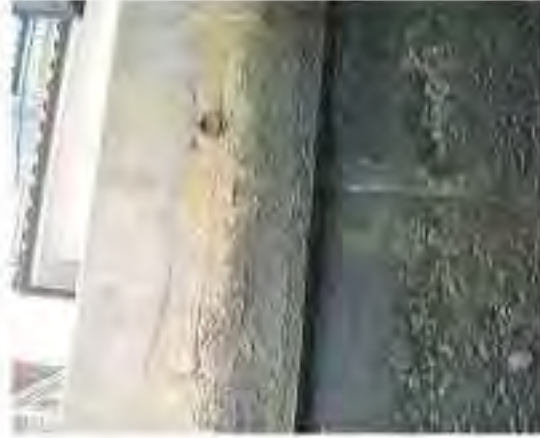
South Bay Front, 144' West of Emerald

| Item | Location | Description |
|---|---|---|
| 3 | 144' West of Emerald Avenue | Waterside, vertical crack through cap 30" long |

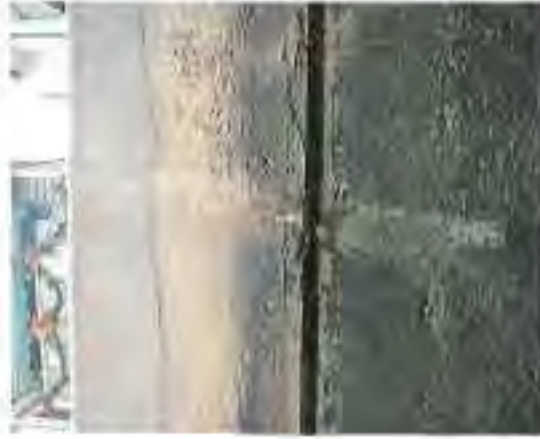
South Bay Front, 153' West of Emerald

| Item | Location | Description |
|---|---|---|
| 4 | 153' West of Emerald Avenue | Waterside, vertical crack at panel joints |

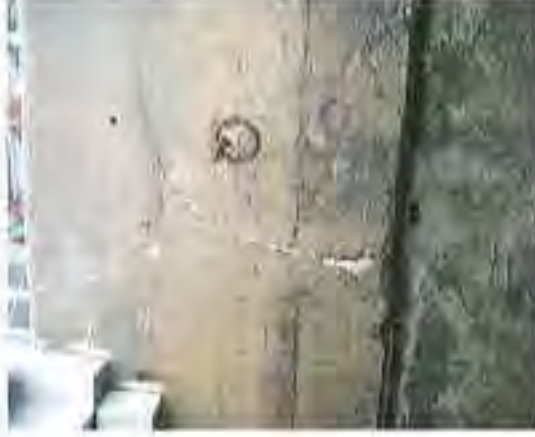
South Bay Front, 160' West of Emerald

| Item | Location | Description |
|---|---|---|
| 5 | 160' West of Emerald Avenue | Waterside, vertical crack through previous repair |

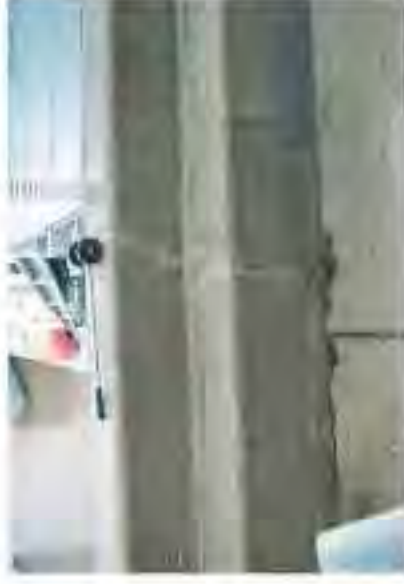
South Bay Front, 170' West of Emerald

| Item | Location | Description |
|---|---|---|
| 6 | 170' West of Emerald Avenue | Landside, crack through previous repair |

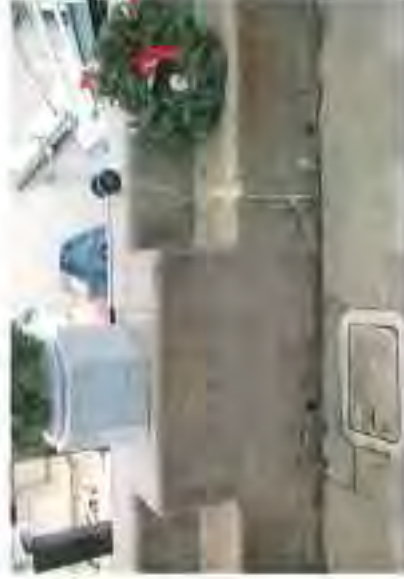
South Bay Front, 195' West of Emerald

| Item | Location | Description |
|---|---|---|
| 7 | 195' West of Emerald Avenue | Landside, transverse crack through cap at lightpole |

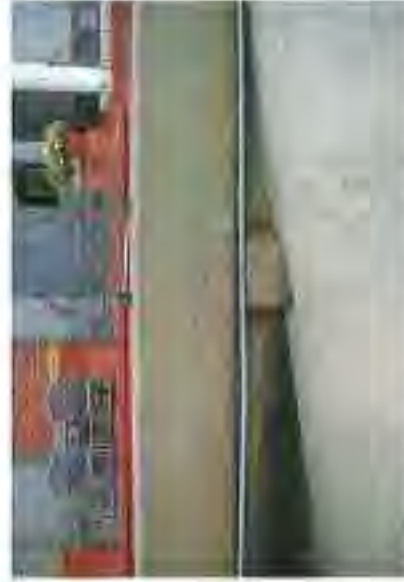
South Bay Front, 67' West of Garnet

| Item | Location | Description |
|---|---|---|
| 2 | 67' West of Garnet Avenue | Waterside, crack over pile 60" long |

| Item | Description | QUANTITY | | MATERIAL COST | | LABOR COST | | ENGINEERING ESTIMATE | |
|---|---|---|---|---|---|---|---|---|---|
| 2 | 67' West of Garnet Avenue, crack injection | 5 | LF | | | | | \$70 | \$350.00 |

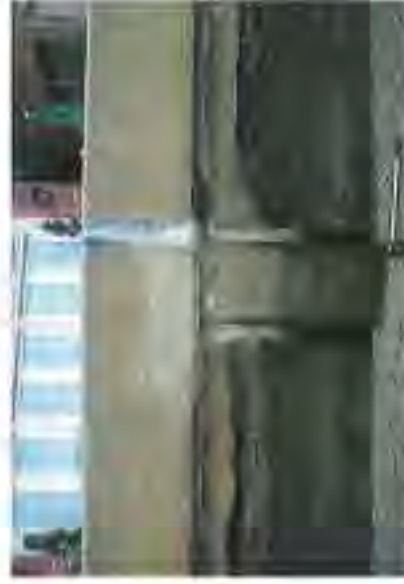
South Bay Front, 101' West of Garnet

| Item | Location | Description |
|---|---|---|
| 3 | 101' West of Garnet Avenue | Construction joint, sealant waterside and landside cracked and split |

| Item | Description | QUANTITY | | MATERIAL COST | | LABOR COST | | ENGINEERING ESTIMATE | |
|---|---|---|---|---|---|---|---|---|---|
| 3 | 101' West of Garnet Avenue, sealant repair | 6 | LF | | | | | \$25 | \$150.00 |

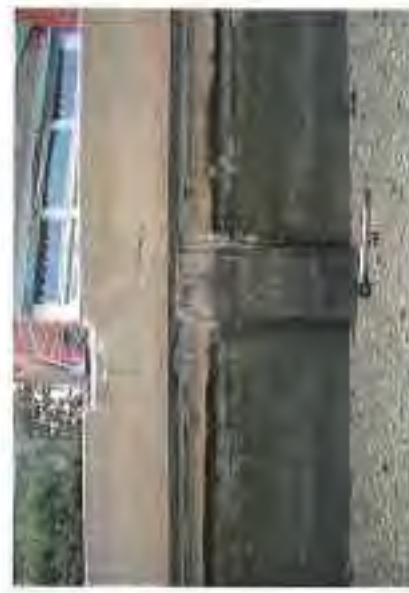
South Bay Front, 113' West of Garnet

| Item | Location | Description |
|---|---|---|
| 4 | 113' West of Garnet Avenue | Waterside, 72" crack over pile, spall 12" long x 12" wide x 4" high on west side of pile bottom of cap |

| Item | Description | QUANTITY | | MATERIAL COST | | LABOR COST | | ENGINEERING ESTIMATE | |
|---|---|---|---|---|---|---|---|---|---|
| 4 | 113' West of Garnet Avenue, crack injection | 8 | LF | | | | | \$70 | \$560.00 |

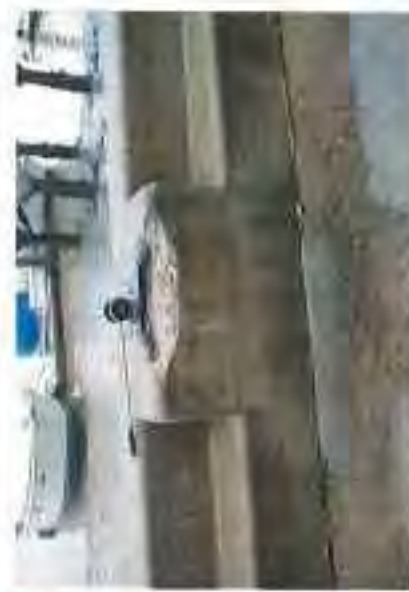
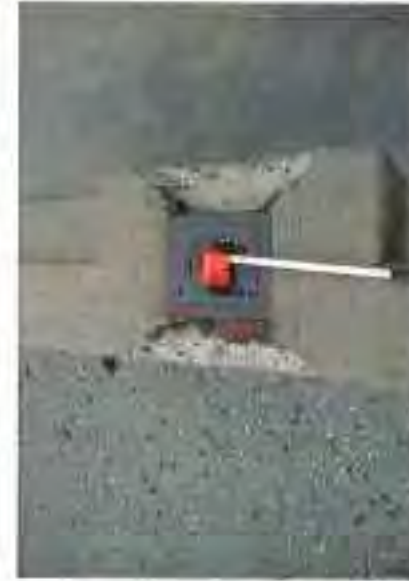
South Bay Front, 115' West of Garnet

| Item | Location | Description |
|---|---|---|
| 5 | 115' West of Garnet Avenue | Pullbox, spall on waterside and landside |

| Item | Description | QUANTITY | | MATERIAL COST | | LABOR COST | | ENGINEERING ESTIMATE | |
|---|---|---|---|---|---|---|---|---|---|
| 5 | 115' West of Garnet Avenue, spall repair | 6 | SF | | | | | \$70 | \$420.00 |

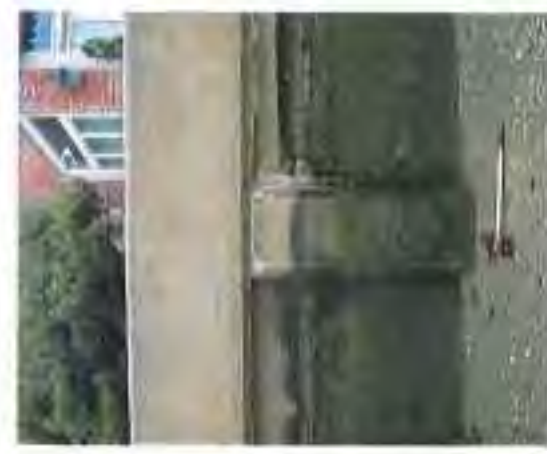
South Bay Front, 125' West of Garnet

| Item | Location | Description |
|---|---|---|
| 6 | 125' West of Garnet Avenue | Waterside, crack 60" long over pile |

| Item | Description | QUANTITY | | MATERIAL COST | | LABOR COST | | ENGINEERING ESTIMATE | |
|---|---|---|---|---|---|---|---|---|---|
| 6 | 125' West of Garnet Avenue, crack injection | 5 | LF | | | | | \$70 | \$350.00 |

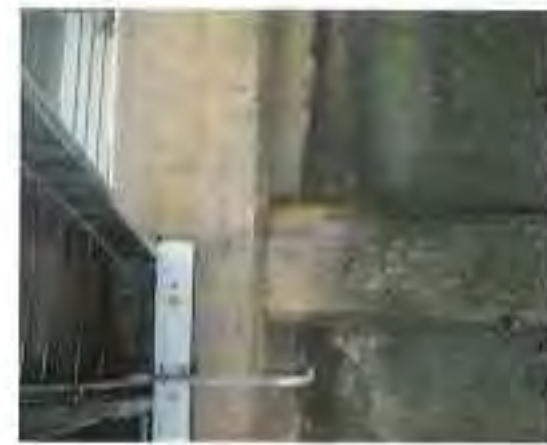
South Bay Front, 148' West of Garnet

| Item | Location | Description |
|---|---|---|
| 7 | 148' West of Garnet Avenue | Waterside, crack 60" long over pile |

| Item | Description | QUANTITY | | MATERIAL COST | | LABOR COST | | ENGINEERING ESTIMATE | |
|---|---|---|---|---|---|---|---|---|---|
| 7 | 148' West of Garnet Avenue, crack injection | 5 | LF | | | | | \$70 | \$350.00 |

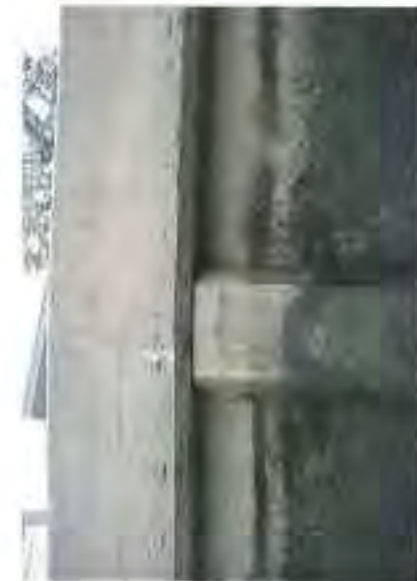
South Bay Front, 159' West of Garnet

| Item | Location | Description |
|---|---|---|
| 8 | 159' West of Garnet Avenue | Waterside, crack at bottom of cap 96" long |

| Item | Description | QUANTITY | | MATERIAL COST | | LABOR COST | | ENGINEERING ESTIMATE | |
|---|---|---|---|---|---|---|---|---|---|
| 8 | 159' West of Garnet Avenue, crack injection | 8 | LF | | | | | \$70 | \$560.00 |

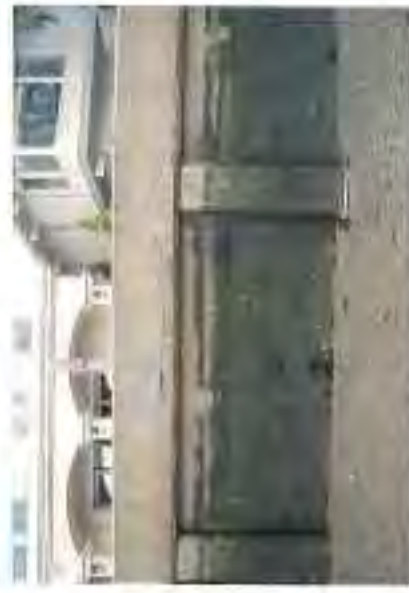
South Bay Front, 172' West of Garnet

| Item | Location | Description |
|---|---|---|
| 9 | 172' West of Garnet Avenue | Waterside, crack at bottom of cap 120" long |

| Item | Description | QUANTITY | | MATERIAL COST | | LABOR COST | | ENGINEERING ESTIMATE | |
|---|---|---|---|---|---|---|---|---|---|
| 9 | 172' West of Garnet Avenue, crack injection | 10 | LF | | | | | \$70 | \$700.00 |

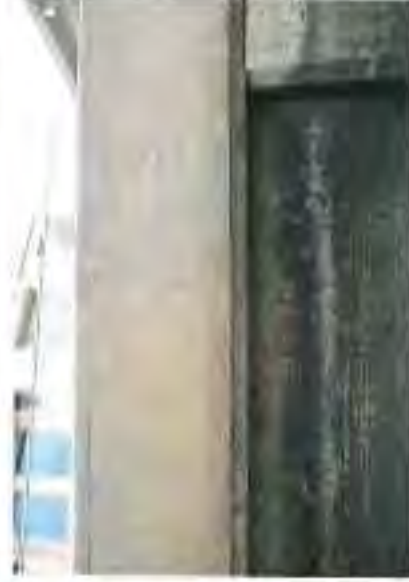
South Bay Front, 185' West of Garnet

| Item | Location | Description |
|---|---|---|
| 10 | 185' West of Garnet Avenue | Waterside, cross crack 24" long x 12" high |

| Item | Description | QUANTITY | | MATERIAL COST | | LABOR COST | | ENGINEERING ESTIMATE | |
|---|---|---|---|---|---|---|---|---|---|
| 10 | 185' West of Garnet Avenue, crack injection | 4 | LF | | | | | \$70 | \$280.00 |

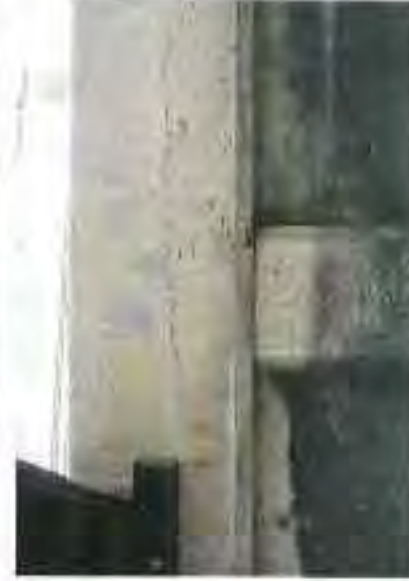
South Bay Front, 194' West of Garnet

| Item | Location | Description |
|---|---|---|
| 11 | 194' West of Garnet Avenue | Waterside, crack 36" long over pile |

| Item | Description | QUANTITY | | MATERIAL COST | | LABOR COST | | ENGINEERING ESTIMATE | |
|---|---|---|---|---|---|---|---|---|---|
| 11 | 194' West of Garnet Avenue, crack injection | 3 | LF | | | | | \$70 | \$210.00 |
