**Subject: City of Newport Beach Balboa Island Coping Repair Project (C-7066-1)**

**PROPOSED PROJECT:** Balboa Island Seawall Coping Repair Project

Repair and maintenance of existing seawalls, and increase  
height of seawalls by 9 inches.

# Bulkhead Condition Report for Portions of the Balboa Island Seawall

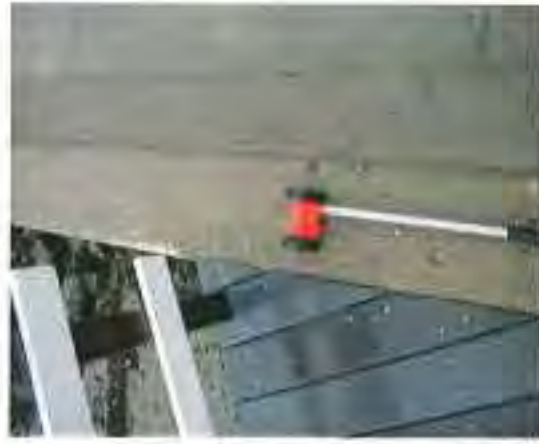
South Bay Front, 201' West of Garnet

| Item | Location | Description |
|---|---|---|
| 12 | 201' West of Garnet Avenue | Landside, crack at top of walk going to waterside 24" long |

| Item | Description | QUANTITY | | MATERIAL COST | | LABOR COST | | ENGINEERING ESTIMATE | |
|---|---|---|---|---|---|---|---|---|---|
| 12 | 201' West of Garnet Avenue, crack injection | 2 | LF | | | | | \$70 | \$140.00 |

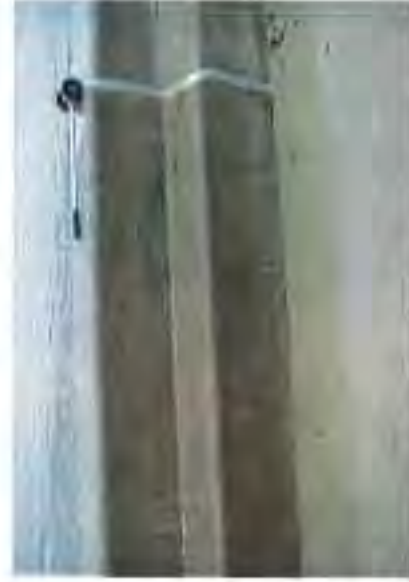
South Bay Front, 213' West of Garnet

| Item | Location | Description |
|---|---|---|
| 14 | 213' West of Garnet Avenue | Landside, longitudinal crack to east of construction joint 72" long lower step |

| Item | Description | QUANTITY | | MATERIAL COST | | LABOR COST | | ENGINEERING ESTIMATE | |
|---|---|---|---|---|---|---|---|---|---|
| 14 | 213' West of Garnet Avenue, crack injection | 6 | LF | | | | | \$70 | \$420.00 |

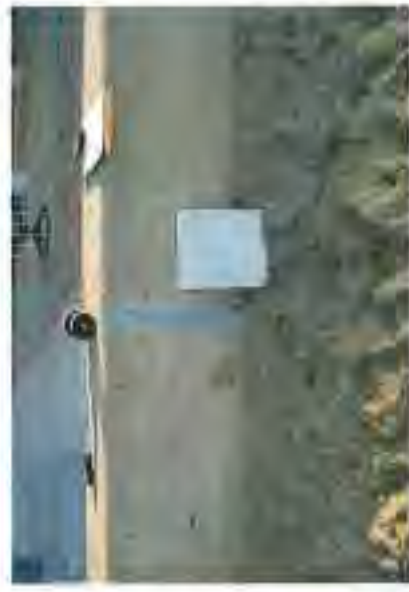
South Bay Front, 17' East of Garnet

| Item | Location | Description |
|---|---|---|
| 2 | 17' East of Garnet Avenue | Waterside, minor cracking |

| Item | Description | QUANTITY | | MATERIAL COST | | LABOR COST | | ENGINEERING ESTIMATE | |
|---|---|---|---|---|---|---|---|---|---|
| 2 | 17' East of Garnet Avenue, crack injection | 1 | LF | | | | | \$70.00 | \$70 |

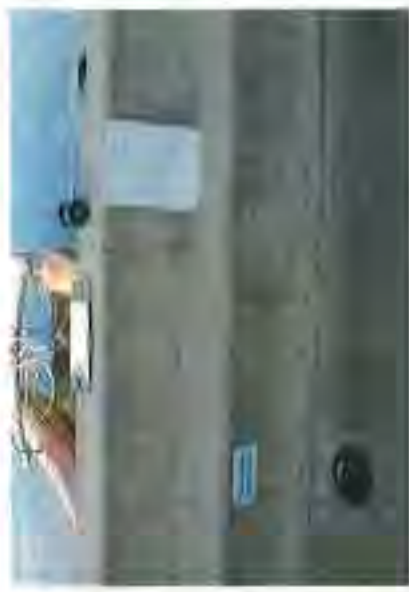
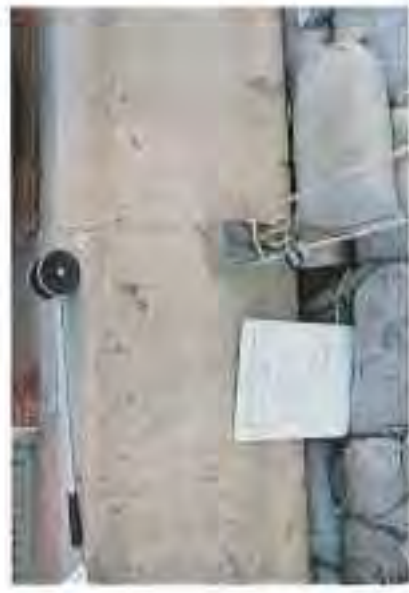
South Bay Front, 51' East of Garnet

| Item | Location | Description |
|---|---|---|
| 3 | 51' East of Garnet Avenue | Waterside, transverse crack through cap |

| Item | Description | QUANTITY | | MATERIAL COST | | LABOR COST | | ENGINEERING ESTIMATE | |
|---|---|---|---|---|---|---|---|---|---|
| 3 | 51' East of Garnet Avenue, crack injection | 6 | LF | | | | | \$70.00 | \$420 |

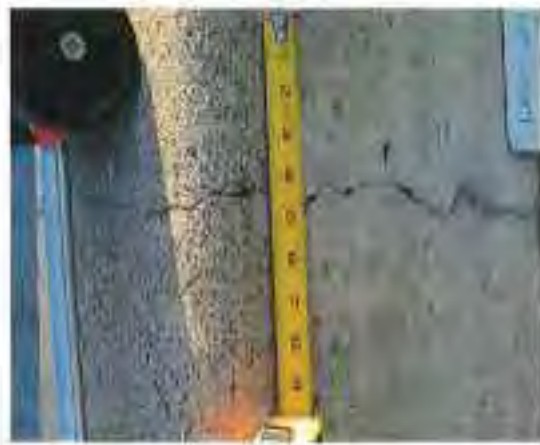
South Bay Front, 84' East of Garnet

| Item | Location | Description |
|---|---|---|
| 4 | 84' East of Garnet Avenue | Waterside, transverse crack through cap |

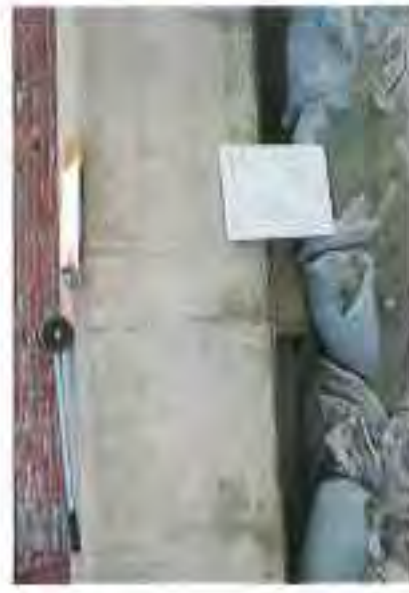
South Bay Front, 85' East of Garnet

| Item | Location | Description |
|---|---|---|
| 5 | 85' East of Garnet Avenue | Waterside, transverse crack through cap |

| Item | Description | QUANTITY | | MATERIAL COST | | LABOR COST | | ENGINEERING ESTIMATE | |
|---|---|---|---|---|---|---|---|---|---|
| 5 | 85' East of Garnet Avenue, crack injection | 6 | LF | | | | | \$70.00 | \$420 |

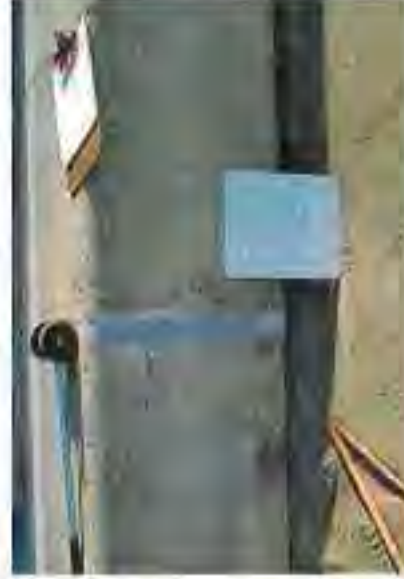
South Bay Front, 23' East of Pearl

| Item Location | Description |
|---|---|
| 1 23' East of Pearl Avenue | Construction joint, waterside sealant cracked, landside sealant in good shape |

| Item | Description | QUANTITY | | MATERIAL COST | | LABOR COST | | ENGINEERING ESTIMATE | |
|---|---|---|---|---|---|---|---|---|---|
| 1 | 23' East of Pearl Avenue, sealant repair | 3 | LF | | | | | \$25.00 | \$75 |

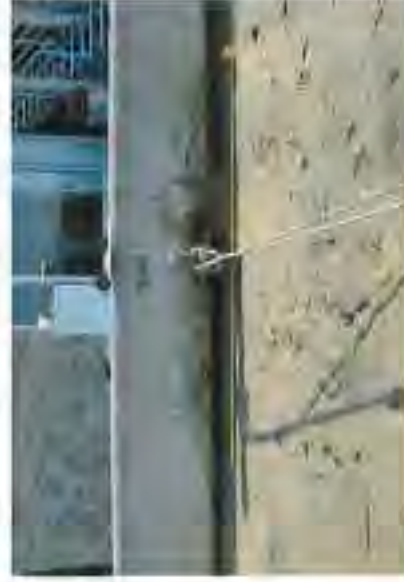
South Bay Front, 33' East of Pearl

| Item Location | Description |
|---|---|
| 2 33' East of Pearl Avenue | Waterside, spall at bottom of cap 96" long x 18" tall x 3" deep |

| Item | Description | QUANTITY | | MATERIAL COST | | LABOR COST | | ENGINEERING ESTIMATE | |
|---|---|---|---|---|---|---|---|---|---|
| 2 | 33' East of Pearl Avenue, crack injection | 8 | LF | | | | | \$70.00 | \$560 |

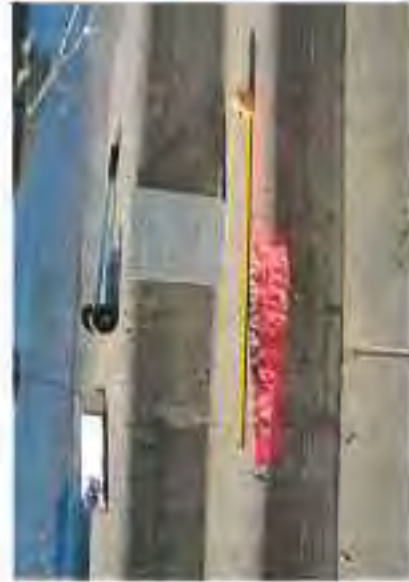
South Bay Front, 45' East of Pearl

| Item Location | Description |
|---|---|
| 3 45' East of Pearl Avenue | Landside, spall at lower step 48" long x 6" high x 4" deep |

| Item | Description | QUANTITY | | MATERIAL COST | | LABOR COST | | ENGINEERING ESTIMATE | |
|---|---|---|---|---|---|---|---|---|---|
| 3 | 45' East of Pearl Avenue, spall repair | 4 | SF | | | | | \$70.00 | \$280 |

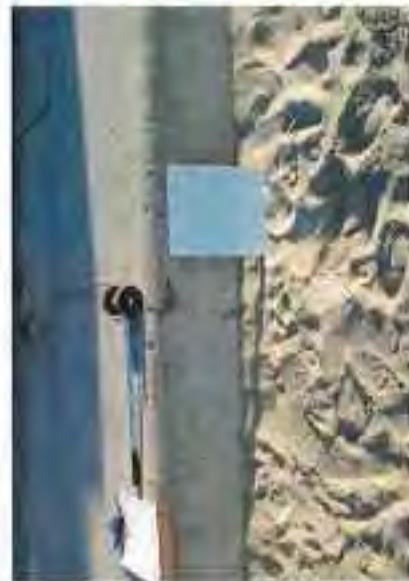
South Bay Front, 92' East of Pearl

| Item Location | Description |
|---|---|
| 4 92' East of Pearl Avenue | Waterside spall at top of cap 2" long x 2" high x 4" deep |

| Item | Description | QUANTITY | | MATERIAL COST | | LABOR COST | | ENGINEERING ESTIMATE | |
|---|---|---|---|---|---|---|---|---|---|
| 4 | 92' East of Pearl Avenue, spall repair | 6 | SF | | | | | \$70.00 | \$420 |

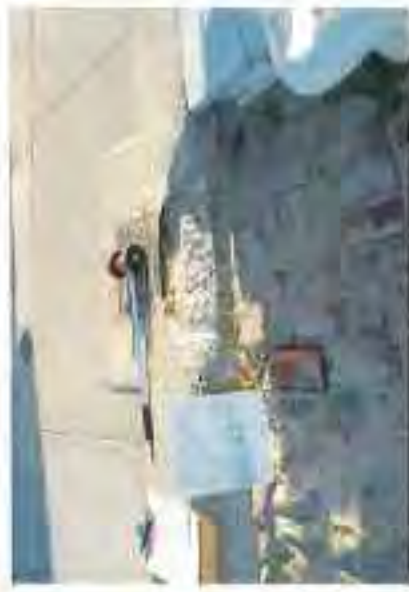
South Bay Front, 112' East of Pearl

| Item Location | Description |
|---|---|
| 5 112' East of Pearl Avenue | Pullbox, spall 30" long x 7" high x 5" deep |

| Item | Description | QUANTITY | | MATERIAL COST | | LABOR COST | | ENGINEERING ESTIMATE | |
|---|---|---|---|---|---|---|---|---|---|
| 5 | 112' East of Pearl Avenue, spall repair | 3 | SF | | | | | \$70.00 | \$210 |

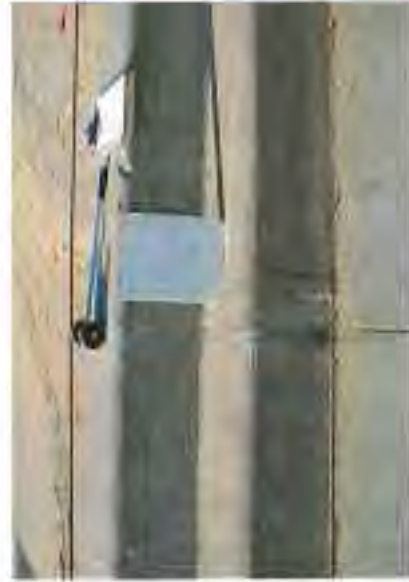
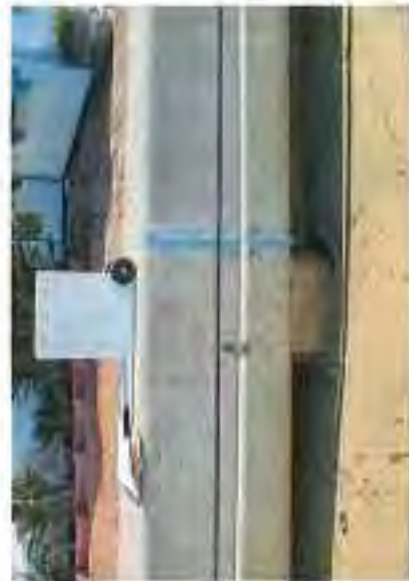
South Bay Front, 141' East of Pearl

| Item Location | Description |
|---|---|
| 6 141' East of Pearl Avenue | Construction joint, waterside sealant cracked, landside sealant in good shape |

| Item | Description | QUANTITY | | MATERIAL COST | | LABOR COST | | ENGINEERING ESTIMATE | |
|---|---|---|---|---|---|---|---|---|---|
| 6 | 141' East of Pearl Avenue, sealant repair | 3 | LF | | | | | \$25.00 | \$75 |

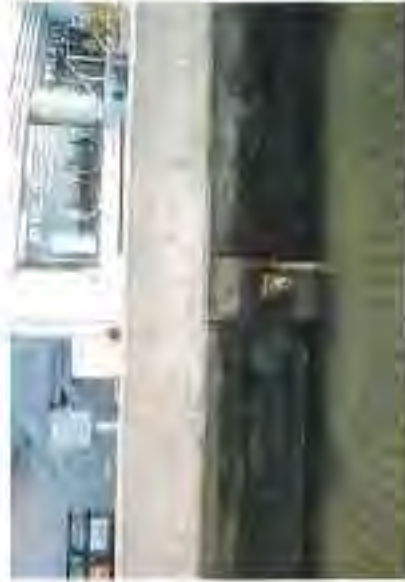
South Bay Front, 79' East of Agate

| Item | Location | Description |
|---|---|---|
| 5 | 79' East of Agate Avenue | Previously repaired spill, cracked 60" long x 6" high x 2" deep, bottom half of cap |

| Item | Description | QUANTITY | | MATERIAL COST | | LABOR COST | | ENGINEERING ESTIMATE | |
|---|---|---|---|---|---|---|---|---|---|
| 5 | 79' East of Agate Avenue, crack repair | 5 | LF | | | | | \$70.00 | \$350 |

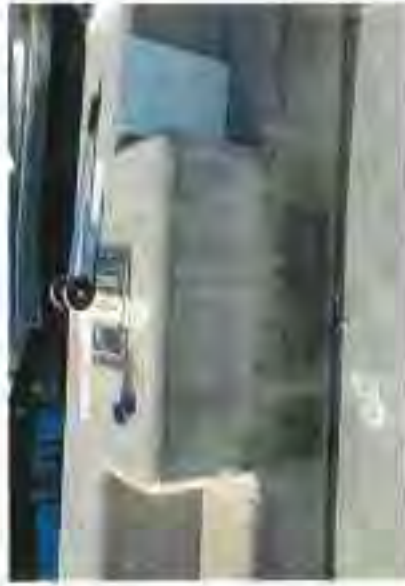
South Bay Front, 110' East of Agate

| Item | Location | Description |
|---|---|---|
| 2 | 110' East of Agate Avenue | Pull box, in good condition |

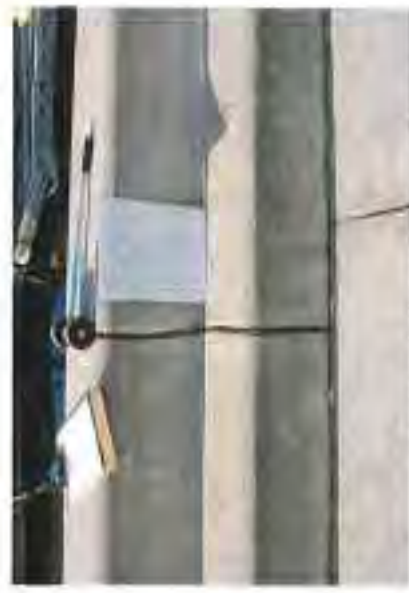
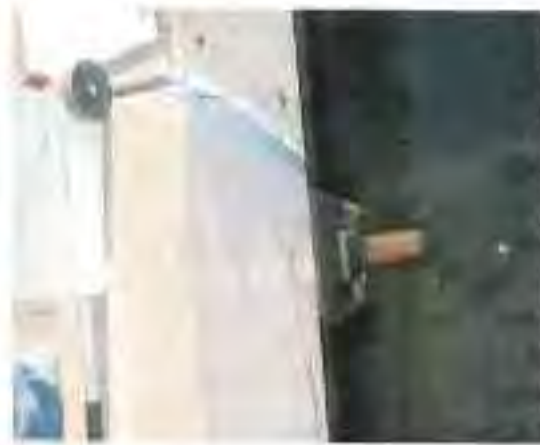
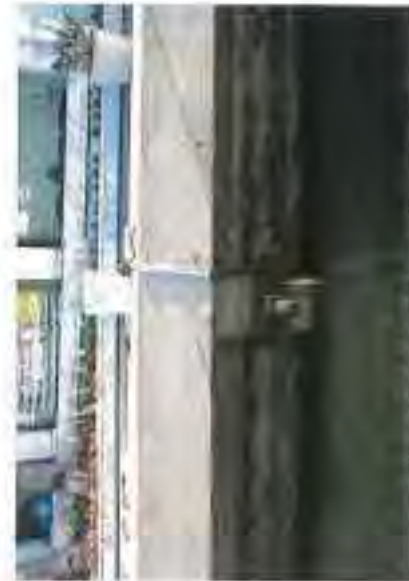
South Bay Front, 116' East of Agate

| Item | Location | Description |
|---|---|---|
| 3 | 116' East of Agate Avenue | Construction joint, landside and top missing sealant, waterside cracked and needs repair |

| Item | Description | QUANTITY | | MATERIAL COST | | LABOR COST | | ENGINEERING ESTIMATE | |
|---|---|---|---|---|---|---|---|---|---|
| 3 | 116' East of Agate Avenue, sealant repair | 3 | LF | | | | | \$25.00 | \$75 |
| 4 | 116' East of Agate Avenue, crack injection | 6 | LF | | | | | \$70.00 | \$420 |

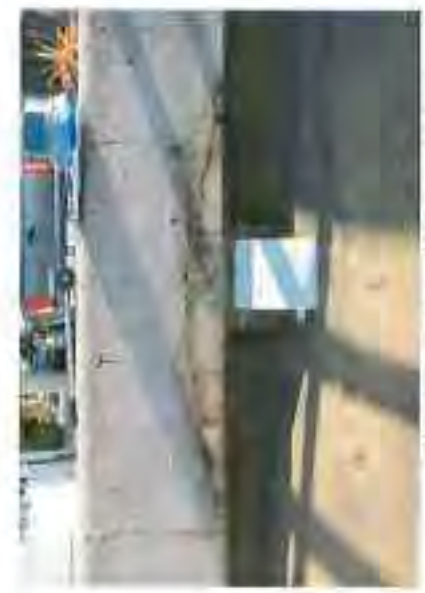
South Bay Front, 209' East of Agate

| Item | Location | Description |
|---|---|---|
| 6 | 209' East of Agate Avenue | Waterside, bottom of cap spalled 72" long x 8" high |

| Item | Description | QUANTITY | | MATERIAL COST | | LABOR COST | | ENGINEERING ESTIMATE | |
|---|---|---|---|---|---|---|---|---|---|
| 6 | 209' East of Agate Avenue, crack injection | 6 | LF | | | | | \$70.00 | \$420 |

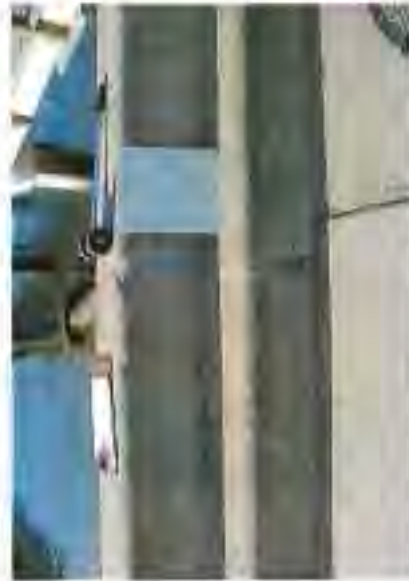
South Bay Front, 17' East of Opal

| Item | Location | Description |
|---|---|---|
| 2 | 17' East of Opal Avenue | Construction joint, landside sealant and top in good shape, waterside sealant cracked and split |
| 3 | 17' East of Opal Avenue | Waterside, crack at bottom of cap 36" long |

| Item | Description | QUANTITY | | MATERIAL COST | | LABOR COST | | ENGINEERING ESTIMATE | |
|---|---|---|---|---|---|---|---|---|---|
| 2 | 17' East of Opal Avenue, sealant repair | 3 | LF | | | | \$25.00 | | \$75 |
| 3 | 17' East of Opal Avenue, crack injection | 3 | LF | | | | \$70.00 | | \$210 |

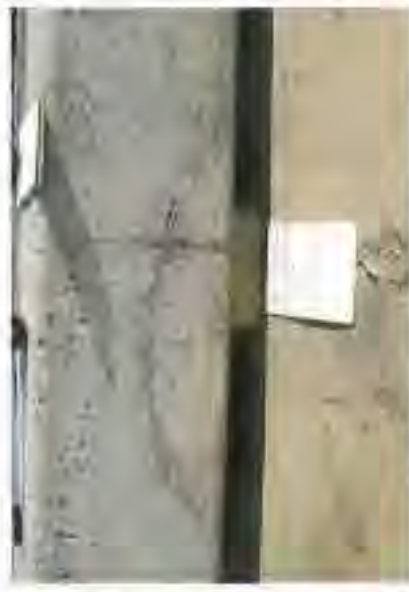
South Bay Front, 27' East of Opal

| Item | Location | Description |
|---|---|---|
| 4 | 27' East of Opal Avenue | Waterside, crack at bottom of cap 60" long |

| Item | Description | QUANTITY | | MATERIAL COST | | LABOR COST | | ENGINEERING ESTIMATE | |
|---|---|---|---|---|---|---|---|---|---|
| 4 | 27' East of Opal Avenue, crack injection | 5 | LF | | | | \$70.00 | | \$350 |

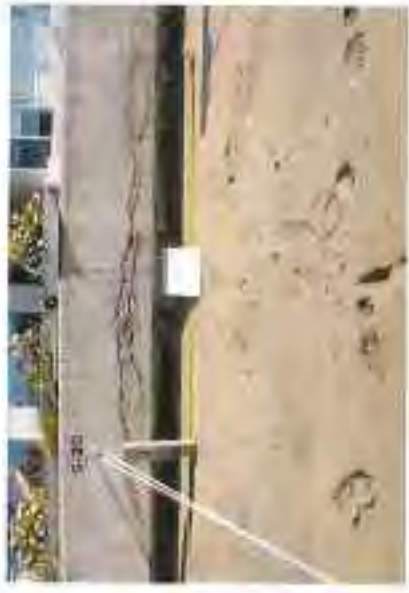
South Bay Front, 51' East of Opal

| Item | Location | Description |
|---|---|---|
| 5 | 51' East of Opal Avenue | Waterside, crack at bottom of cap 168" long |

| Item | Description | QUANTITY | | MATERIAL COST | | LABOR COST | | ENGINEERING ESTIMATE | |
|---|---|---|---|---|---|---|---|---|---|
| 5 | 51' East of Opal Avenue, crack injection | 13 | LF | | | | \$70.00 | | \$910 |

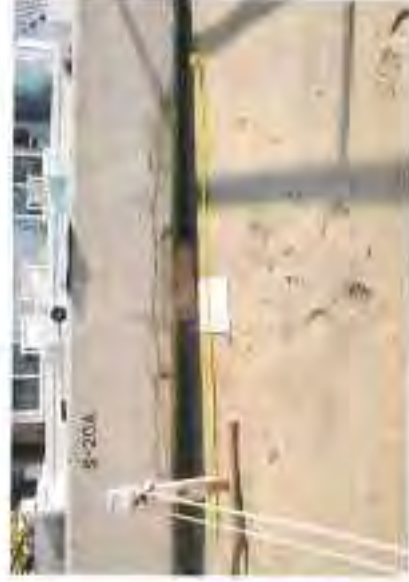
South Bay Front, 63' East of Opal

| Item | Location | Description |
|---|---|---|
| 6 | 63' East of Opal Avenue | Waterside, crack at bottom of cap, 108 long |

| Item | Description | QUANTITY | | MATERIAL COST | | LABOR COST | | ENGINEERING ESTIMATE | |
|---|---|---|---|---|---|---|---|---|---|
| 6 | 63' East of Opal Avenue, crack injection | 9 | LF | | | | \$70.00 | | \$630 |

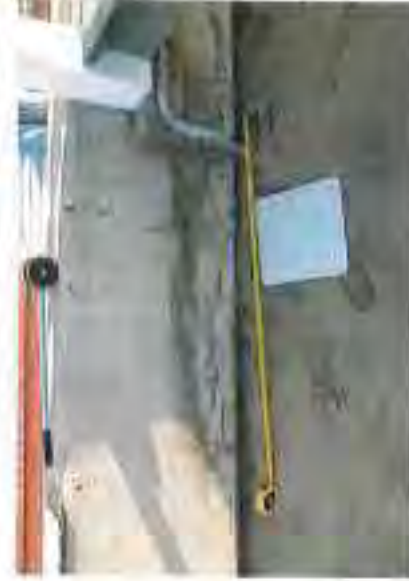
South Bay Front, 74' East of Opal

| Item | Location | Description |
|---|---|---|
| 7 | 74' East of Opal Avenue | Waterside, crack at bottom of cap, 48" long |

| Item | Description | QUANTITY | | MATERIAL COST | | LABOR COST | | ENGINEERING ESTIMATE | |
|---|---|---|---|---|---|---|---|---|---|
| 7 | 74' East of Opal Avenue, crack injection | 4 | LF | | | | \$70.00 | | \$280 |

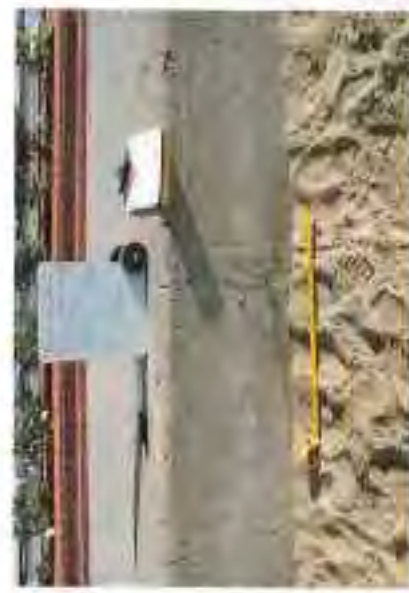
South Bay Front, 98' East of Opal

| Item | Location | Description |
|---|---|---|
| 8 | 86' East of Opal Avenue | Waterside, crack at bottom of cap 24" long, light spalling |

| Item | Description | QUANTITY | | MATERIAL COST | | LABOR COST | | ENGINEERING ESTIMATE | |
|---|---|---|---|---|---|---|---|---|---|
| 8 | 96' East of Opal Avenue, crack injection | 2 | LF | | | | \$70.00 | | \$140 |

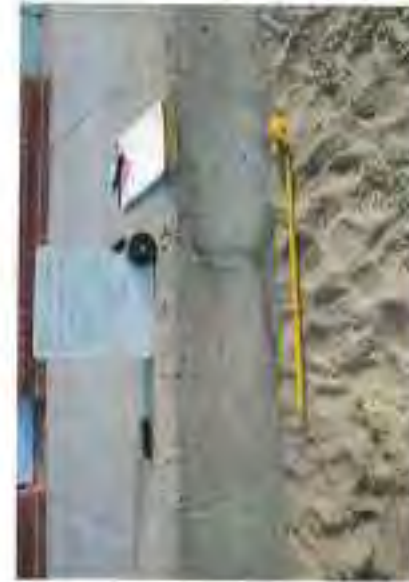
South Bay Front, 108' East of Opal

| Item | Location | Description |
|---|---|---|
| 9 | 108' East of Opal Avenue | Waterside, crack at bottom of cap, 24" long light spalling |

| Item | Description | QUANTITY | | MATERIAL COST | | LABOR COST | | ENGINEERING ESTIMATE | |
|---|---|---|---|---|---|---|---|---|---|
| 9 | 108' East of Opal Avenue, crack injection | 2 | LF | | | | \$70.00 | | \$140 |

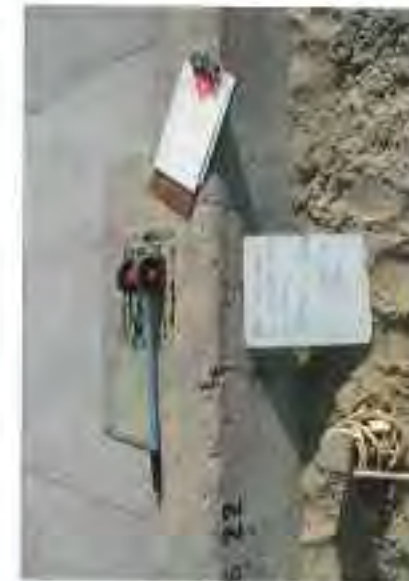
South Bay Front, 116' East of Opal

| Item | Location | Description |
|---|---|---|
| 10 | 116' East of Opal Avenue | Pullbox, spalling at landside and waterside 24" long x 3" wide x 3" deep |

| Item | Description | QUANTITY | | MATERIAL COST | | LABOR COST | | ENGINEERING ESTIMATE | |
|---|---|---|---|---|---|---|---|---|---|
| 10 | 116' East of Opal Avenue, spill repair | 6 | LF | | | | \$70.00 | | \$420 |

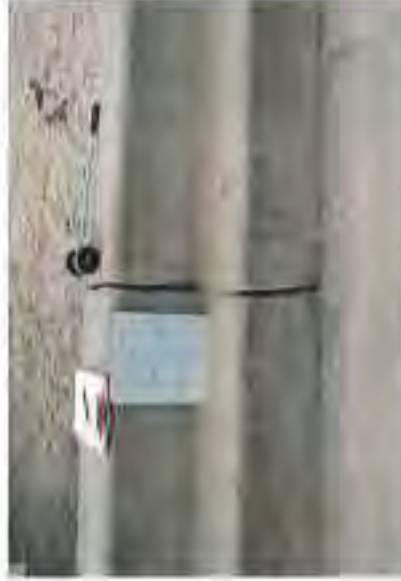
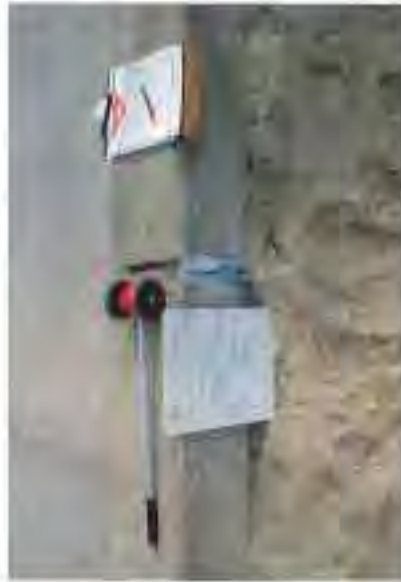
South Bay Front, 132' East of Opal

| Item | Location | Description |
|---|---|---|
| 11 | 132' East of Opal Avenue | Construction joint, sealant landside and top missing; waterside sealant cracked and split |

| Item | Description | QUANTITY | | MATERIAL COST | | LABOR COST | | ENGINEERING ESTIMATE | |
|---|---|---|---|---|---|---|---|---|---|
| 11 | 132' East of Opal Avenue, sealant repair | 6 | LF | | | | \$25.00 | | \$150 |

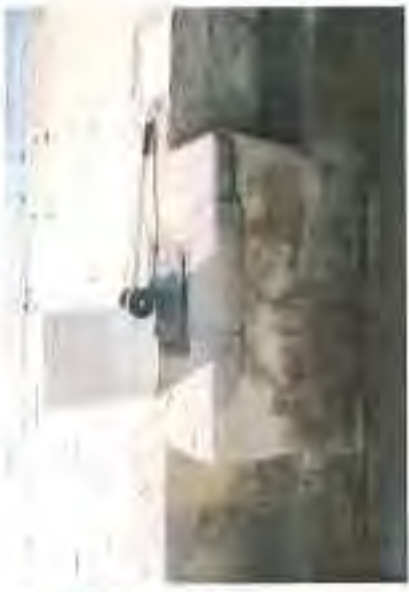
South Bay Front, 118' East of Turquoise

| <b>ACTIVITY</b><br><b>Balboa Island Bulkhead Inspection</b> | | <b>CASH &amp; ASSOCIATES</b><br>Engineering and Architecture | | | | <br><small>CASH &amp; ASSOCIATES<br/>ENGINEERING &amp; ARCHITECTURE<br/>(314) 883-2632<br/>40560701.10/04.11</small> | | | |
|---|---|---|---|---|---|---|---|---|---|
| 4 | 118' East of Turquoise Avenue, sealant repair | 6 | LF | | | | | \$25.00 | \$150 |

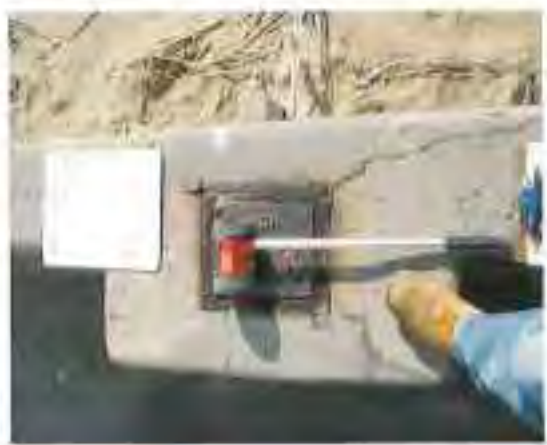
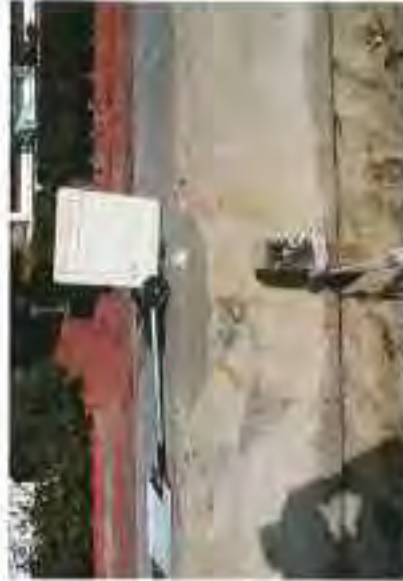
South Bay Front, 124' East of Turquoise

| <b>ACTIVITY</b><br><b>Balboa Island Bulkhead Inspection</b> | | <b>CASH &amp; ASSOCIATES</b><br>Engineering and Architecture | | | | <br><small>CASH &amp; ASSOCIATES<br/>ENGINEERING &amp; ARCHITECTURE<br/>(314) 883-2632<br/>40560701.10/04.11</small> | | | |
|---|---|---|---|---|---|---|---|---|---|
| 5 | 124' East of Turquoise Avenue, crack injection | 3 | LF | | | | | \$70.00 | \$210 |

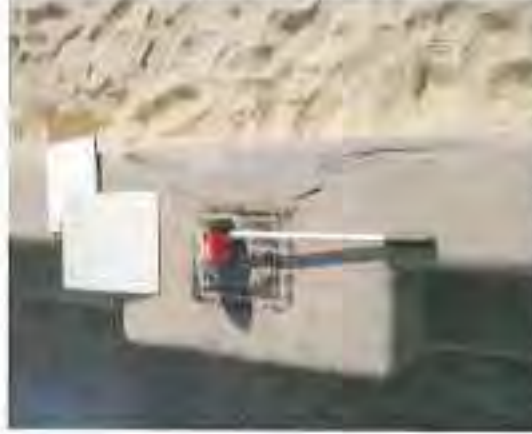
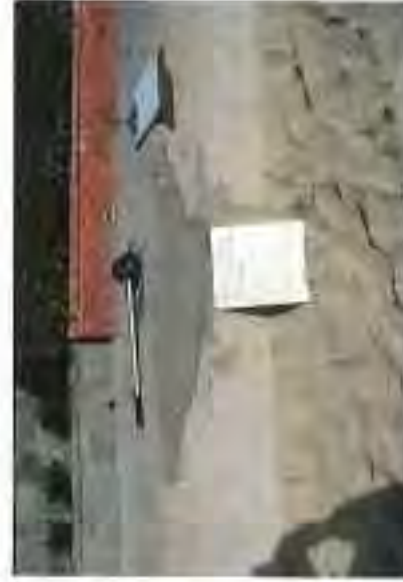
South Bay Front, 214' East of Turquoise

| <b>ACTIVITY</b><br><b>Balboa Island Bulkhead Inspection</b> | | <b>CASH &amp; ASSOCIATES</b><br>Engineering and Architecture | | | | <br><small>CASH &amp; ASSOCIATES<br/>ENGINEERING &amp; ARCHITECTURE<br/>(314) 883-2632<br/>40560701.10/04.11</small> | | | |
|---|---|---|---|---|---|---|---|---|---|
| 6 | 214' East of Turquoise Avenue, spall repair | 3 | SF | | | | | \$70.00 | \$210 |

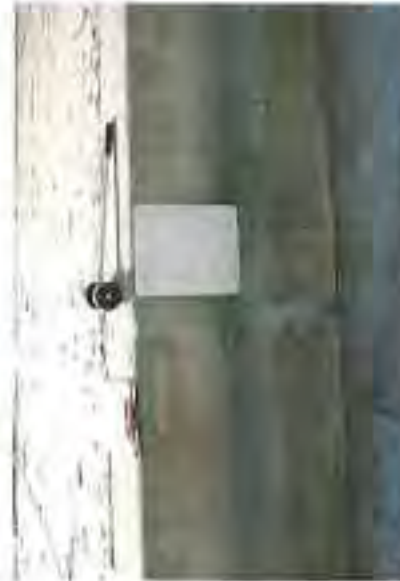
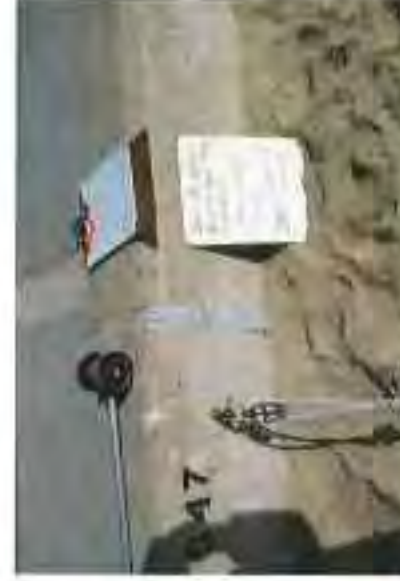
South Bay Front, 235' East of Turquoise

| <b>ACTIVITY</b><br><b>Balboa Island Bulkhead Inspection</b> | | <b>CASH &amp; ASSOCIATES</b><br>Engineering and Architecture | | | | <br><small>CASH &amp; ASSOCIATES<br/>ENGINEERING &amp; ARCHITECTURE<br/>(314) 883-2632<br/>40560701.10/04.11</small> | | | |
|---|---|---|---|---|---|---|---|---|---|
| 7 | 235' East of Turquoise Avenue, sealant repair | 6 | LF | | | | | \$25.00 | \$150 |

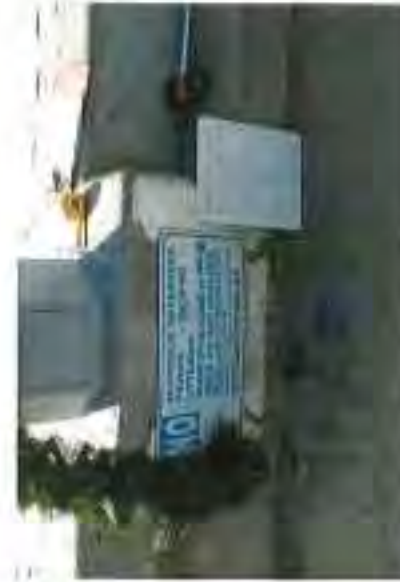
South Bay Front, 322' East of Turquoise

| Item | Location | Description |
|---|---|---|
| 8 | 322' East of Turquoise Avenue | Waterside, lightpole at Collins Avenue, spalled at top of cap, landside spall behind plaque |

| <b>ACTIVITY</b><br><b>Balboa Island Bulkhead Inspection</b> | | <b>CASH &amp; ASSOCIATES</b><br>Engineering and Architecture | | | | <br><small>CASH &amp; ASSOCIATES<br/>ENGINEERING &amp; ARCHITECTURE<br/>(314) 883-2632<br/>40560701.10/04.11</small> | | | |
|---|---|---|---|---|---|---|---|---|---|
| 8 | 322' East of Turquoise Avenue, spall repair | 6 | SF | | | | | \$70.00 | \$420 |

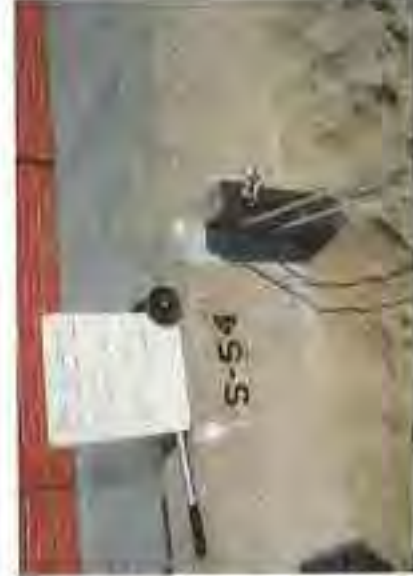
South Bay Front, 29' East of Collins

| Item | Location | Description |
|---|---|---|
| 2 | 29' East of Collins Avenue | Landside, spall at top of cap 14" long x 3" high x 2" deep |

| <b>ACTIVITY</b><br><b>Balboa Island Bulkhead Inspection</b> | | <b>CASH &amp; ASSOCIATES</b><br>Engineering and Architecture | | | | <div> CASH &amp; ASSOCIATES<br/> INTERIOR &amp; ARCHITECTURE<br/> 2714 38th St. #202<br/> SAN FRANCISCO, CA 94114 </div> | | | |
|---|---|---|---|---|---|---|---|---|---|
| 2 | 29' East of Collins Avenue, crack injection | 4 | LF | | | | | \$70.00 | \$280 |

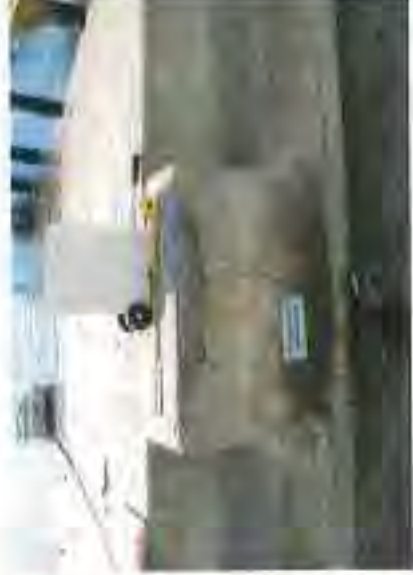
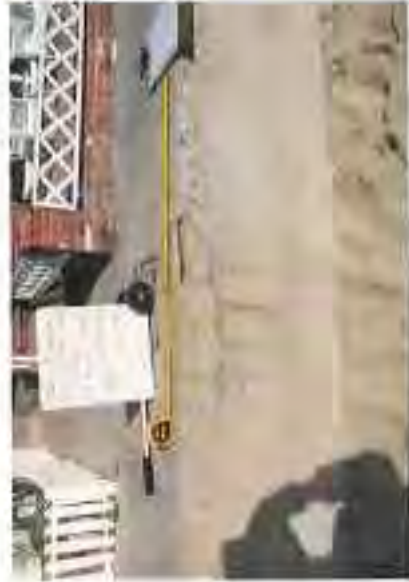
South Bay Front, 110' East of Collins

| Item | Location | Description |
|---|---|---|
| 3 | 110' East of Collins Avenue | Pullbox, waterside spall 36" x 6" x 3", landside spall 24" long x 8" high x 7" deep |

| <b>ACTIVITY</b><br><b>Balboa Island Bulkhead Inspection</b> | | <b>CASH &amp; ASSOCIATES</b><br>Engineering and Architecture | | | | <div> CASH &amp; ASSOCIATES<br/> INTERIOR &amp; ARCHITECTURE<br/> 2714 38th St. #202<br/> SAN FRANCISCO, CA 94114 </div> | | | |
|---|---|---|---|---|---|---|---|---|---|
| 3 | 110' East of Collins Avenue, spall repair | 6 | SF | | | | | \$70.00 | \$420 |

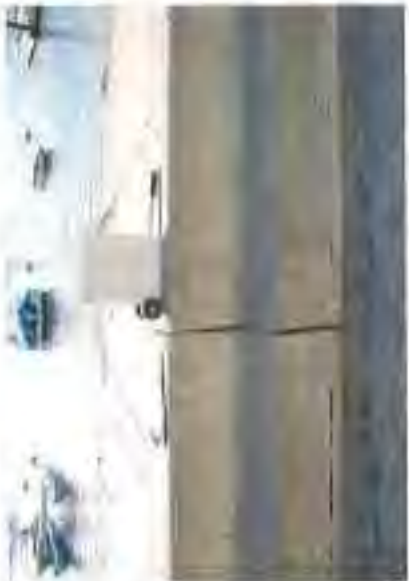
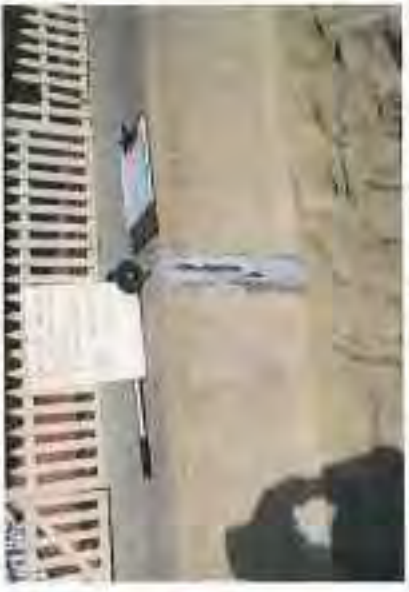
South Bay Front, 146' East of Collins

| Item | Location | Description |
|---|---|---|
| 4 | 146' East of Collins Avenue | Construction joint, landside and top missing sealant, waterside sealant cracked and split |

| <b>ACTIVITY</b><br><b>Balboa Island Bulkhead Inspection</b> | | <b>CASH &amp; ASSOCIATES</b><br>Engineering and Architecture | | | | <div> CASH &amp; ASSOCIATES<br/> INTERIOR &amp; ARCHITECTURE<br/> 2714 38th St. #202<br/> SAN FRANCISCO, CA 94114 </div> | | | |
|---|---|---|---|---|---|---|---|---|---|
| 4 | 146' East of Collins Avenue, sealant repair | 6 | LF | | | | | \$25.00 | \$150 |

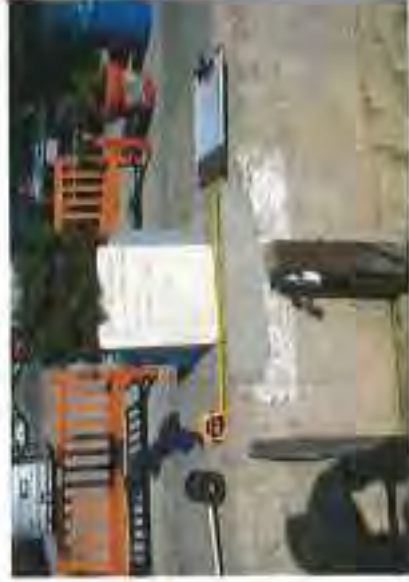
South Bay Front, 219' East of Collins

| Item | Location | Description |
|---|---|---|
| 5 | 219' East of Collins Avenue | Waterside, Ruby Avenue lightpole, spall and "hollow sounding" 24" long x 5" high x 3" deep |

| <b>ACTIVITY</b><br><b>Balboa Island Bulkhead Inspection</b> | | <b>CASH &amp; ASSOCIATES</b><br>Engineering and Architecture | | | | <div> CASH &amp; ASSOCIATES<br/> INTERIOR &amp; ARCHITECTURE<br/> 2714 38th St. #202<br/> SAN FRANCISCO, CA 94114 </div> | | | |
|---|---|---|---|---|---|---|---|---|---|
| 5 | 219' East of Collins Avenue, spall repair | 6 | SF | | | | | \$70.00 | \$420 |

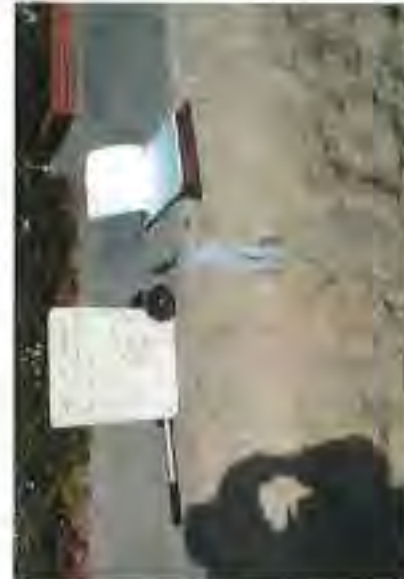
South Bay Front, 43' East of Ruby

| Item Location | Description |
|---|---|
| 1 43' East of Ruby Avenue | Construction joint, landside and top missing sealant, waterside sealant cracked and split |

| Item | Description | QUANTITY | | MATERIAL COST | | LABOR COST | | ENGINEERING ESTIMATE | |
|---|---|---|---|---|---|---|---|---|---|
| 1 | 43' East of Ruby Avenue, sealant repair | 6 | LF | | | | | \$25.00 | \$150 |

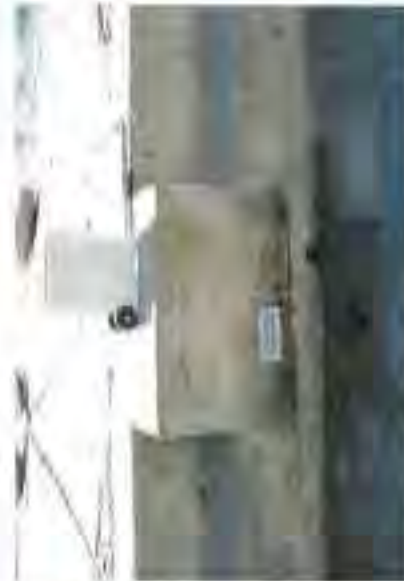
South Bay Front, 110' East of Ruby

| Item Location | Description |
|---|---|
| 2 110' East of Ruby Avenue | Pullbox, spall on landside and waterside 24" long x 6" high x 6" deep |

| Item | Description | QUANTITY | | MATERIAL COST | | LABOR COST | | ENGINEERING ESTIMATE | |
|---|---|---|---|---|---|---|---|---|---|
| 2 | 110' East of Ruby Avenue, spall repair | 4 | SF | | | | | \$70.00 | \$280 |

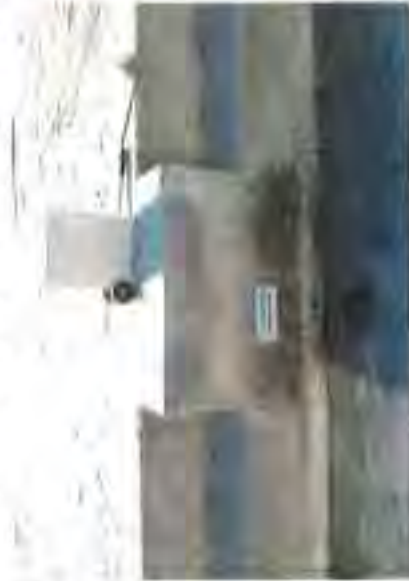
South Bay Front 57' East of Diamond

| Item | Location | Description |
|---|---|---|
| 1 | 57' East of Diamond Avenue | Construction joint, waterside sealant obscured by pier, landside sealant cracked |

| 1 | 57' East of Diamond Avenue, sealant repair | 3 | LF | | | | | \$25.00 | \$75 |

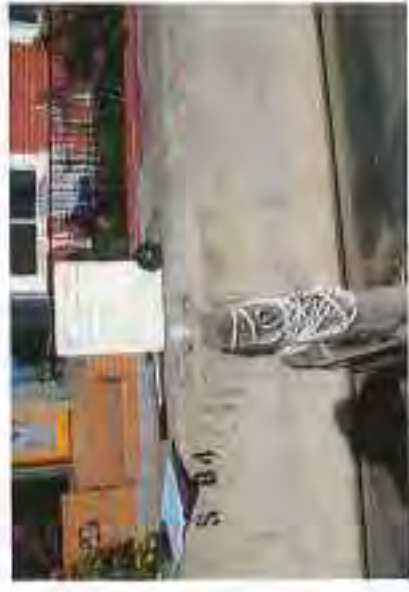
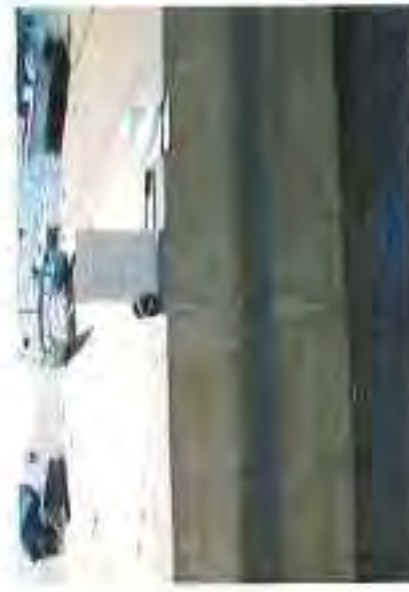
South Bay Front 110' East of Diamond

| 2 | 109' East of Diamond Avenue, spill repair | 3 | SF | | | | | \$70.00 | \$210 |

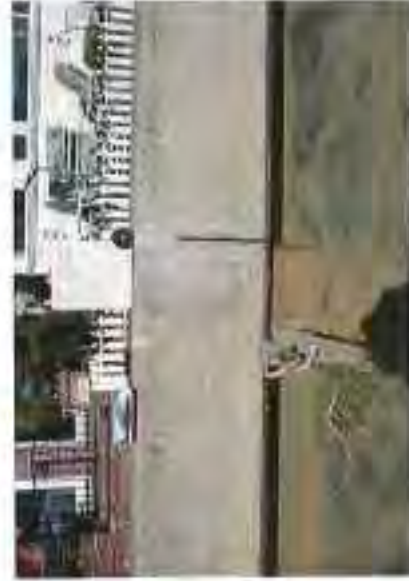
South Bay Front 173' East of Diamond

| Item | Location | Description |
|---|---|---|
| 3 | 173' East of Diamond Avenue | Construction joint, top and landside sealant in good shape, waterside sealant missing |

| 3 | 173' East of Diamond Avenue, sealant repair | 3 | LF | | | | | \$25.00 | \$75 |

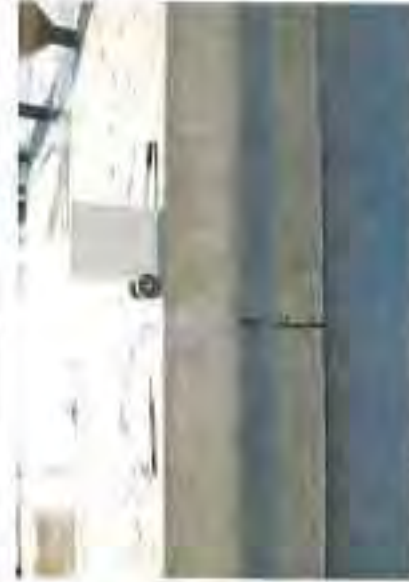
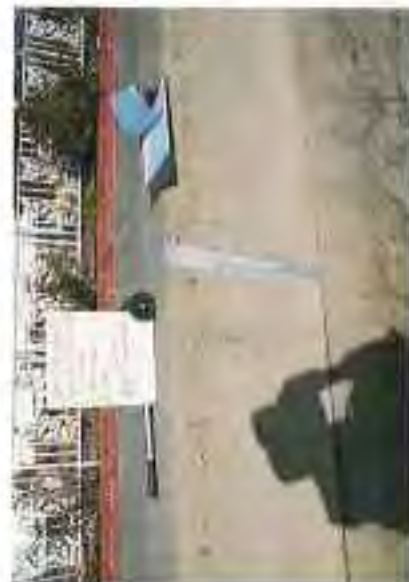
South Bay Front, 188' East of Sapphire

| Item | Location | Description |
|---|---|---|
| 4 | 188' East of Sapphire Avenue | Construction joint, landside sealant missing, waterside sealant cracked and split |

| Item | Description | QUANTITY | | MATERIAL COST | | LABOR COST | | ENGINEERING ESTIMATE | |
|---|---|---|---|---|---|---|---|---|---|
| 4 | 188' East of Sapphire Avenue, sealant repair | 6 | LF | | | | | \$25.00 | \$150 |

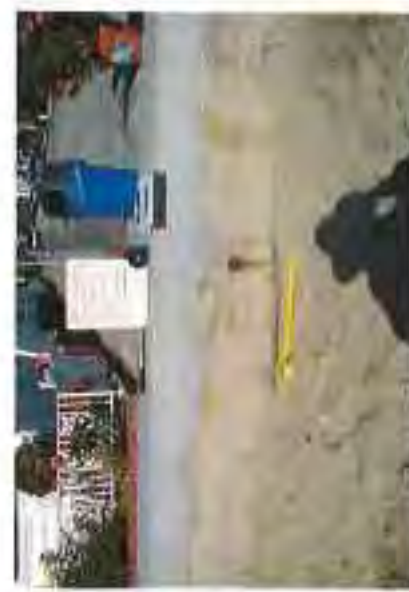
South Bay Front, 206' East of Sapphire

| Item | Location | Description |
|---|---|---|
| 6 | 206' East of Sapphire Avenue | Waterside, spall at bottom of cap over previous repair, 18" long x 6" high x 1/2" deep |

| Item | Description | QUANTITY | | MATERIAL COST | | LABOR COST | | ENGINEERING ESTIMATE | |
|---|---|---|---|---|---|---|---|---|---|
| 6 | 206' East of Sapphire Avenue, crack injection | 2 | LF | | | | | \$70.00 | \$140 |

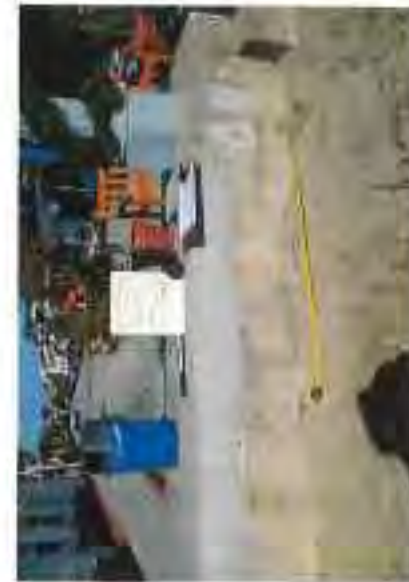
South Bay Front, 210' East of Sapphire

| Item | Location | Description |
|---|---|---|
| 5 | 210' East of Sapphire Avenue | Waterside, spall at bottom of cap 36" long x 6" high x 1" deep |

| Item | Description | QUANTITY | | MATERIAL COST | | LABOR COST | | ENGINEERING ESTIMATE | |
|---|---|---|---|---|---|---|---|---|---|
| 5 | 210' East of Sapphire Avenue, crack injection | 3 | LF | | | | | \$70.00 | \$210 |

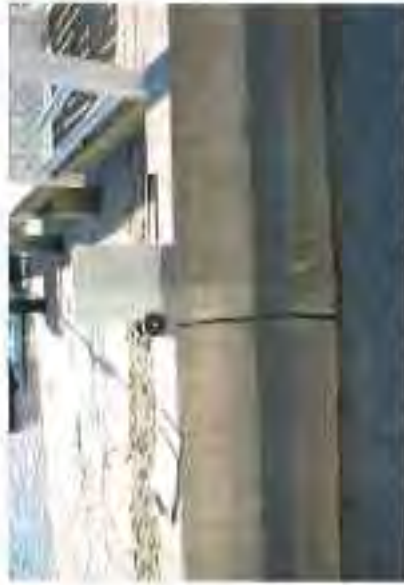
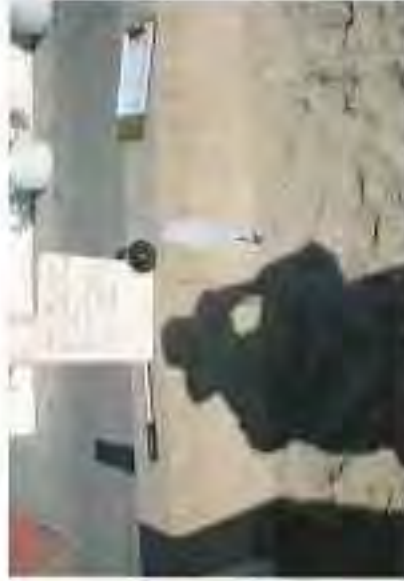
South Bay Front, 91' East of Coral

| Item | Location | Description |
|---|---|---|
| 1 | 91' East of Coral Avenue | Construction joint, waterside sealant is cracked and split, landside sealant is missing |

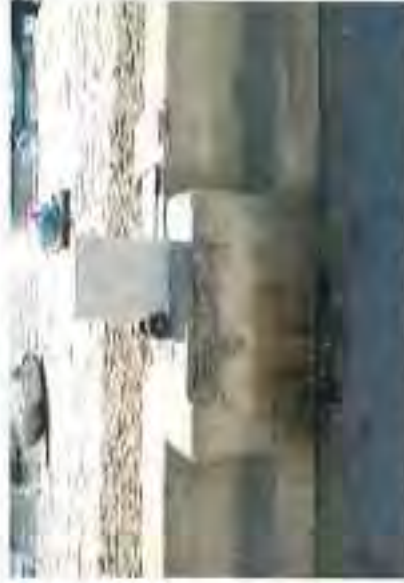
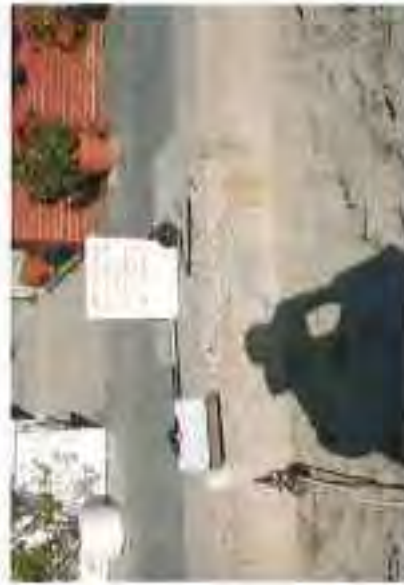
South Bay Front, 116' East of Coral

| Item | Location | Description |
|---|---|---|
| 2 | 116' East of Coral Avenue | Pullbox, spall and landside and waterside at top of cap, 24" long x 5" high x 6" wide |

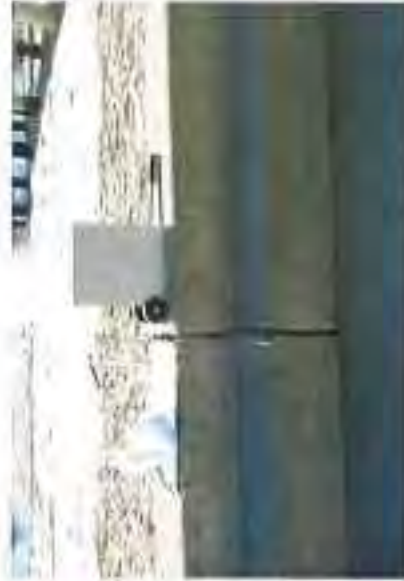
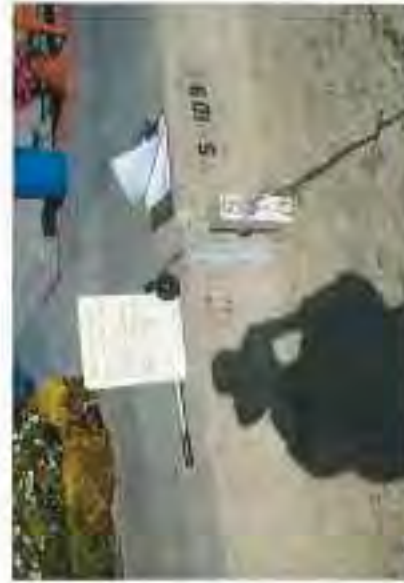
South Bay Front, 207' East of Coral

| Item | Location | Description |
|---|---|---|
| 3 | 207' East of Coral Avenue | Construction joint, waterside sealant is cracked and split, landside sealant is missing |

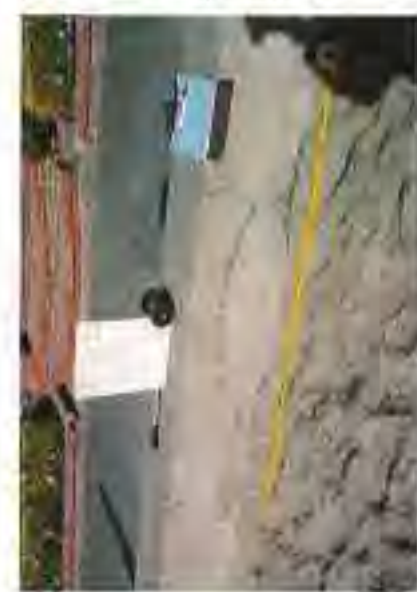
South Bay Front, 44' East of Apolena

| Item | Location | Description |
|---|---|---|
| 1 | 44' East of Apolena Avenue | Waterside, crack at bottom of cap 132" long |

| Item | Description | QUANTITY | | MATERIAL COST | | LABOR COST | | ENGINEERING ESTIMATE | |
|---|---|---|---|---|---|---|---|---|---|
| 1 | 44' East of Apolena Avenue, crack injection | 11 | LF | | | | | \$70.00 | \$770 |

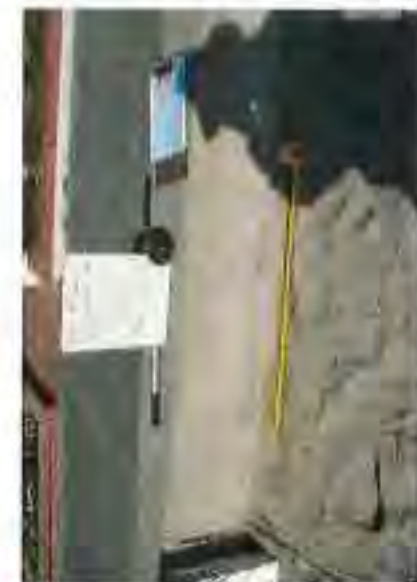
South Bay Front, 56' East of Apolena

| Item | Location | Description |
|---|---|---|
| 2 | 56' East of Apolena Avenue | Waterside, crack at bottom of cap 36" long |

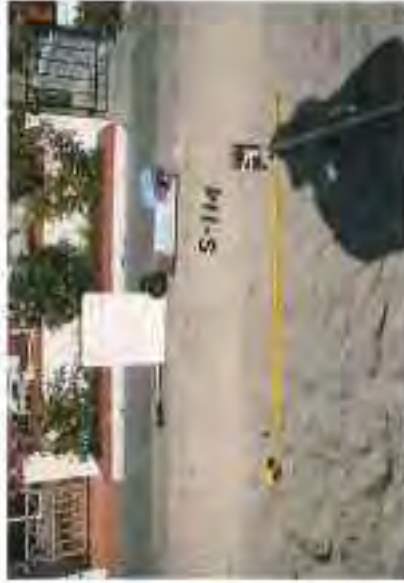
South Bay Front, 76' East of Apolena

| Item | Location | Description |
|---|---|---|
| 3 | 76' East of Apolena Avenue | Waterside, crack at bottom of cap 48" long |

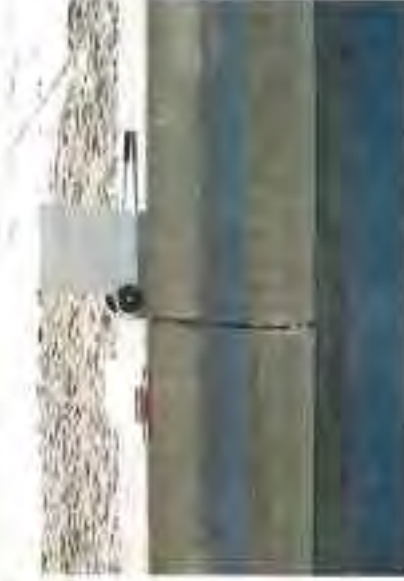
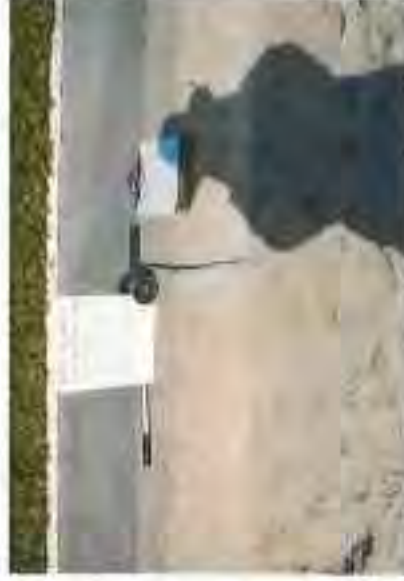
South Bay Front, 100' East of Apolena

| Item | Location | Description |
|---|---|---|
| 4 | 100' East of Apolena Avenue | Construction joint, waterside sealant split, landside and top sealant missing |

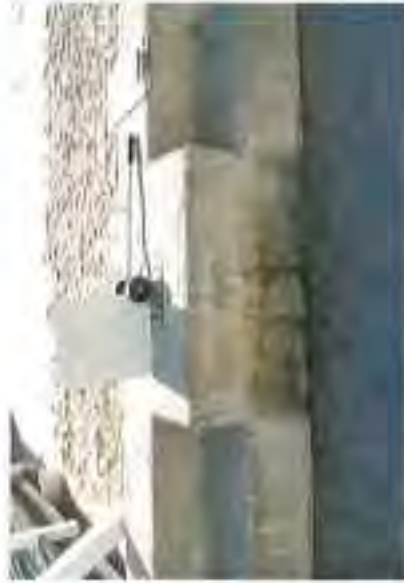
South Bay Front, 110' East of Apolena

| Item | Location | Description |
|---|---|---|
| 5 | 110' East of Apolena Avenue | Pullbox, waterside and landside spall 30" long x 7" high x 6" wide |

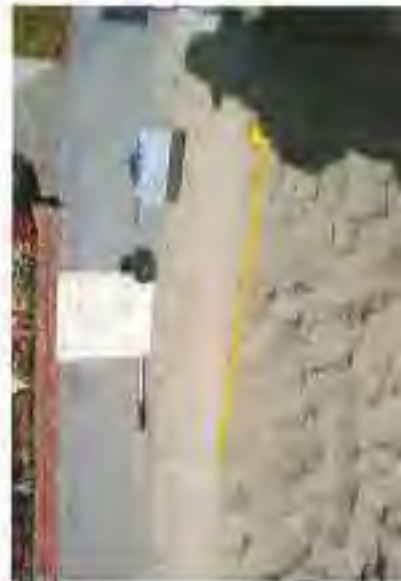
South Bay Front, 46' East of Amethyst

| Item Location | Description |
|---|---|
| 2 46' East of Amethyst Avenue | Waterside, crack at bottom of cap, 36" long |

| Item | Description | QUANTITY | | MATERIAL COST | | LABOR COST | | ENGINEERING ESTIMATE | |
|---|---|---|---|---|---|---|---|---|---|
| 2 | 46' East of Amethyst Avenue, crack injection | 3 | LF | | | | | \$70.00 | \$210 |

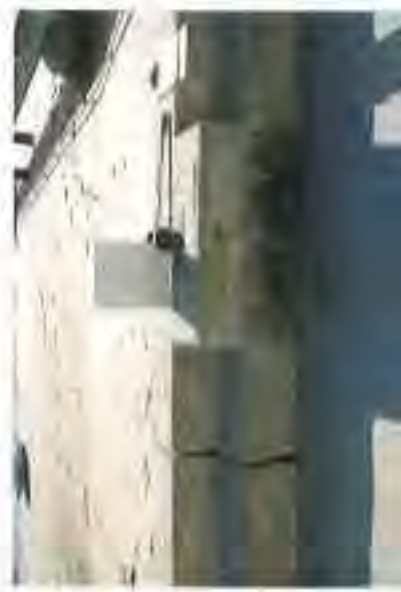
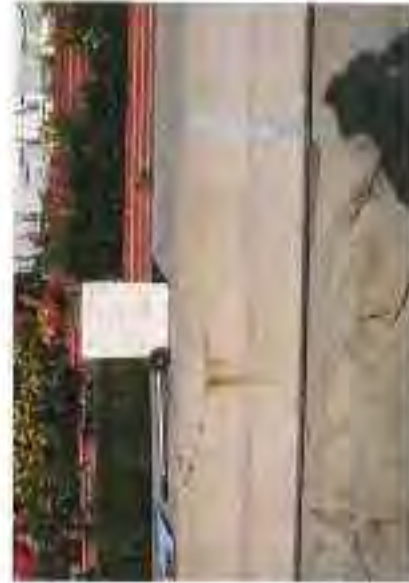
South Bay Front, 111' East of Amethyst

| Item Location | Description |
|---|---|
| 3 111' East of Amethyst Avenue | Pullbox, spall on waterside 36" long x 6" high x 4" wide, spall on landside 24" long x 6" high x 4" wide |
| 4 111' East of Amethyst Avenue | Construction joint, waterside sealant split and cracked, landside and top sealant missing |

| Item | Description | QUANTITY | | MATERIAL COST | | LABOR COST | | ENGINEERING ESTIMATE | |
|---|---|---|---|---|---|---|---|---|---|
| 3 | 111' East of Amethyst Avenue, spall repair | 5 | SF | | | | | \$70.00 | \$350 |
| 4 | 111' East of Amethyst Avenue, sealant repair | 6 | LF | | | | | \$25.00 | \$150 |

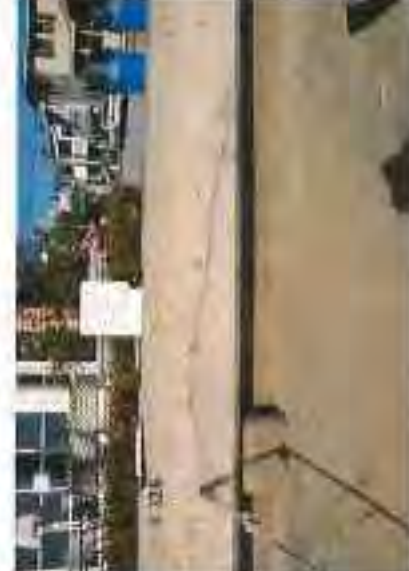
South Bay Front, 198' East of Amethyst

| Item Location | Description |
|---|---|
| 5 198' East of Amethyst Avenue | Waterside, crack at bottom of cap 108" long |

| Item | Description | QUANTITY | | MATERIAL COST | | LABOR COST | | ENGINEERING ESTIMATE | |
|---|---|---|---|---|---|---|---|---|---|
| 5 | 198' East of Amethyst Avenue, crack injection | 9 | LF | | | | | \$70.00 | \$630 |

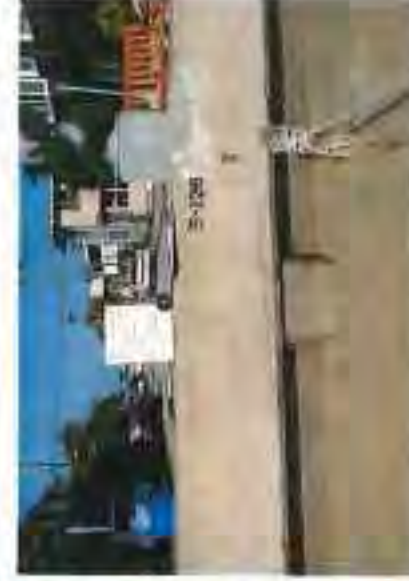
South Bay Front, 218' East of Amethyst

| Item Location | Description |
|---|---|
| 6 218' East of Amethyst Avenue | Waterside, crack at bottom of cap, 48" long |

| Item | Description | QUANTITY | | MATERIAL COST | | LABOR COST | | ENGINEERING ESTIMATE | |
|---|---|---|---|---|---|---|---|---|---|
| 6 | 218' East of Amethyst Avenue, crack injection | 4 | LF | | | | | \$70.00 | \$280 |
