**Subject: City of Newport Beach Balboa Island Coping Repair Project (C-7066-1)**

**PROPOSED PROJECT:** Balboa Island Seawall Coping Repair Project

Repair and maintenance of existing seawalls, and increase  
height of seawalls by 9 inches.

# Bulkhead Condition Report for Portions of the Balboa Island Seawall

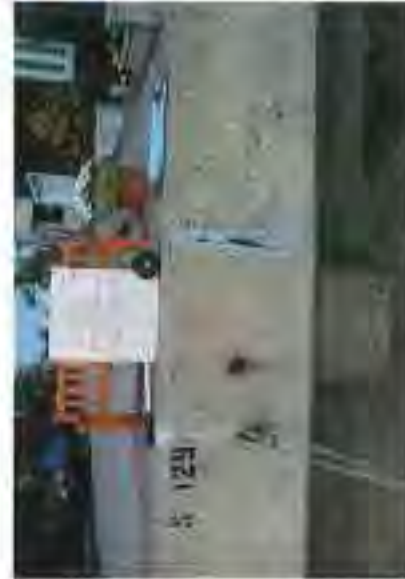
South Bay Front, 10' East of Onyx

| Item | Location | Description |
|---|---|---|
| 1 | 10' East of Onyx Avenue | Construction joint, waterside sealant cracked and split, landside and top sealant missing |

| Item | Description | QUANTITY | | MATERIAL COST | | LABOR COST | | ENGINEERING ESTIMATE | |
|---|---|---|---|---|---|---|---|---|---|
| 1 | 10' East of Onyx Avenue, sealant repair | 6 | LF | | | | | \$25.00 | \$150 |

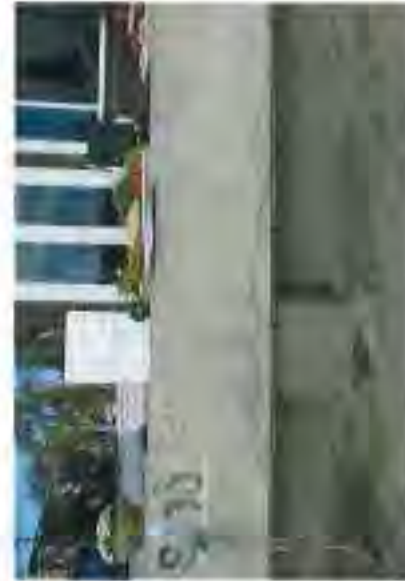
South Bay Front, 21' East of Onyx

| Item | Location | Description |
|---|---|---|
| 2 | 21' East of Onyx Avenue | Waterside, crack at bottom of cap 48" long |

| Item | Description | QUANTITY | | MATERIAL COST | | LABOR COST | | ENGINEERING ESTIMATE | |
|---|---|---|---|---|---|---|---|---|---|
| 2 | 21' East of Onyx Avenue, crack injection | 4 | LF | | | | | \$70.00 | \$280 |

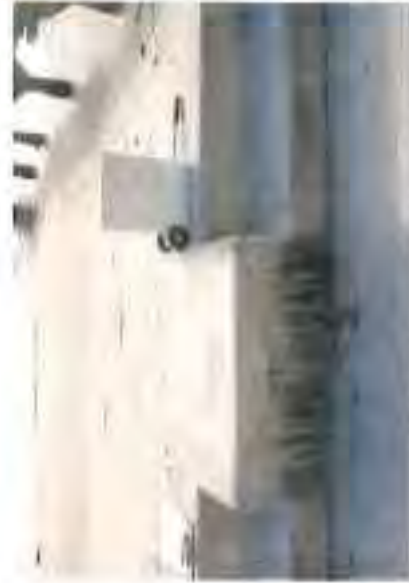
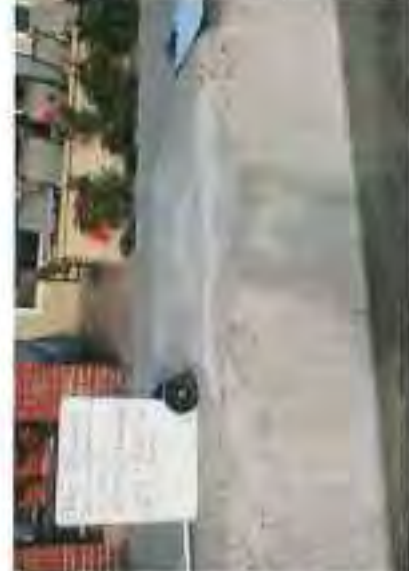
South Bay Front, 109' East of Onyx

| Item | Location | Description |
|---|---|---|
| 3 | 109' east of Onyx Avenue | Pullbox in good condition |

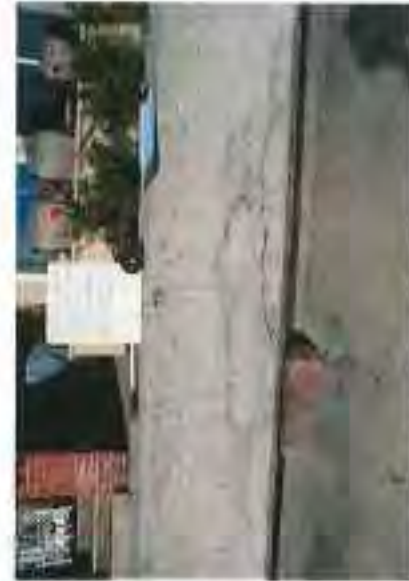
South Bay Front, 116' East of Onyx

| Item | Location | Description |
|---|---|---|
| 4 | 116' East of Onyx Avenue | Waterside, crack at bottom of cap 72" long |

| Item | Description | QUANTITY | | MATERIAL COST | | LABOR COST | | ENGINEERING ESTIMATE | |
|---|---|---|---|---|---|---|---|---|---|
| 4 | 116' East of Onyx Avenue, crack injection | 6 | LF | | | | | \$70.00 | \$420 |

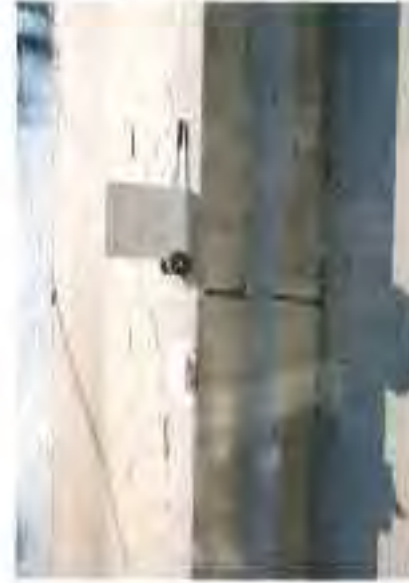
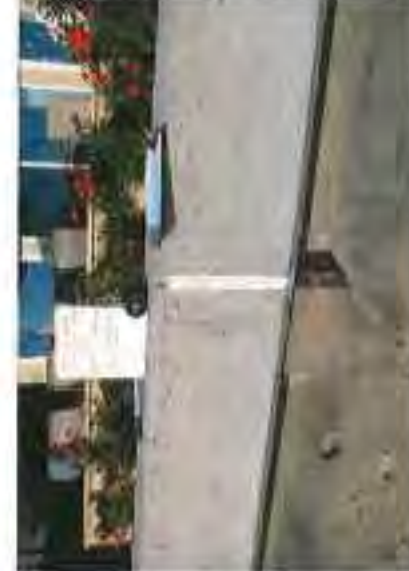
South Bay Front, 126' East of Onyx

| Item | Location | Description |
|---|---|---|
| 5 | 126' East of Onyx Avenue | Construction joint, waterside sealant plyable in good shape, landside sealant missing |

| Item | Description | QUANTITY | | MATERIAL COST | | LABOR COST | | ENGINEERING ESTIMATE | |
|---|---|---|---|---|---|---|---|---|---|
| 5 | 126' East of Onyx Avenue, sealant repair | 6 | LF | | | | | \$25.00 | \$150 |

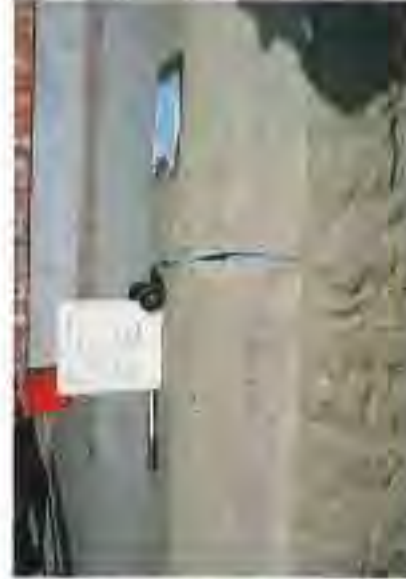
South Bay Front, 24' East of Marine

| Item | Location | Description |
|---|---|---|
| 1 | 24' East of Marine Avenue | Construction joint, waterside sealant cracked and split, landside sealant missing |

| Item | Description | QUANTITY | | MATERIAL COST | | LABOR COST | | ENGINEERING ESTIMATE | |
|---|---|---|---|---|---|---|---|---|---|
| 1 | 24' East of Marine Avenue, sealant repair | 6 | LF | | | | | \$25.00 | \$150 |

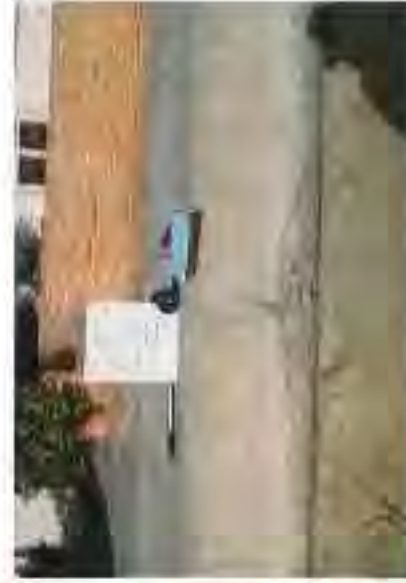
South Bay Front, 58' East of Marine

| Item | Location | Description |
|---|---|---|
| 2 | 58' East of Marine Avenue | Waterside, crack at bottom of cap 48" long x 9" high x 3" deep |

| Item | Description | QUANTITY | | MATERIAL COST | | LABOR COST | | ENGINEERING ESTIMATE | |
|---|---|---|---|---|---|---|---|---|---|
| 2 | 58' East of Marine Avenue, crack injection | 4 | LF | | | | | \$70.00 | \$280 |

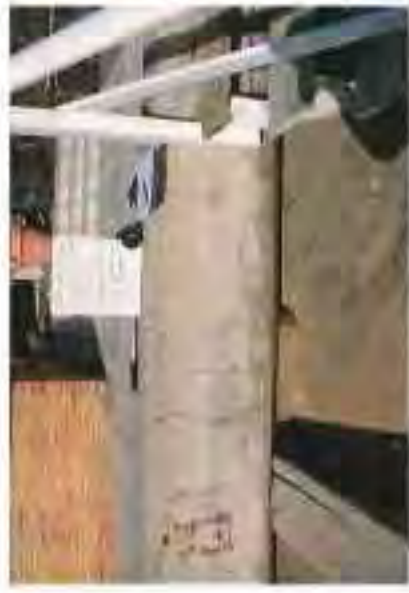
South Bay Front, 83' East of Marine

| Item | Location | Description |
|---|---|---|
| 3 | 83' East of Marine Avenue | Waterside, crack at bottom of cap 48" long x 9" high x 3" deep |

| Item | Description | QUANTITY | | MATERIAL COST | | LABOR COST | | ENGINEERING ESTIMATE | |
|---|---|---|---|---|---|---|---|---|---|
| 3 | 83' East of Marine Avenue, crack injection | 4 | LF | | | | | \$70.00 | \$280 |

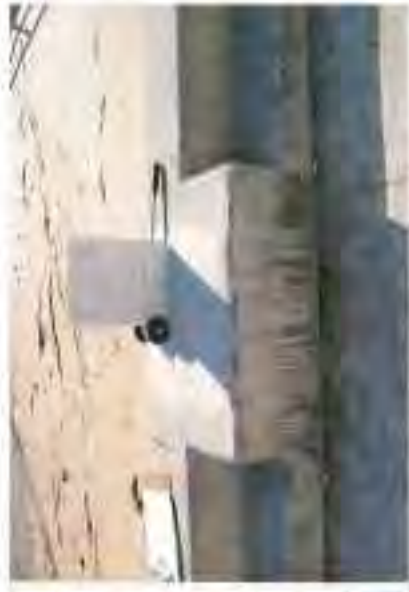
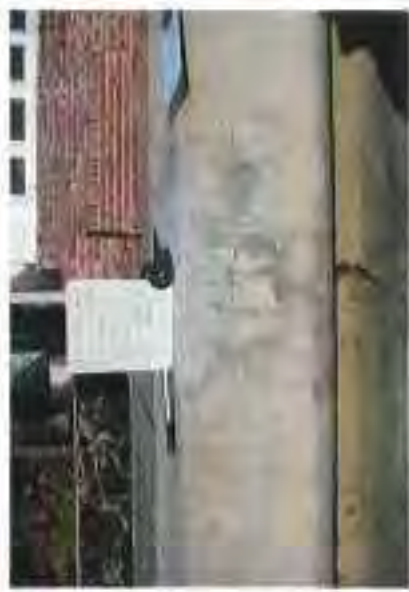
South Bay Front, 109' East of Marine

| Item | Location | Description |
|---|---|---|
| 4 | 109' East of Marine Avenue | Pullbox, previous repairs to waterside and landside spalls are "hollow" 24" long x 6" high x 7" wide |

| Item | Description | QUANTITY | | MATERIAL COST | | LABOR COST | | ENGINEERING ESTIMATE | |
|---|---|---|---|---|---|---|---|---|---|
| 4 | 109' East of Marine Avenue, spall repair | 6 | LF | | | | | \$70.00 | \$420 |

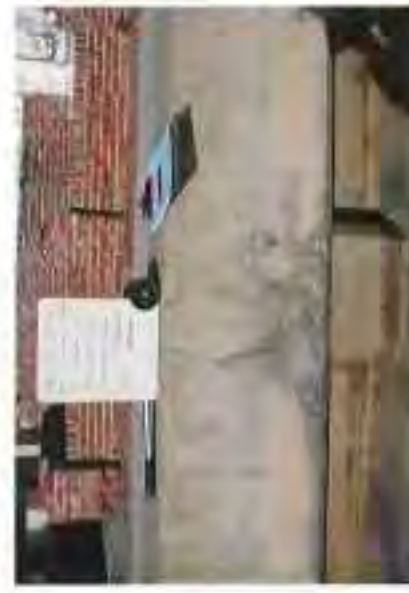
South Bay Front, 116' East of Marine

| Item | Location | Description |
|---|---|---|
| 5 | 116' East of Marine Avenue | Waterside, crack at bottom of cap, 36" long |

| Item | Description | QUANTITY | | MATERIAL COST | | LABOR COST | | ENGINEERING ESTIMATE | |
|---|---|---|---|---|---|---|---|---|---|
| 5 | 116' East of Marine Avenue, crack injection | 3 | LF | | | | | \$70.00 | \$210 |

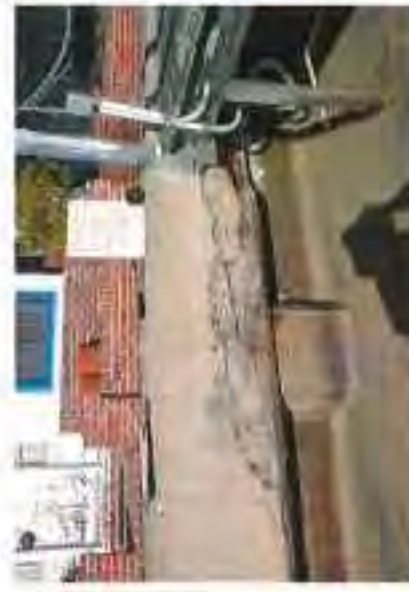
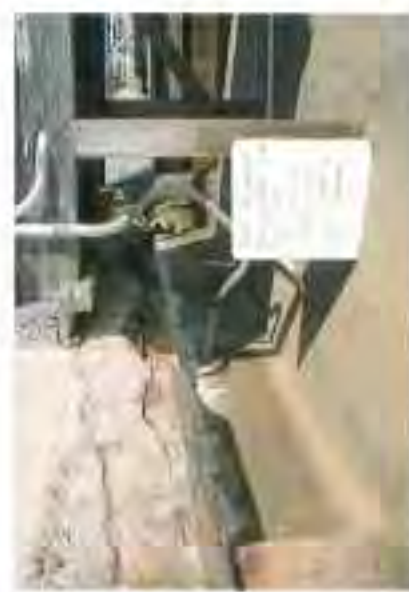
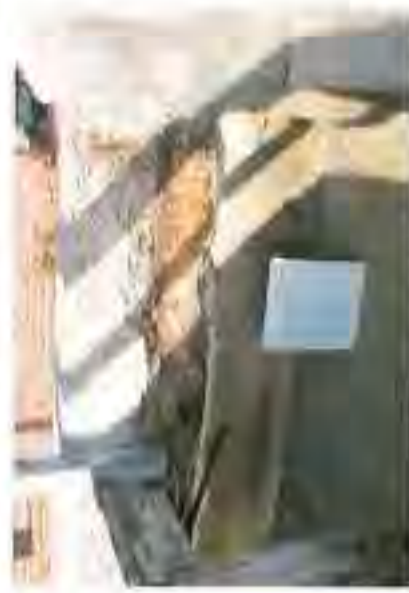
South Bay Front, 130' East of Marine

| Item | Location | Description |
|---|---|---|
| 6 | 130' East of Marine Avenue | Waterside, spalled at bottom of cap 156" long x 12" high x 12" deep |

| Item | Description | QUANTITY | | MATERIAL COST | | LABOR COST | | ENGINEERING ESTIMATE | |
|---|---|---|---|---|---|---|---|---|---|
| 6 | 130' East of Marine Avenue, spall repair | 13 | SF | | | | | \$70.00 | \$910 |

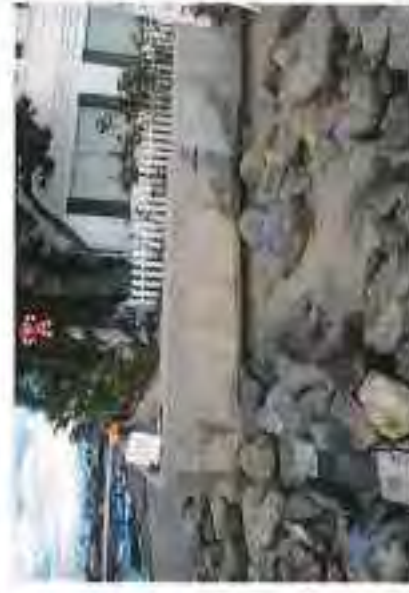
South Bay Front, 3' East of Grand Canal

| Item | Location | Description |
|---|---|---|
| 1 | Corner | Waterside, cracking on face of cap |

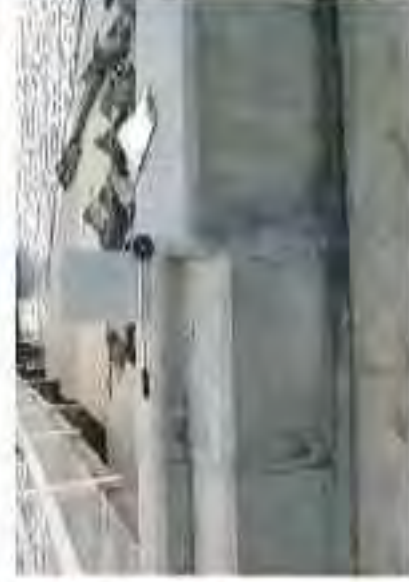
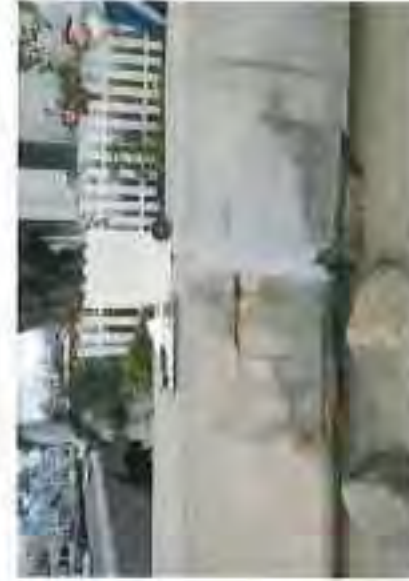
South Bay Front, 11' East of Grand Canal

| Item | Location | Description |
|---|---|---|
| 2 | 11' East of Grand Canal East | Waterside, spall at bottom of cap, 48" long x 5" high |
| 3 | 11' East of Grand Canal East | Construction joint, sealant waterside and landside cracked and split |

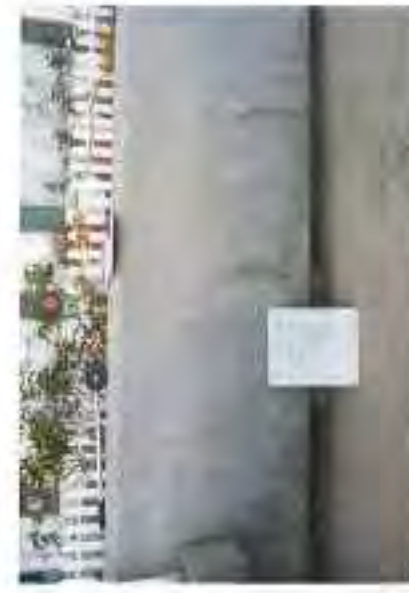
South Bay Front, 24' East of Grand Canal

| Item | Location | Description |
|---|---|---|
| 4 | 24' East of Grand Canal East | Waterside, cracking of surface of cap, 2'-3' on center |

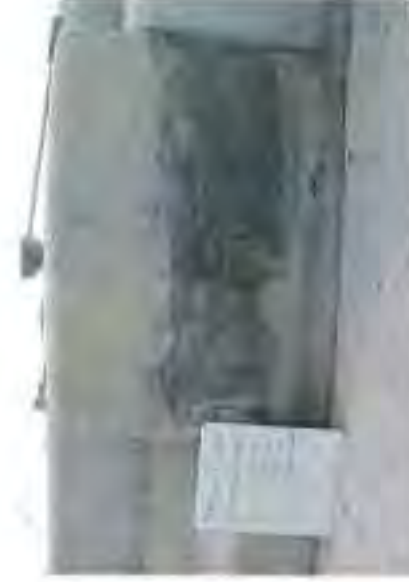
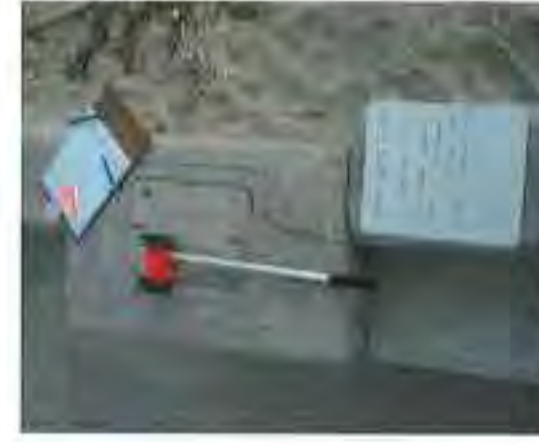
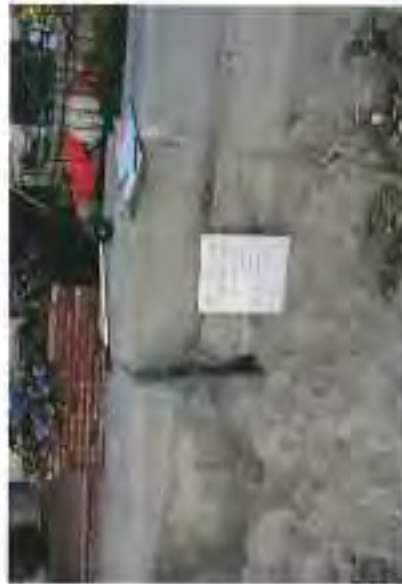
South Bay Front, 103' East of Grand Canal

| Item | Location | Description |
|---|---|---|
| 5 | 103' East of Grand Canal East | Pullbox, landside cracking of top of cap, 36" long |

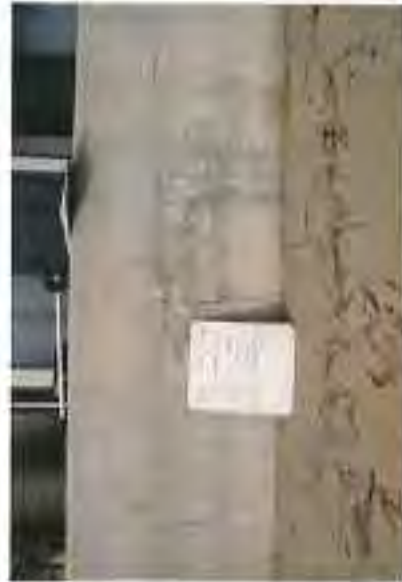
South Bay Front, 138' East of Grand Canal

| Item | Location | Description |
|---|---|---|
| 6 | 138' East of Grand Canal East | Waterside, cracking through cap 12" below top of cap, 30" long vertical crack through cap 12" long |

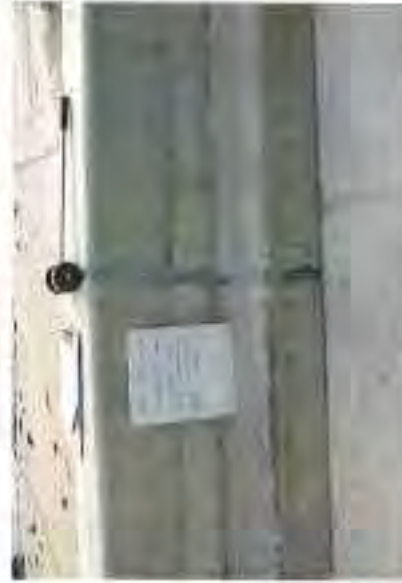
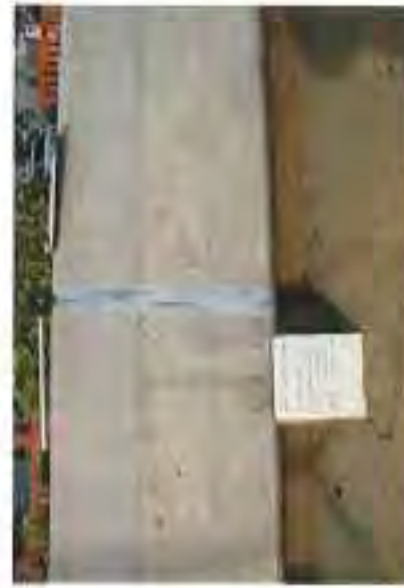
South Bay Front, 187' East of Grand Canal

| Item | Location | Description |
|---|---|---|
| 7 | 187' East of Grand Canal East | Construction joint, sealant waterside and landside cracked and split |

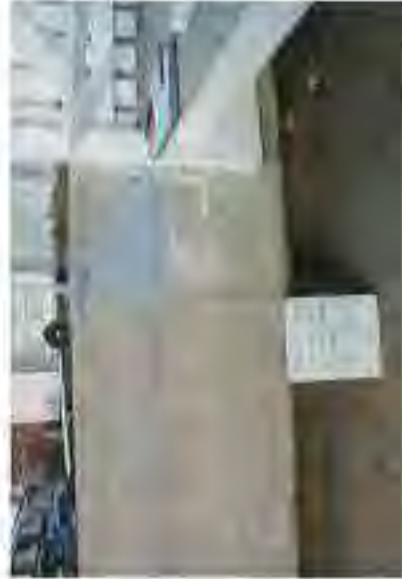
South Bay Front, 30' East of Abalone

| Item | Location | Description |
|---|---|---|
| 1 | 30' East of Abalone Avenue | Crack through cap, 12" high x 1/4" wide |

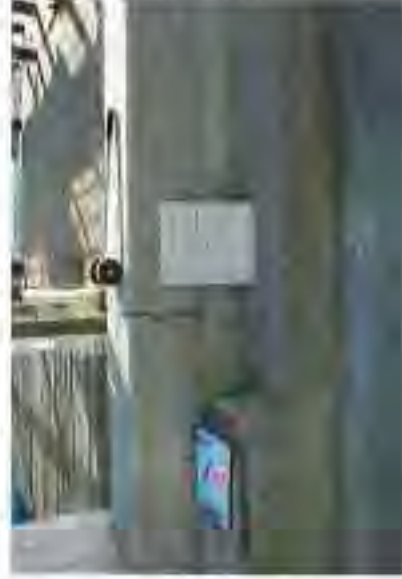
South Bay Front, 54' East of Abalone

| Item | Location | Description |
|---|---|---|
| 2 | 54' East of Abalone Avenue | Crack through cap, 12" high x 1/4" wide |

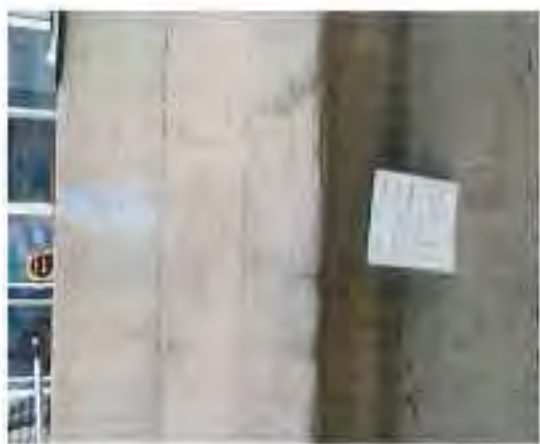
South Bay Front, 64' East of Abalone

| Item | Location | Description |
|---|---|---|
| 3 | 64' East of Abalone Avenue | Crack through cap, 12" high x 1/4" wide |

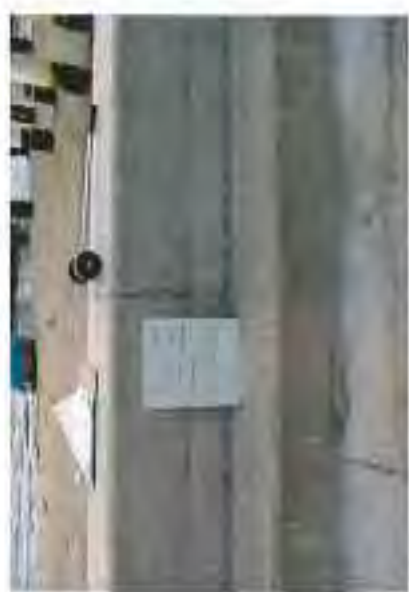
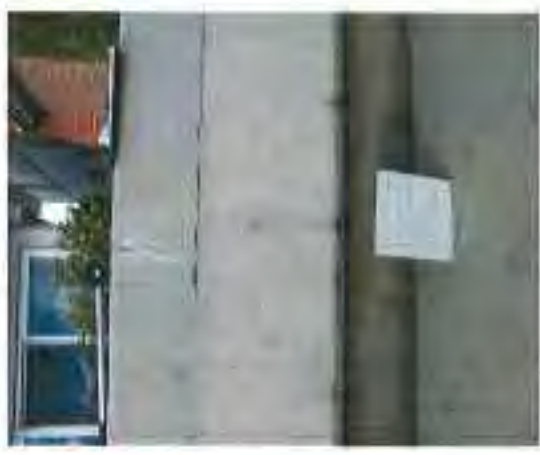
South Bay Front, 74' East of Abalone

| Item | Location | Description |
|---|---|---|
| 4 | 74' East of Abalone Avenue | Crack through cap, 12" high x 1/4" wide |

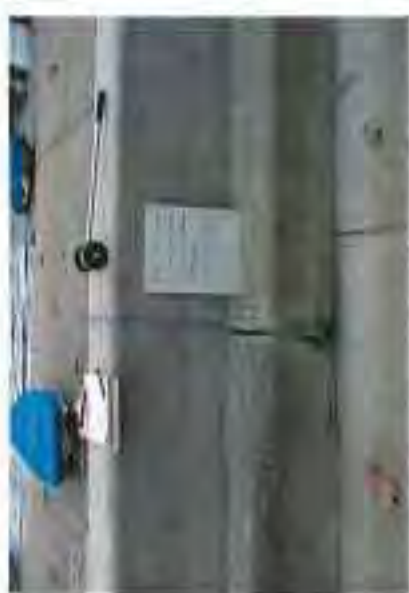
South Bay Front, 93' East of Abalone

| Item | Location | Description |
|---|---|---|
| 5 | 93' East of Abalone Avenue | Construction Joint, sealant split and cracked both sides |

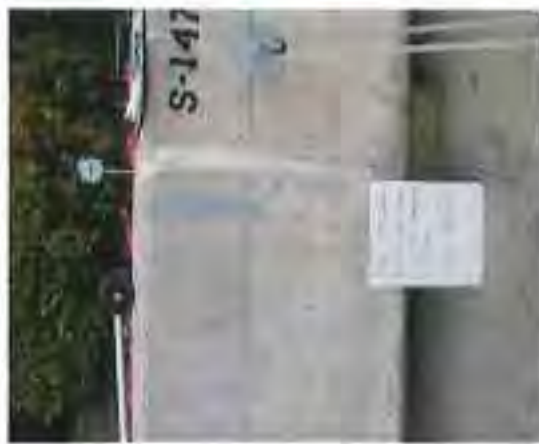
South Bay Front, 102' East of Abalone

| Item | Location | Description |
|---|---|---|
| 6 | 102' East of Abalone Avenue | Previously repaired crack though cap still moving, cracked |

| 6 | 102' East of Abalone Avenue, crack injection | 6 | LF | | | | | \$70.00 | \$420 |

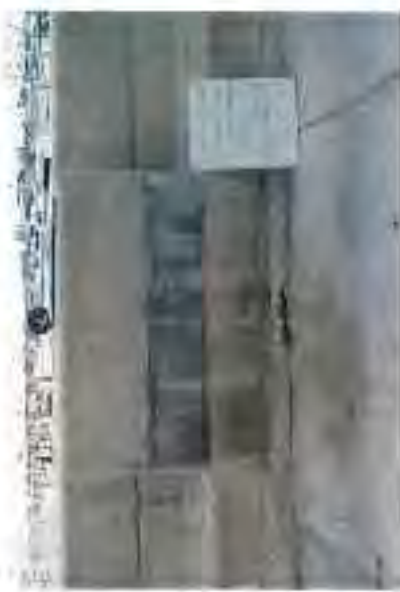
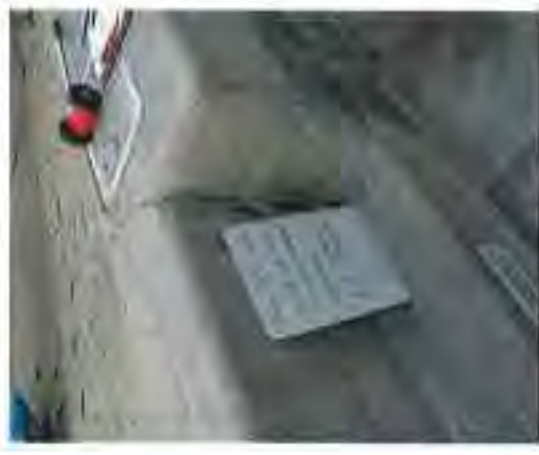
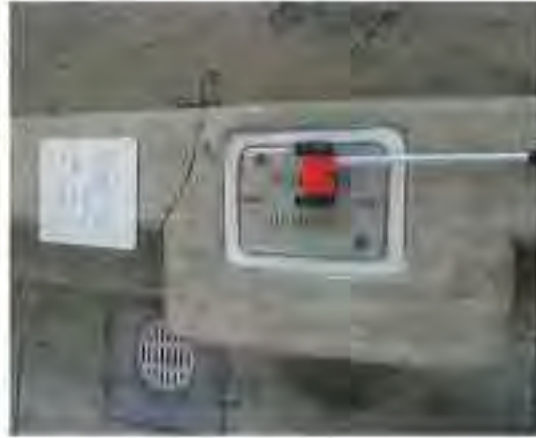
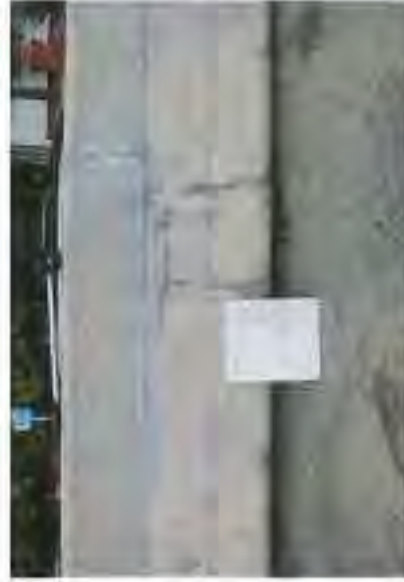
South Bay Front, 110' East of Abalone

| Item | Location | Description |
|---|---|---|
| 7 | 110' East of Abalone Avenue | Pullbox, cracked though cap top 12" at east end of pullbox and horizontally through cap |

| 7 | 110' East of Abalone Avenue, crack injection | 5 | LF | | | | | \$70.00 | \$350 |

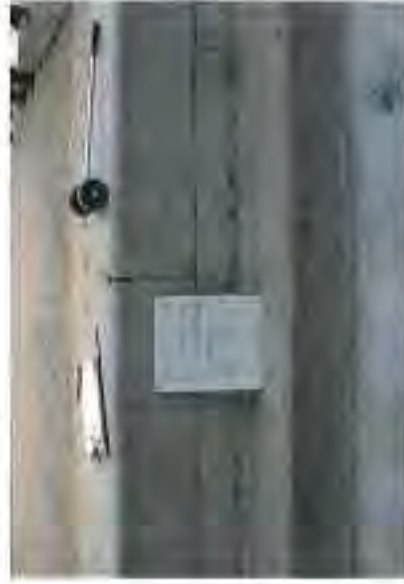
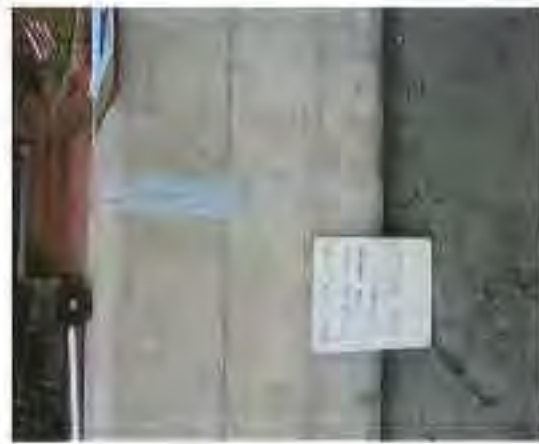
South Bay Front, 152' East of Abalone

| Item | Location | Description |
|---|---|---|
| 8 | 152' East of Abalone Avenue | Crack through cap, 12" high x 1/4" wide |

| 8 | 152' East of Abalone Avenue, crack injection | 3 | LF | | | | | \$70.00 | \$210 |

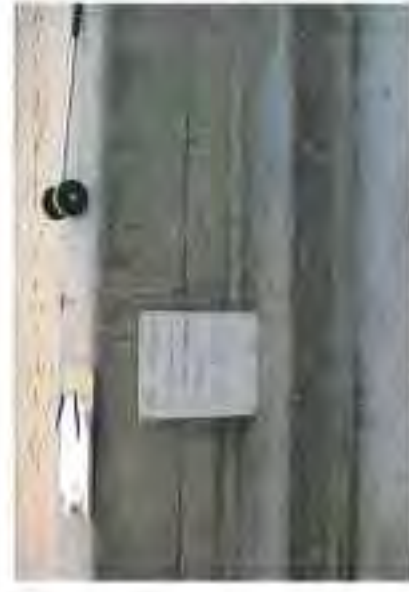
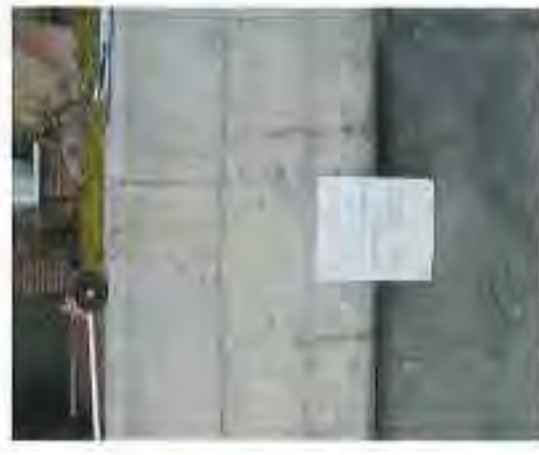
South Bay Front, 159' East of Abalone

| Item | Location | Description |
|---|---|---|
| 9 | 159' East of Abalone Avenue | Crack through cap, 12" high x 1/4" wide |

| 9 | 159' East of Abalone Avenue, crack injection | 3 | LF | | | | | \$70.00 | \$210 |

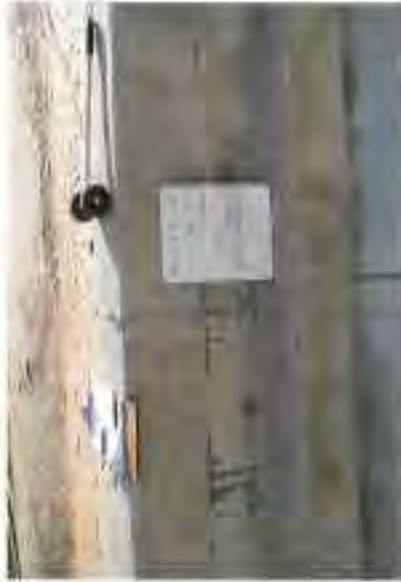
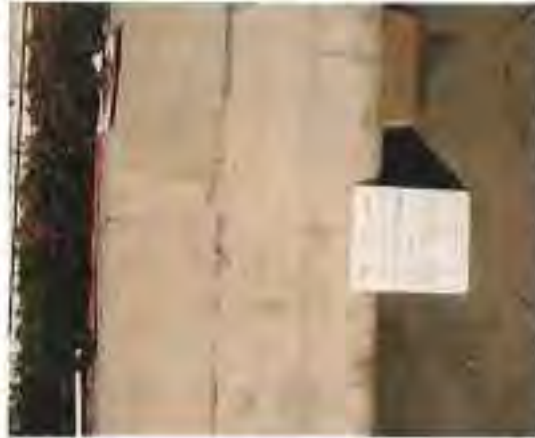
South Bay Front, 183' East of Abalone

| Item | Location | Description |
|---|---|---|
| 10 | 183' East of Abalone Avenue | Crack through cap, 12" high x 1/16" wide |

| 10 | 183' East of Abalone Avenue, crack injection | 3 | LF | | | | | \$70.00 | \$210 |

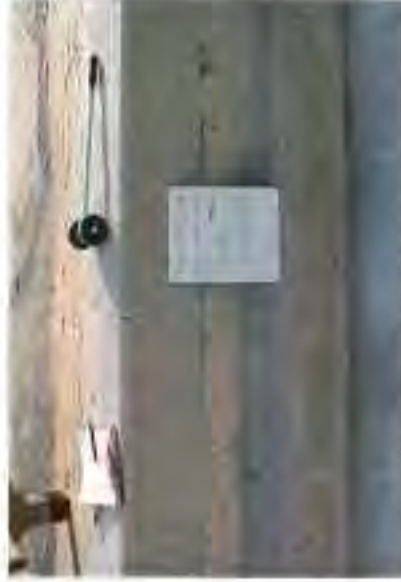
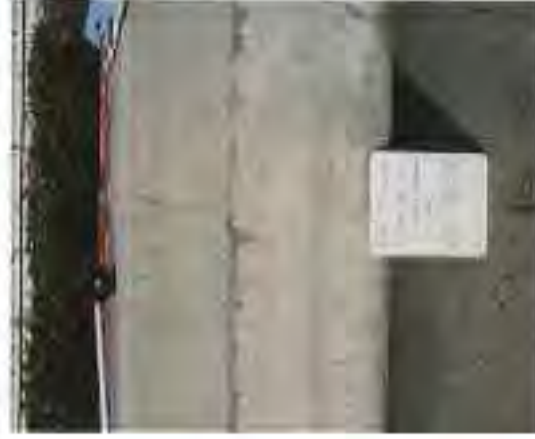
South Bay Front, 190' East of Abalone

| Item | Location | Description |
|---|---|---|
| 11 | 190' East of Abalone Avenue | Crack through cap, 12" high x 1/16" wide |

| 11 | 190' East of Abalone Avenue, crack injection | 3 | LF | | | | | \$70.00 | \$210 |

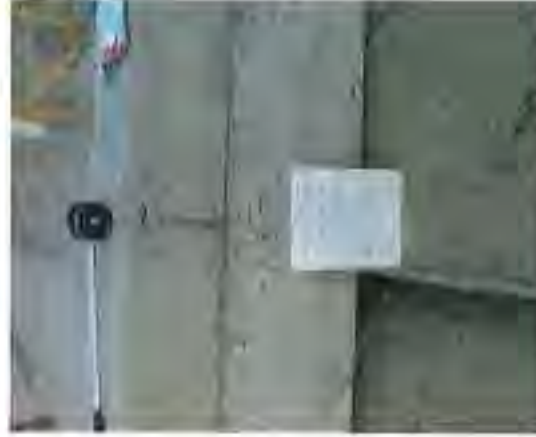
South Bay Front, 20' East of Crystal

| Item | Location | Description |
|---|---|---|
| 1 | 20' East of Crystal Avenue | Crack through cap at 2'-5" on center, top 12" of cap |

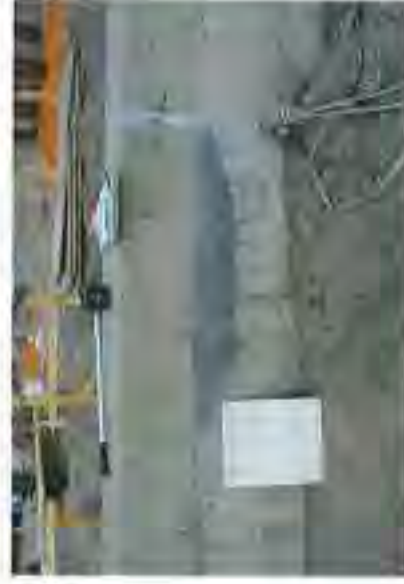
South Bay Front, 30' East of Crystal

| Item | Location | Description |
|---|---|---|
| 4 | 30' East of Crystal Avenue | Waterside, spall repair loose at lower edges, 48" long x 7" high |

| Item | Description | QUANTITY | | MATERIAL COST | | LABOR COST | | ENGINEERING ESTIMATE | |
|---|---|---|---|---|---|---|---|---|---|
| 4 | 30' East of Crystal Avenue, crack injection | 4 | LF | | | | | \$70.00 | \$280 |

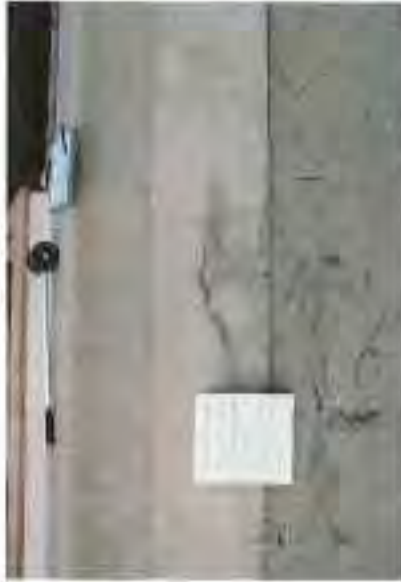
South Bay Front, 94' East of Crystal

| Item | Location | Description |
|---|---|---|
| 5 | 94' East of Crystal Avenue | Waterside, crack at bottom of cap 30" long |

| Item | Description | QUANTITY | | MATERIAL COST | | LABOR COST | | ENGINEERING ESTIMATE | |
|---|---|---|---|---|---|---|---|---|---|
| 5 | 94' East of Crystal Avenue, crack injection | 3 | LF | | | | | \$70.00 | \$210 |

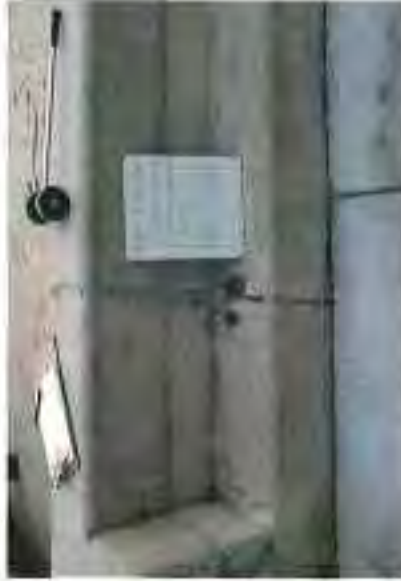
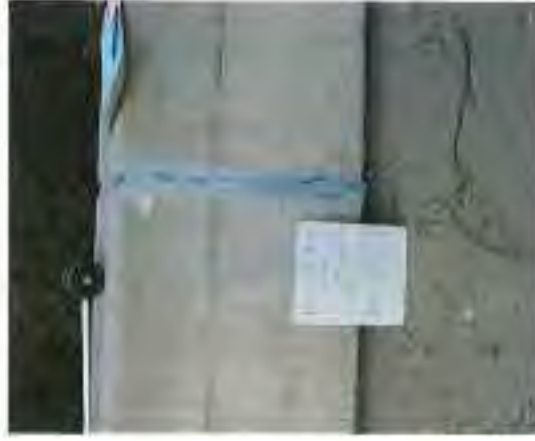
South Bay Front, 106' East of Crystal

| Item | Location | Description |
|---|---|---|
| 6 | 106' East of Crystal Avenue | Construction joint, sealant on waterside and landside cracked and split |

| Item | Description | QUANTITY | | MATERIAL COST | | LABOR COST | | ENGINEERING ESTIMATE | |
|---|---|---|---|---|---|---|---|---|---|
| 6 | 106' East of Crystal Avenue, sealant repair | 6 | LF | | | | | \$25.00 | \$150 |

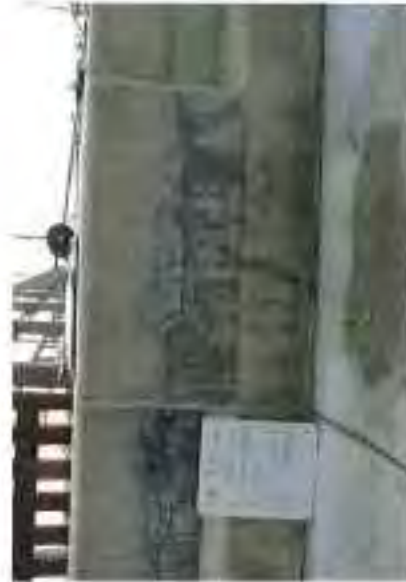
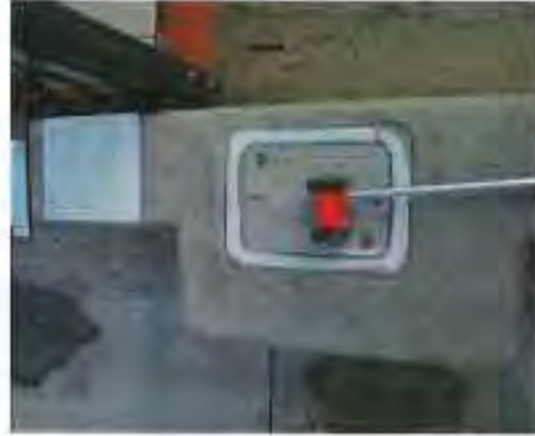
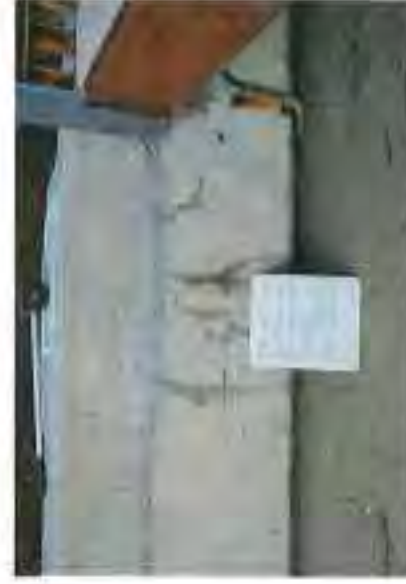
South Bay Front, 110' East of Crystal

| Item | Location | Description |
|---|---|---|
| 7 | 110' East of Crystal Avenue | Pullbox, landside horizontal crack 12" down from top 36" long |

| Item | Description | QUANTITY | | MATERIAL COST | | LABOR COST | | ENGINEERING ESTIMATE | |
|---|---|---|---|---|---|---|---|---|---|
| 7 | 110' East of Crystal Avenue, crack injection | 3 | LF | | | | | \$70.00 | \$210 |

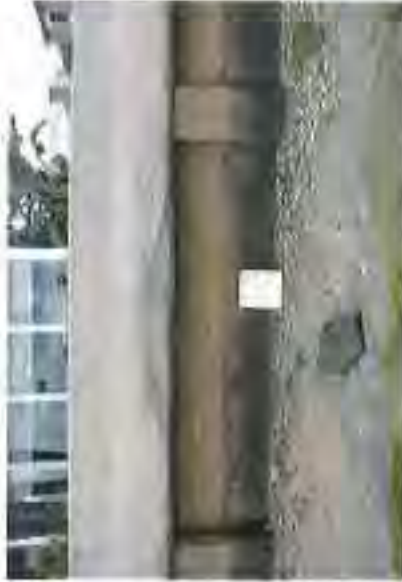
South Bay Front, 195' East of Crystal

| Item | Location | Description |
|---|---|---|
| 9 | 195' East of Crystal Avenue | Waterside, crack at bottom of cap, 96" long |

| Item | Description | QUANTITY | | MATERIAL COST | | LABOR COST | | ENGINEERING ESTIMATE | |
|---|---|---|---|---|---|---|---|---|---|
| 9 | 195' East of Crystal Avenue, crack injection | 8 | LF | | | | | \$70.00 | \$560 |

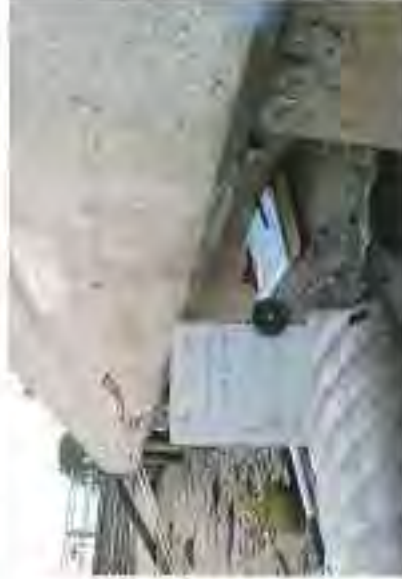
South Bay Front, 220' East of Crystal

| Item | Location | Description |
|---|---|---|
| 10 | 220' East of Crystal Avenue (at Jade Avenue) | Waterside, crack at bottom of wall, 60" long |

| Item | Description | QUANTITY | | MATERIAL COST | | LABOR COST | | ENGINEERING ESTIMATE | |
|---|---|---|---|---|---|---|---|---|---|
| 10 | 220' East of Crystal Avenue, crack injection | 5 | LF | | | | | \$70.00 | \$350 |

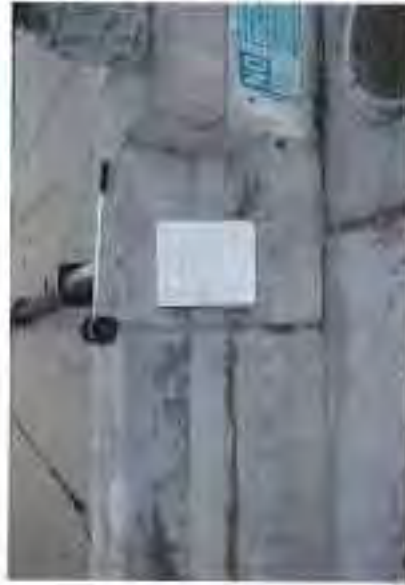
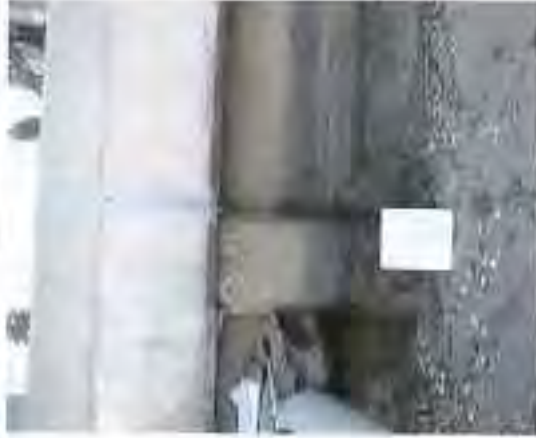
South Bay Front, 4' East of Jade

| Item Location | Description |
|---|---|
| 1 4' East of Jade Avenue | Construction joint, waterside cracked and split |

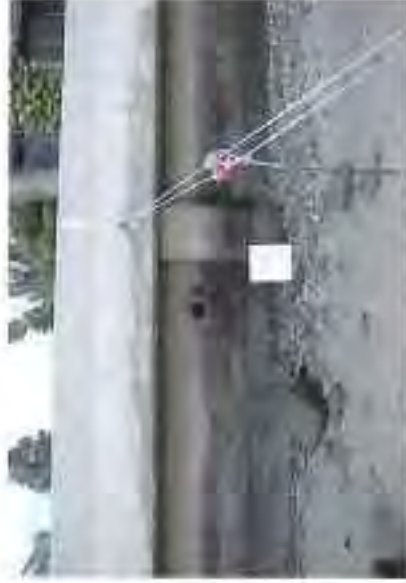
South Bay Front 11' East of Jade

| Item Location | Description |
|---|---|
| 2 11' East of Jade Avenue | Waterside, crack at bottom of cap 180" long |

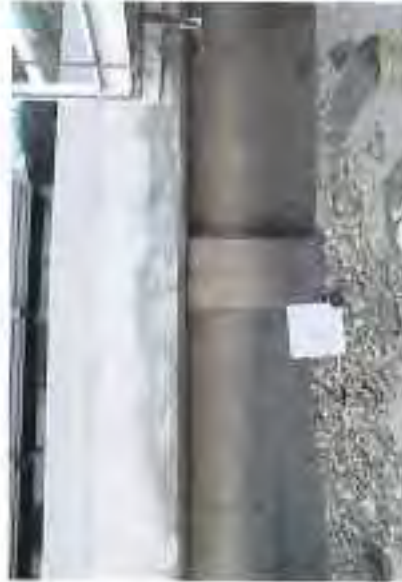
South Bay Front, 37' East of Jade

| Item Location | Description |
|---|---|
| 3 37' East of Jade Avenue | Waterside, crack at bottom of cap 96" long |

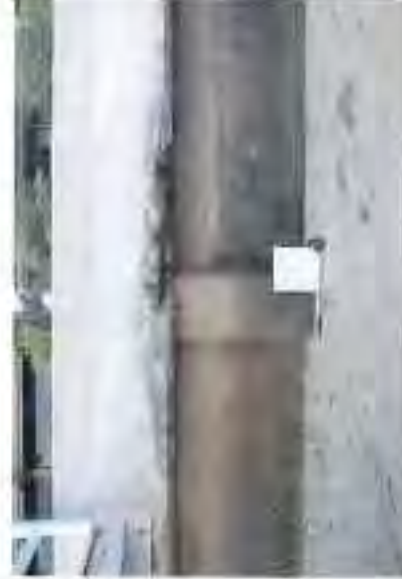
South Bay Front, 51' East of Jade

| Item Location | Description |
|---|---|
| 4 51' East of Jade Avenue | Waterside, spall at bottom of cap 72" long x 12" high x 6" long |

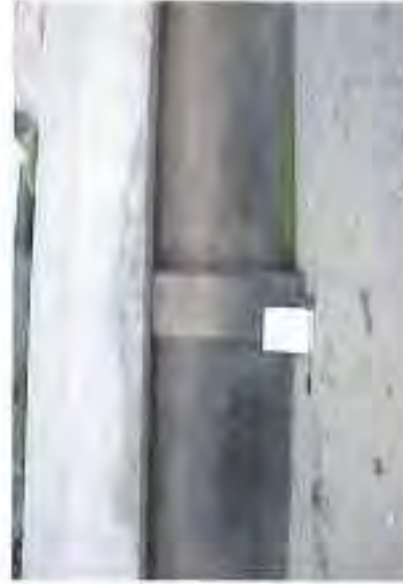
South Bay Front, 61' East of Jade

| Item Location | Description |
|---|---|
| 5 61' East of Jade Avenue | Waterside, crack at bottom of cap 72" long |

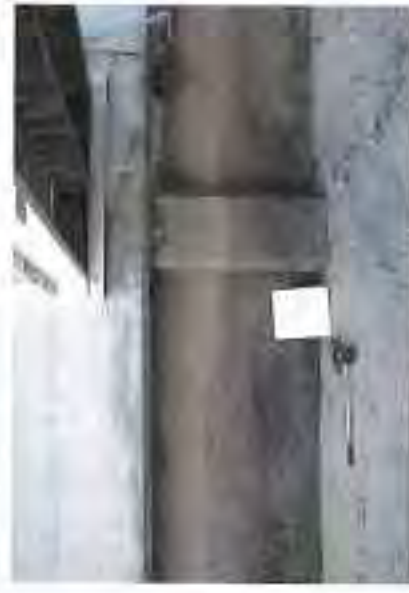
South Bay Front, 71' East of Jade

| Item Location | Description |
|---|---|
| 6 71' East of Jade Avenue | Waterside, crack at bottom of cap 72" long |

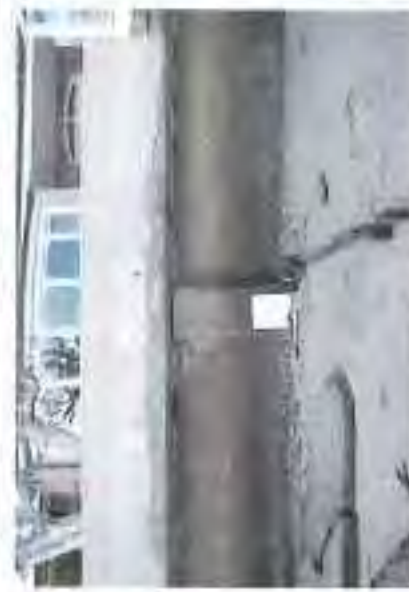
South Bay Front, 96' East of Jade

| Item Location | Description |
|---|---|
| 8 96' East of Jade Avenue | Waterside, crack at bottom of cap 120" long |

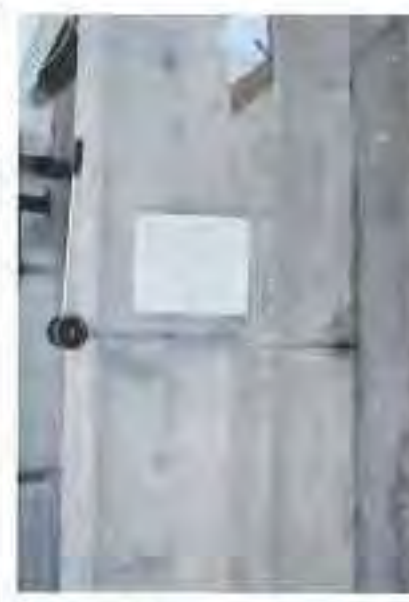
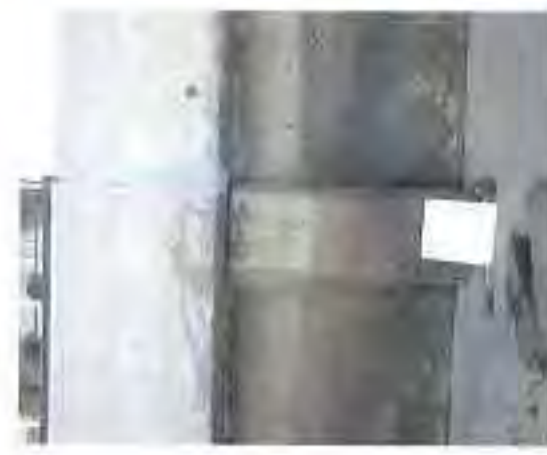
South Bay Front, 119' East of Jade

| Item Location | Description |
|---|---|
| 9 119' East of Jade Avenue | Construction joint, waterside cracked and split |
| 10 119' East of Jade Avenue | Waterside, crack at bottom of cap 12" long |

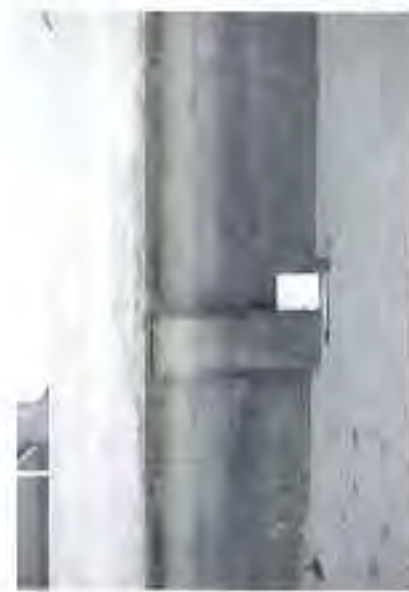
South Bay Front, 132' East of Jade

| Item Location | Description |
|---|---|
| 11 132' East of Jade Avenue | Waterside, crack at bottom of cap 72" long |

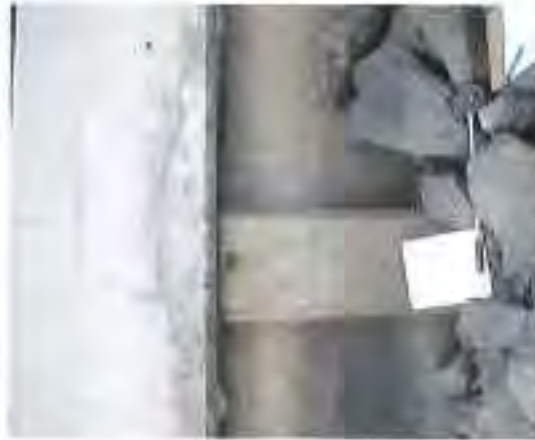
South Bay Front, 177' East of Jade

| Item Location | Description |
|---|---|
| 12 177' East of Jade Avenue | Waterside, crack at bottom of cap 60" long |

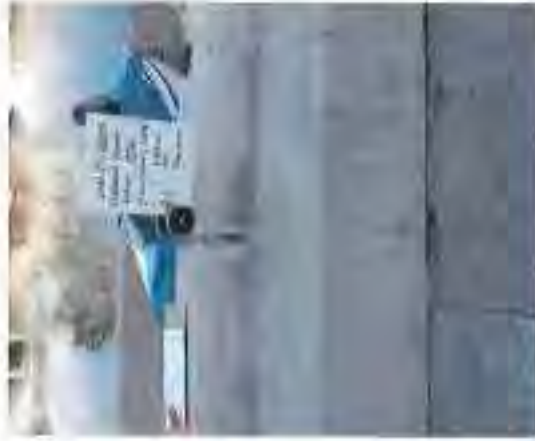
| Item | Location | Description |
|---|---|---|
| 2 | 15' North of Balboa Avenue | Waterside, crack on face of pile |

| Item | Description | QUANTITY | | MATERIAL COST | | LABOR COST | | ENGINEERING ESTIMATE | |
|---|---|---|---|---|---|---|---|---|---|
| 2 | 15' North of Balboa Avenue, shotcrete repair | 6 | SF | | | | | \$70.00 | \$420 |

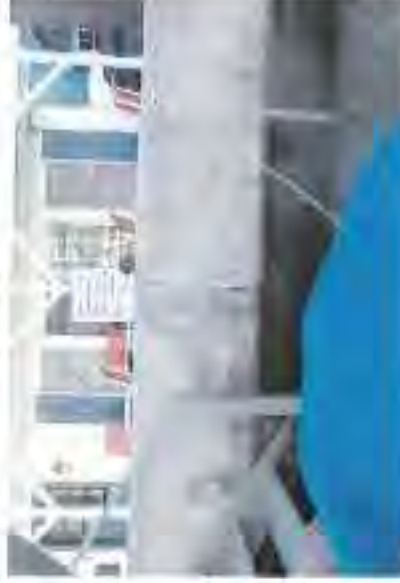
| Item | Location | Description |
|---|---|---|
| 3 | 41' North of Balboa Avenue | Construction joint at top of cap only, sealant cracked and split |

| Item | Description | QUANTITY | | MATERIAL COST | | LABOR COST | | ENGINEERING ESTIMATE | |
|---|---|---|---|---|---|---|---|---|---|
| 3 | 41' North of Balboa Avenue, sealant repair | 2 | SF | | | | | \$70.00 | \$140 |

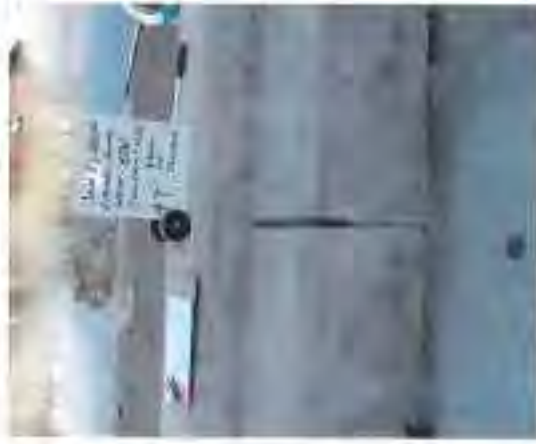
| Item | Location | Description |
|---|---|---|
| 4 | 47' North of Balboa Avenue | Construction joint at lower step only, sealant cracked and split |

| Item | Description | QUANTITY | | MATERIAL COST | | LABOR COST | | ENGINEERING ESTIMATE | |
|---|---|---|---|---|---|---|---|---|---|
| 4 | 47' North of Balboa Avenue, sealant repair | 3 | SF | | | | | \$70.00 | \$210 |

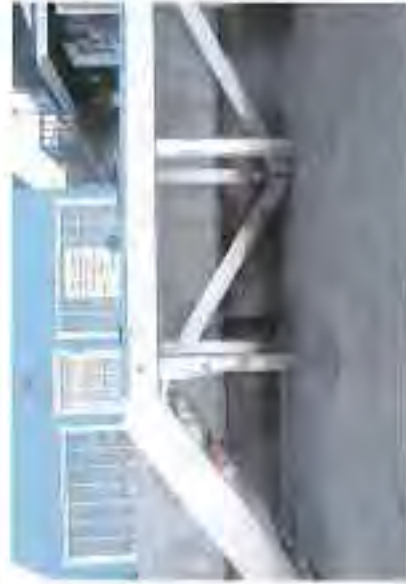
| Item | Location | Description |
|---|---|---|
| 5 | 70' North of Balboa Avenue | Waterside, crack on sides of pile |

| Item | Description | QUANTITY | | MATERIAL COST | | LABOR COST | | ENGINEERING ESTIMATE | |
|---|---|---|---|---|---|---|---|---|---|
| 5 | 70' North of Balboa Avenue, shotcrete repair | 6 | SF | | | | | \$70.00 | \$420 |

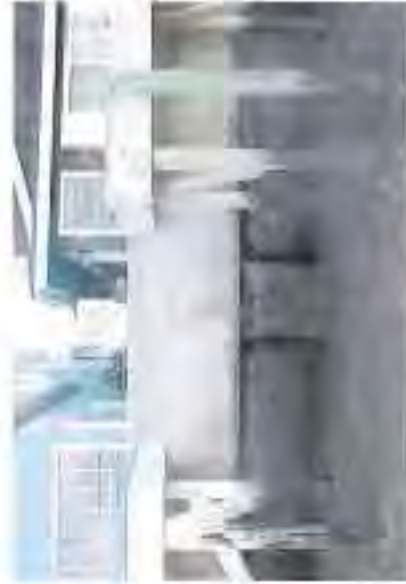
| Item | Location | Description |
|---|---|---|
| 6 | 81' North of Balboa Avenue | Waterside, crack on south side of pile |

| Item | Description | QUANTITY | | MATERIAL COST | | LABOR COST | | ENGINEERING ESTIMATE | |
|---|---|---|---|---|---|---|---|---|---|
| 6 | 81' North of Balboa Avenue, shotcrete repair | 6 | SF | | | | | \$70.00 | \$420 |

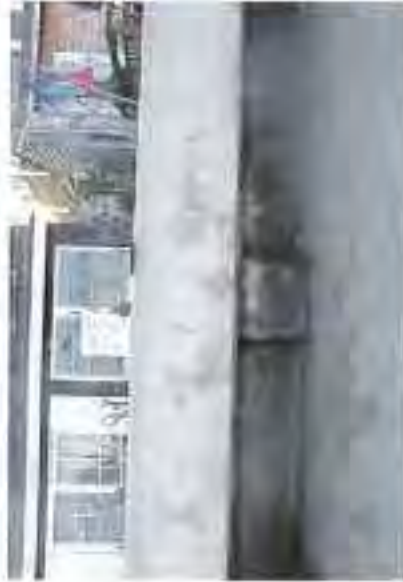
| Item | Location | Description |
|---|---|---|
| 7 | 103' North of Balboa Avenue | Waterside, crack on face and south side of pile |

| Item | Description | QUANTITY | | MATERIAL COST | | LABOR COST | | ENGINEERING ESTIMATE | |
|---|---|---|---|---|---|---|---|---|---|
| 7 | 103' North of Balboa Avenue, shotcrete repair | 6 | SF | | | | | \$70.00 | \$420 |

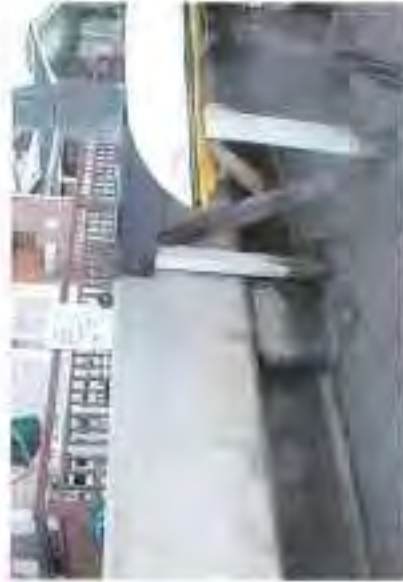
| Item | Location | Description |
|---|---|---|
| 8 | 114' North of Balboa Avenue | Waterside, crack on face of pile |

| Item | Description | QUANTITY | | MATERIAL COST | | LABOR COST | | ENGINEERING ESTIMATE | |
|---|---|---|---|---|---|---|---|---|---|
| 8 | 114' North of Balboa Avenue, shotcrete repair | 6 | SF | | | | | \$70.00 | \$420 |

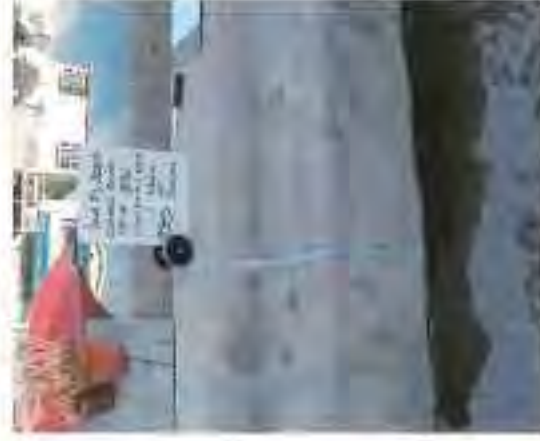
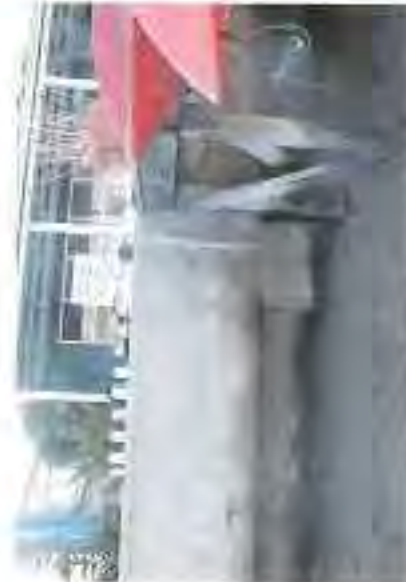
| Item | Location | Description |
|---|---|---|
| 9 | 235' North of Balboa Avenue | Waterside, crack on face of pile |
| 10 | 235' North of Balboa Avenue | Construction joint, sealant split and crack |

| Item | Description | QUANTITY | | MATERIAL COST | | LABOR COST | | ENGINEERING ESTIMATE | |
|---|---|---|---|---|---|---|---|---|---|
| 9 | 235' North of Balboa Avenue, shotcrete repair | 6 | SF | | | | | \$70.00 | \$420 |
| 10 | 235' North of Balboa Avenue, sealant repair | 7 | LF | | | | | \$25.00 | \$175 |

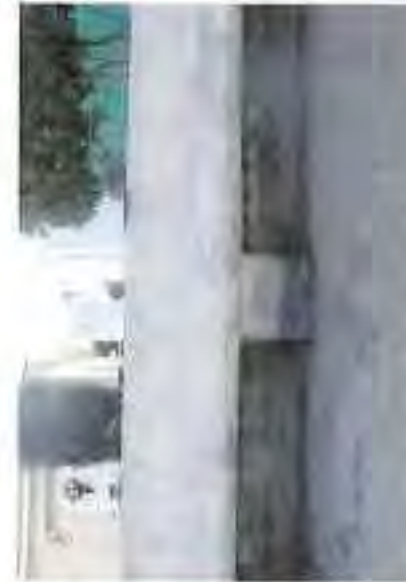
| Item | Location | Description |
|---|---|---|
| 11 | 290' North of Balboa Avenue | Waterside, crack on face and sides of pile |

| Item | Description | QUANTITY | | MATERIAL COST | | LABOR COST | | ENGINEERING ESTIMATE | |
|---|---|---|---|---|---|---|---|---|---|
| 11 | 290' North of Balboa Avenue, shotcrete repair | 6 | SF | | | | | \$70.00 | \$420 |
