**Subject: City of Newport Beach Balboa Island Coping Repair Project (C-7066-1)**

**PROPOSED PROJECT:** Balboa Island Seawall Coping Repair Project

Repair and maintenance of existing seawalls, and increase  
height of seawalls by 9 inches.

# Bulkhead Condition Report for Portions of the Balboa Island Seawall

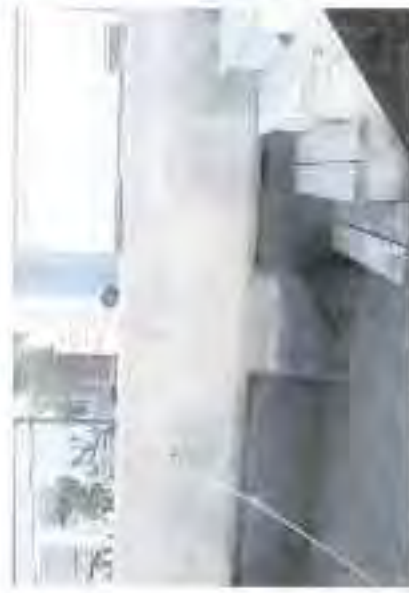
| Item | Location | Description |
|---|---|---|
| 13 | 356' North of Balboa Avenue | Waterside, crack and spalled face of pile |

| Item | Description | QUANTITY | | MATERIAL COST | | LABOR COST | | ENGINEERING ESTIMATE | |
|---|---|---|---|---|---|---|---|---|---|
| 13 | 356' North of Balboa Avenue, shotcrete repair | 6 | SF | | | | | \$70.00 | \$420 |

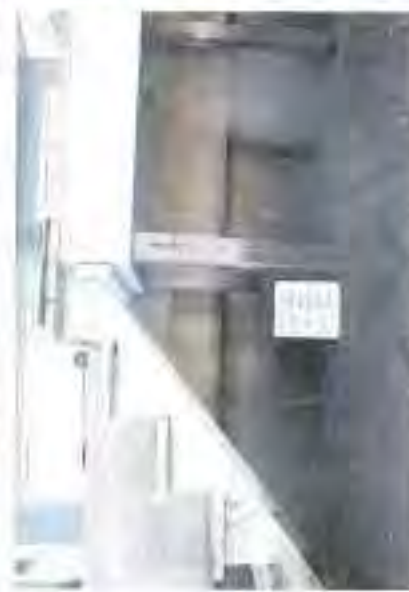
| Item | Location | Description |
|---|---|---|
| 14 | 362' North of Balboa Avenue | Waterside, crack at midline of cap, 96" long |

| Item | Description | QUANTITY | | MATERIAL COST | | LABOR COST | | ENGINEERING ESTIMATE | |
|---|---|---|---|---|---|---|---|---|---|
| 14 | 362' North of Balboa Avenue, crack injection | 8 | LF | | | | | \$70.00 | \$560 |

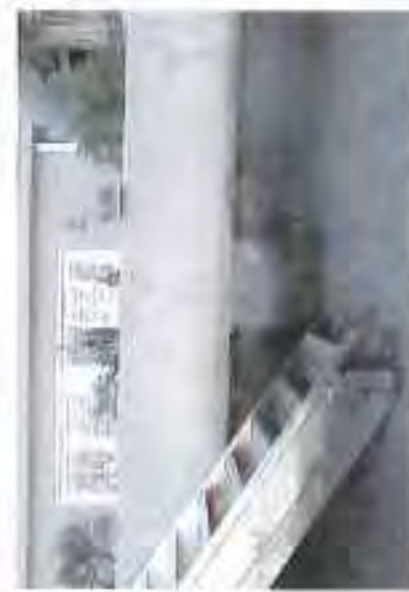
| Item | Location | Description |
|---|---|---|
| 15 | 400' North of Balboa Avenue | Waterside, crack on face of pile |

| Item | Description | QUANTITY | | MATERIAL COST | | LABOR COST | | ENGINEERING ESTIMATE | |
|---|---|---|---|---|---|---|---|---|---|
| 15 | 400' North of Balboa Avenue, shotcrete repair | 6 | SF | | | | | \$70.00 | \$420 |

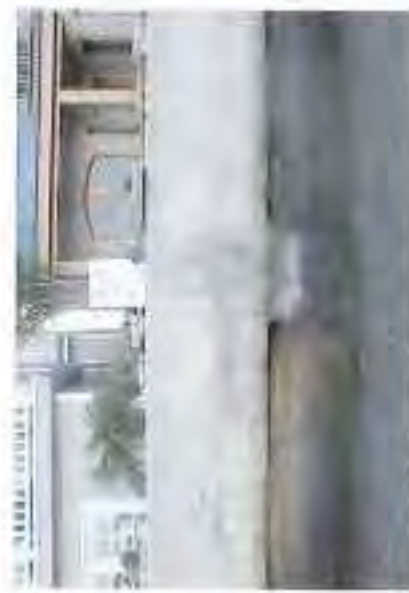
| Item | Location | Description |
|---|---|---|
| 16 | 412' North of Balboa Avenue | Waterside, crack on sides of pile |

| Item | Description | QUANTITY | | MATERIAL COST | | LABOR COST | | ENGINEERING ESTIMATE | |
|---|---|---|---|---|---|---|---|---|---|
| 16 | 412' North of Balboa Avenue, shotcrete repair | 6 | SF | | | | | \$70.00 | \$420 |

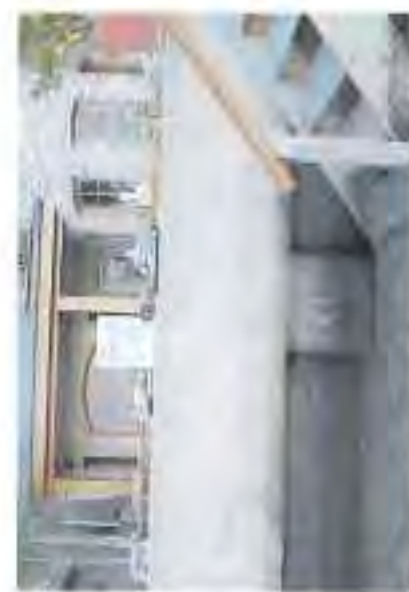
| Item | Location | Description |
|---|---|---|
| 17 | 422' North of Balboa Avenue | Waterside, crack on south side of pile |

| Item | Description | QUANTITY | | MATERIAL COST | | LABOR COST | | ENGINEERING ESTIMATE | |
|---|---|---|---|---|---|---|---|---|---|
| 17 | 422' North of Balboa Avenue, shotcrete repair | 6 | SF | | | | | \$70.00 | \$420 |

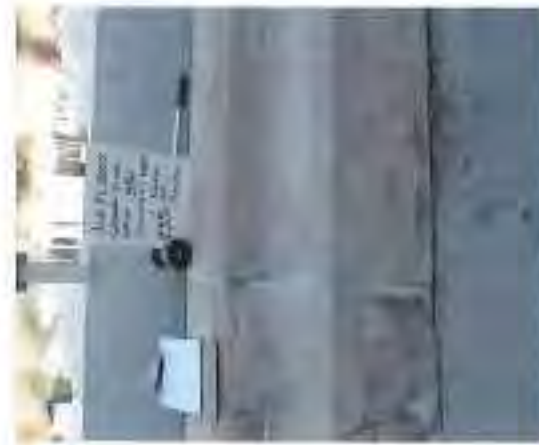
| Item | Location | Description |
|---|---|---|
| 18 | 435' North of Balboa Avenue | Construction joint, sealant split and cracked on land side, waterside obscured by dock |

| Item | Description | QUANTITY | | MATERIAL COST | | LABOR COST | | ENGINEERING ESTIMATE | |
|---|---|---|---|---|---|---|---|---|---|
| 18 | 435' North of Balboa Avenue, sealant repair | 7 | LF | | | | | \$25.00 | \$175 |

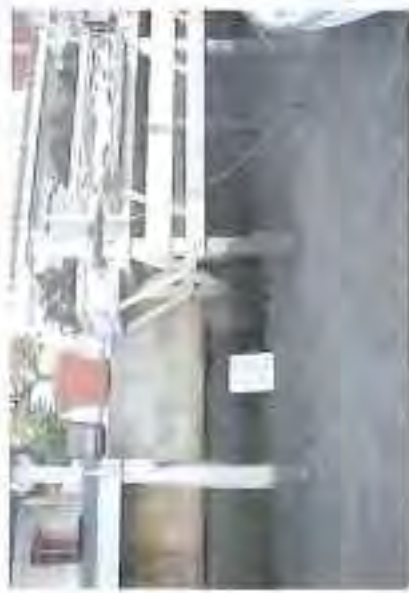
| Item | Location | Description |
|---|---|---|
| 19 | 444' North of Balboa Avenue | Waterside, crack on sides of pile |

| Item | Description | QUANTITY | | MATERIAL COST | | LABOR COST | | ENGINEERING ESTIMATE | |
|---|---|---|---|---|---|---|---|---|---|
| 19 | 444' North of Balboa Avenue, shotcrete repair | 6 | SF | | | | | \$70.00 | \$420 |

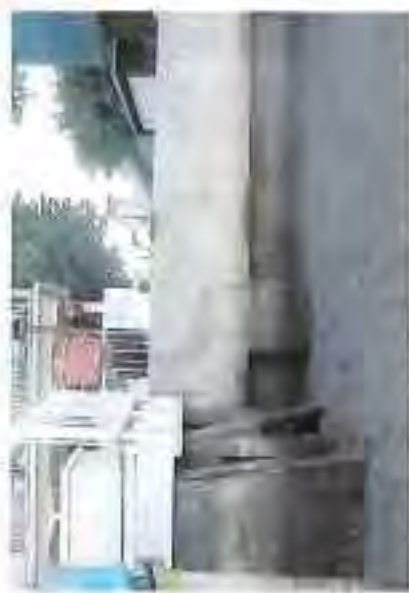
| Item | Location | Description |
|---|---|---|
| 22 | 490' North of Balboa Avenue | Waterside, crack on north side of pile |

| Item | Description | QUANTITY | | MATERIAL COST | | LABOR COST | | ENGINEERING ESTIMATE | |
|---|---|---|---|---|---|---|---|---|---|
| 22 | 490' North of Balboa Avenue, shotcrete repair | 6 | SF | | | | | \$70.00 | \$420 |

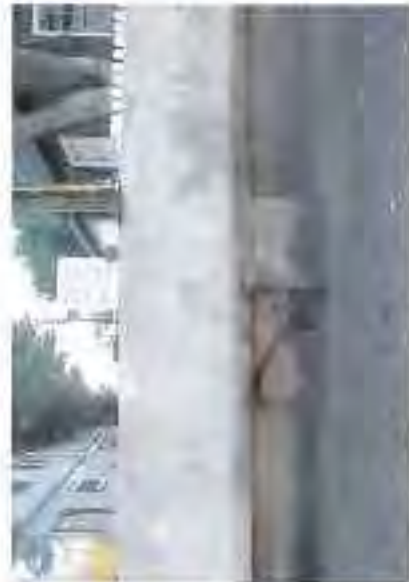
| Item | Location | Description |
|---|---|---|
| 24 | 500' North of Balboa Avenue | Waterside, crack on face and sides of pile |
| 25 | 500' North of Balboa Avenue | Waterside, wall spall, 2 square feet |

| Item | Description | QUANTITY | | MATERIAL COST | | LABOR COST | | ENGINEERING ESTIMATE | |
|---|---|---|---|---|---|---|---|---|---|
| 24 | 500' North of Balboa Avenue, shotcrete repair | 6 | SF | | | | | \$70.00 | \$420 |
| 25 | 500' North of Balboa Avenue, spall repair | 2 | SF | | | | | \$70.00 | \$140 |

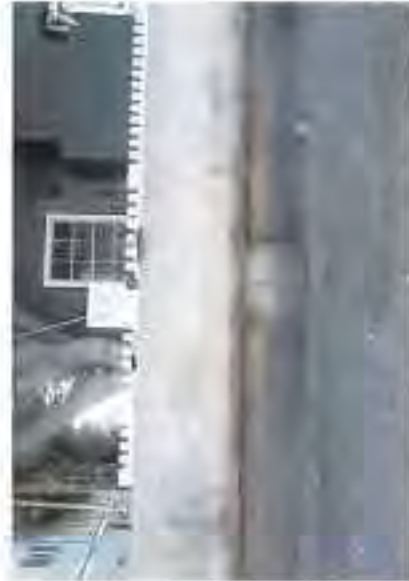
| Item | Location | Description |
|---|---|---|
| 26 | 511' North of Balboa Avenue | Waterside, crack on face and sides of pile |

| Item | Description | QUANTITY | | MATERIAL COST | | LABOR COST | | ENGINEERING ESTIMATE | |
|---|---|---|---|---|---|---|---|---|---|
| 26 | 511' North of Balboa Avenue, shotcrete repair | 6 | SF | | | | | \$70.00 | \$420 |

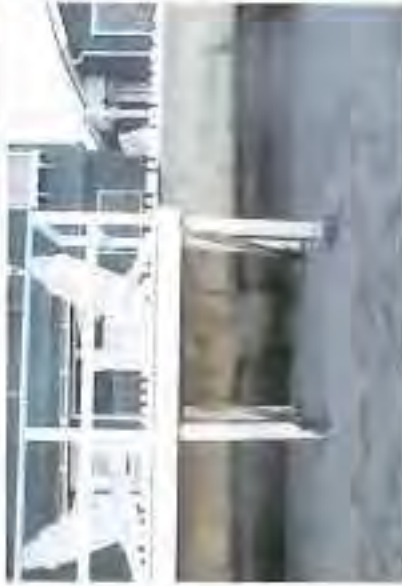
| Item | Location | Description |
|---|---|---|
| 27 | 534' North of Balboa Avenue | Waterside, crack on face and sides of pile |

| Item | Description | QUANTITY | | MATERIAL COST | | LABOR COST | | ENGINEERING ESTIMATE | |
|---|---|---|---|---|---|---|---|---|---|
| 27 | 534' North of Balboa Avenue, shotcrete repair | 6 | SF | | | | | \$70.00 | \$420 |

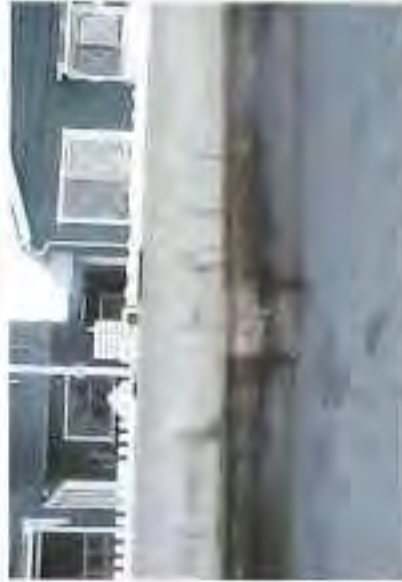
| Item | Location | Description |
|---|---|---|
| 28 | 545' North of Balboa Avenue | Waterside, crack on south side of pile |

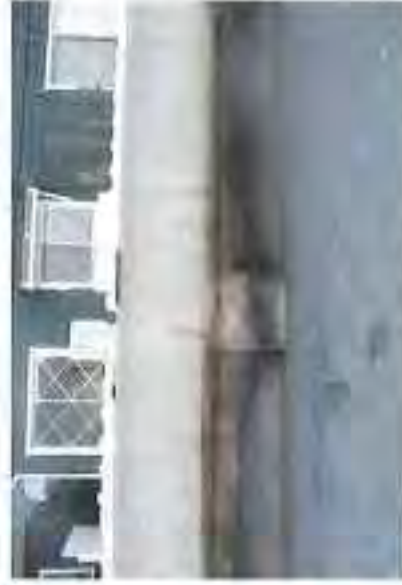
| Item | Location | Description |
|---|---|---|
| 29 | 556' North of Balboa Avenue | Waterside, crack on sides of pile |

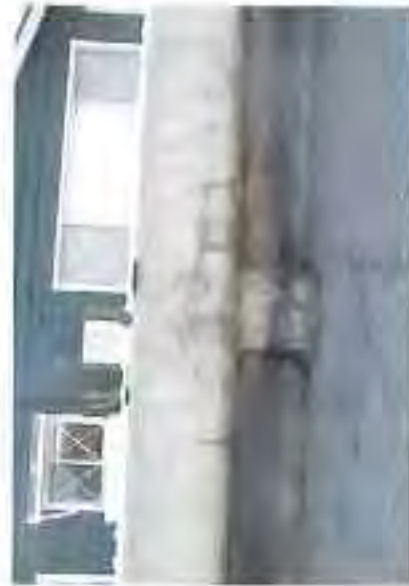
| Item | Location | Description |
|---|---|---|
| 30 | 567' North of Balboa Avenue | Waterside, crack on sides of pile |
| 31 | 567' North of Balboa Avenue | Waterside, crack at middle of cap, 60" long |

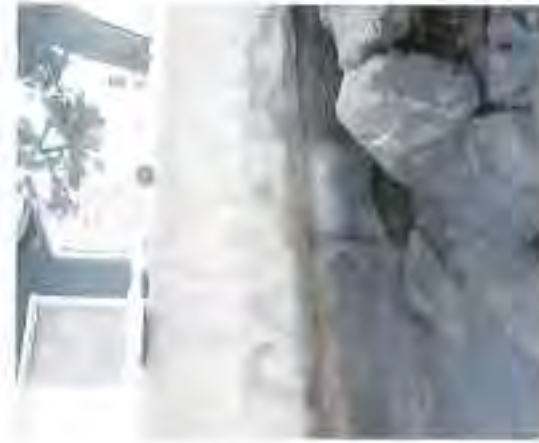
| Item | Location | Description |
|---|---|---|
| 32 | 578' North of Balboa Avenue | Waterside, spall at mudline of pile |
| 33 | 578' North of Balboa Avenue | Waterside, crack at middle of cap, 96" long |

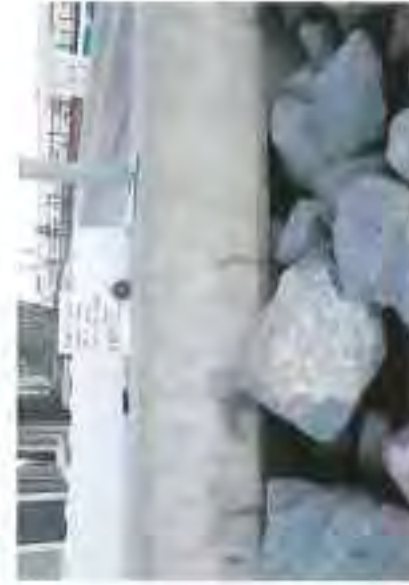
| Item | Location | Description |
|---|---|---|
| 34 | 589' North of Balboa Avenue | Waterside, crack on face and sides of pile, obscured by rocks |

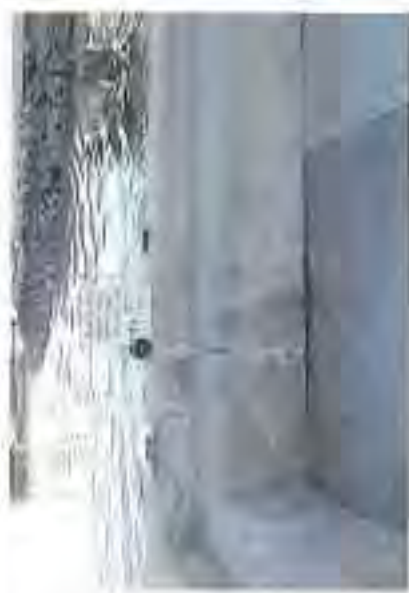
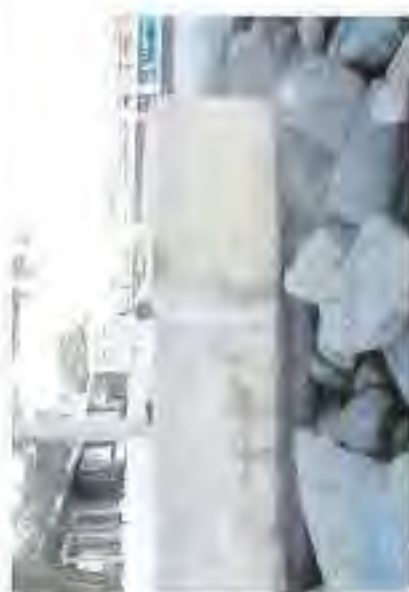
| Item | Location | Description |
|---|---|---|
| 35 | 597' North of Balboa Avenue | Construction joint, sealant split and crack |

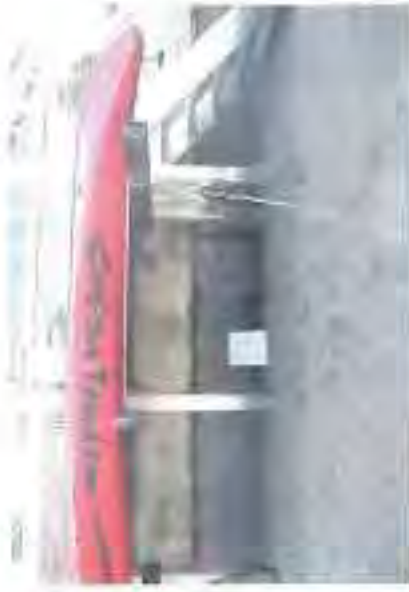
203 feet North of Park

| Item | Location | Description |
|---|---|---|
| 15 | 203' North of Park Avenue | Waterside, cracked pile |

| Item | Description | QUANTITY | | MATERIAL COST | | LABOR COST | | ENGINEERING ESTIMATE | |
|---|---|---|---|---|---|---|---|---|---|
| 15 | 203' North of Park Avenue, shotcrete repair | 6 | SF | | | | | \$70.00 | \$420 |

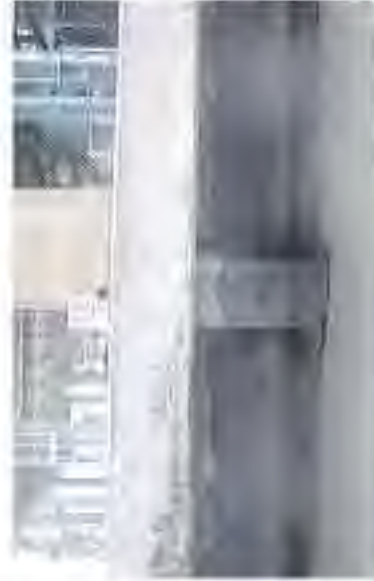
34 feet North of South Bay Front

| Item | Location | Description |
|---|---|---|
| 3 | 34' North of South Bay Front | Waterside, cracked on face of pile, bottom of shotcrete exposed |

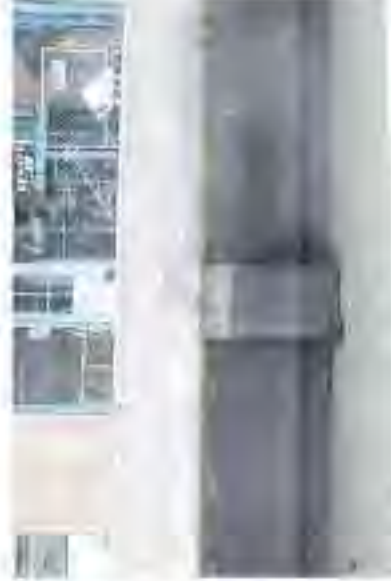
46 feet North of South Bay Front

| Item | Location | Description |
|---|---|---|
| 5 | 46' North of South Bay Front | Waterside, cracked on south side of pile, bottom of shotcrete exposed |

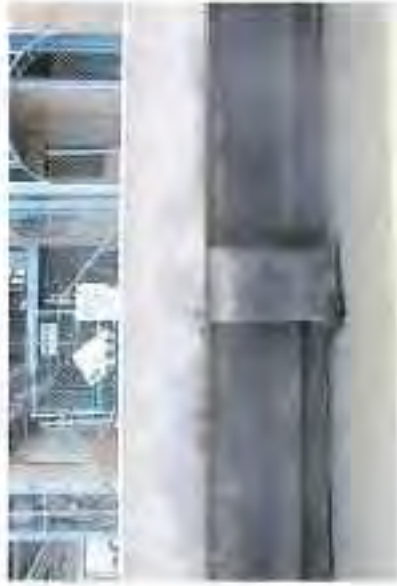
57 feet North of South Bay Front

| Item | Location | Description |
|---|---|---|
| 6 | 57' North of South Bay Front | Waterside, cracked face and sides of pile, bottom of shotcrete exposed |

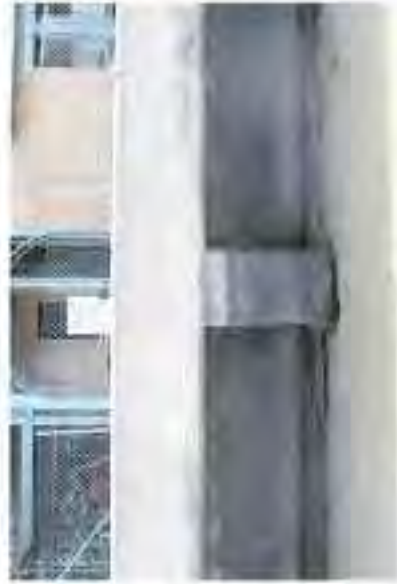
68 feet North of South Bay Front

| Item | Location | Description |
|---|---|---|
| 7 | 68' North of South Bay Front | Waterside, cracked sides of pile, bottom of shotcrete exposed |

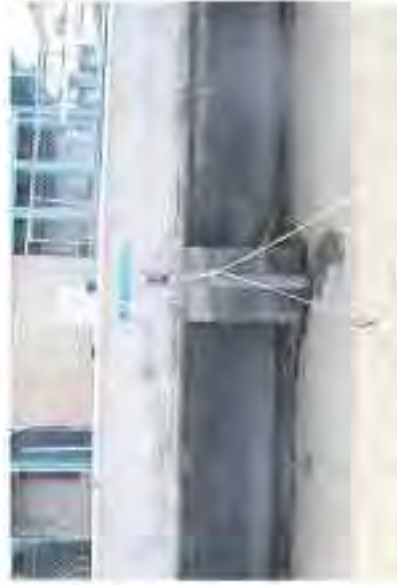
79 feet North of South Bay Front

| Item | Location | Description |
|---|---|---|
| 8 | 79' North of South Bay Front | Waterside, cracked on north side of pile, bottom of shotcrete exposed |

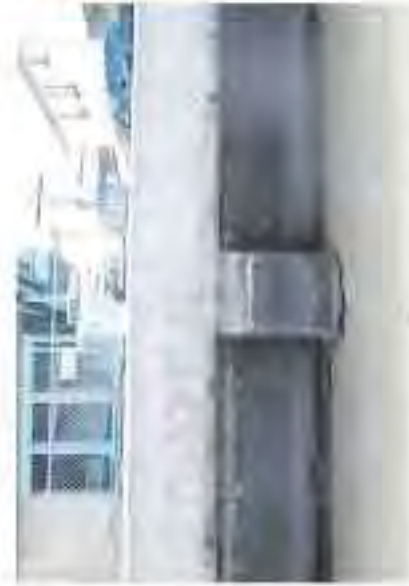
90 feet North of South Bay Front

| Item | Location | Description |
|---|---|---|
| 10 | 90' North of South Bay Front | Waterside, cracked face and sides of pile, bottom of shotcrete exposed |

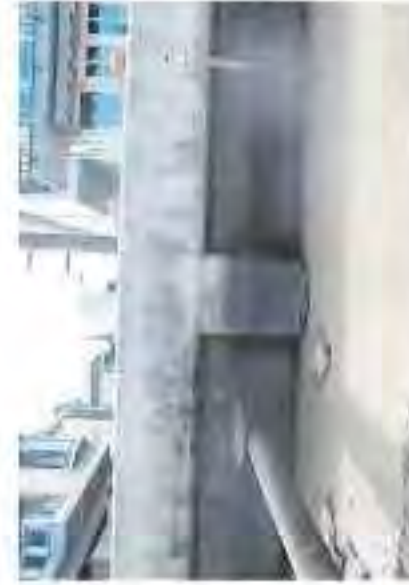
112 feet North of South Bay Front

| Item | Location | Description |
|---|---|---|
| 13 | 112' North of South Bay Front | Waterside, cracked face of pile, bottom of shotcrete exposed |

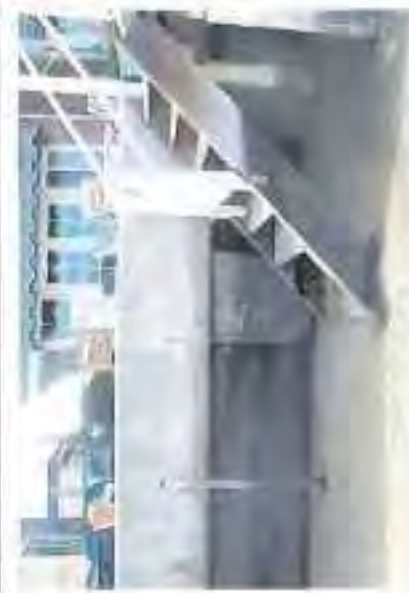
123 feet North of South Bay Front

| Item | Location | Description |
|---|---|---|
| 14 | 123' North of South Bay Front | Waterside, cracked face of pile |

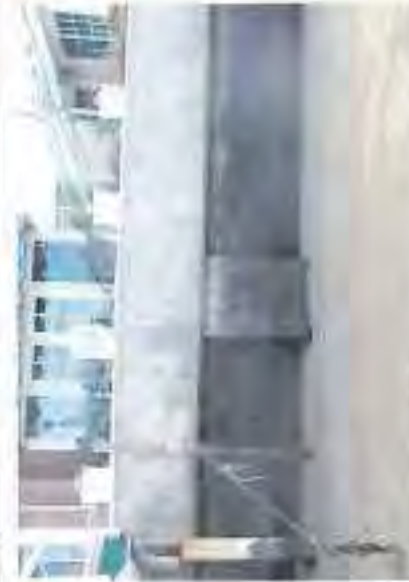
144 feet North of South Bay Front

| Item | Location | Description |
|---|---|---|
| 16 | 144' North of South Bay Front | Waterside, cracked face of pile |

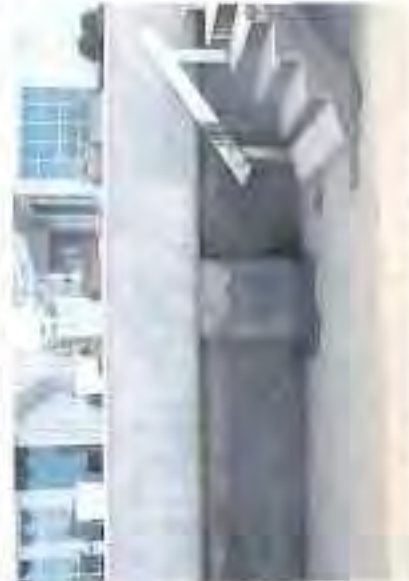
156 feet North of South Bay Front

| Item | Location | Description |
|---|---|---|
| 18 | 156' North of South Bay Front | Construction joint, waterside sealant cracked and split |

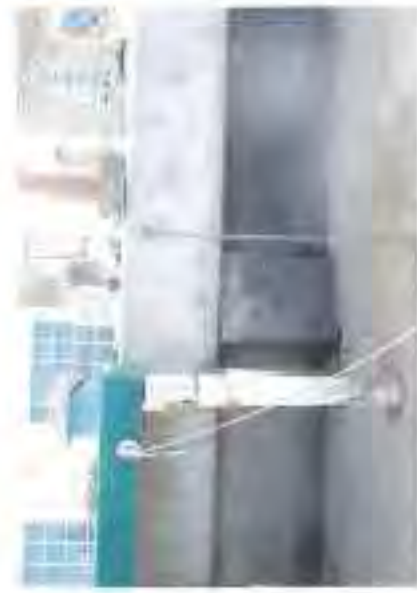
178 feet North of South Bay Front

| Item | Location | Description |
|---|---|---|
| 19 | 178' North of South Bay Front | Waterside, cracked face of pile, south side of pile at mudline, spalled |

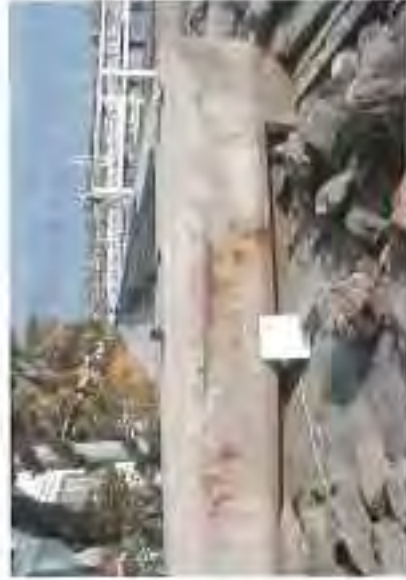
Grand Canal East, 7 ft N. of South Bay Front

| Item | Location | Description |
|---|---|---|
| 2 | 7' North of South Bay Front | Waterside, spall 96" long, rebar exposed |

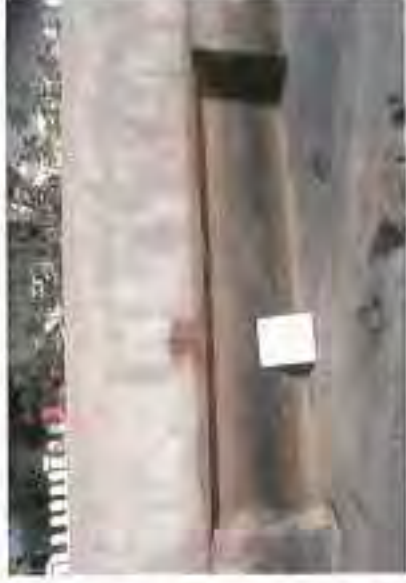
Grand Canal East, 41 ft N. of South Bay Front

| Item | Location | Description |
|---|---|---|
| 3 | 41' North of South Bay Front | Waterside, crack at bottom of cap, 96" long |

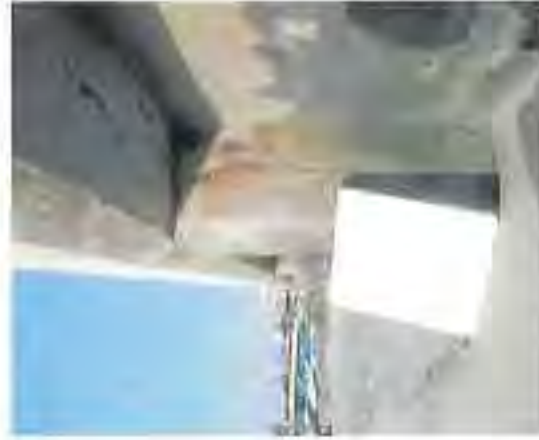
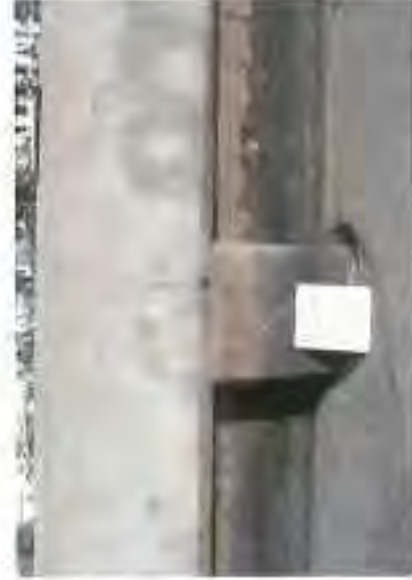
Grand Canal East, 68 ft N. of South Bay Front

| Item | Location | Description |
|---|---|---|
| 4 | 68' North of South Bay Front | Waterside, shotcrete cracked at pile |

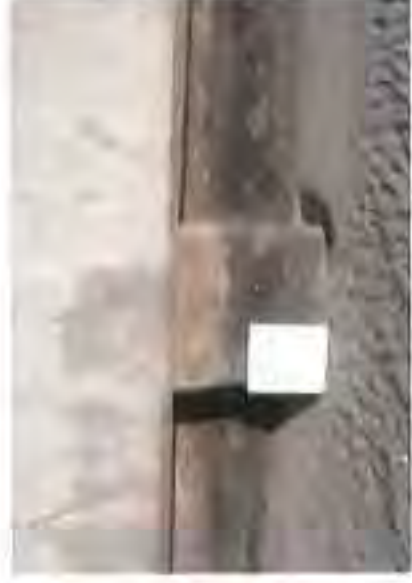
Grand Canal East, 78 ft N. of South Bay Front

| Item | Location | Description |
|---|---|---|
| 5 | 78' North of South Bay Front | Waterside, shotcrete cracked at pile |

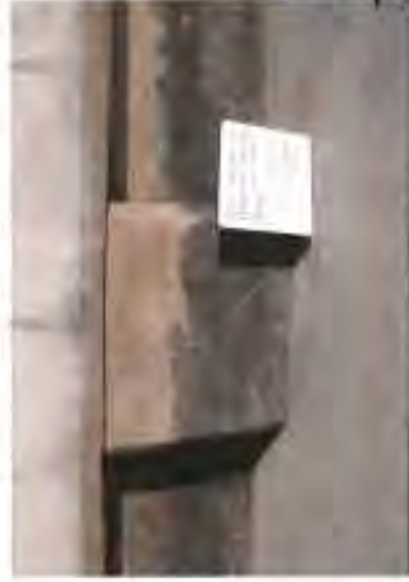
Grand Canal East, 91 ft N. of South Bay

| Item | Location | Description |
|---|---|---|
| 7 | 91' North of South Bay Front | Waterside, shotcrete cracked at pile |

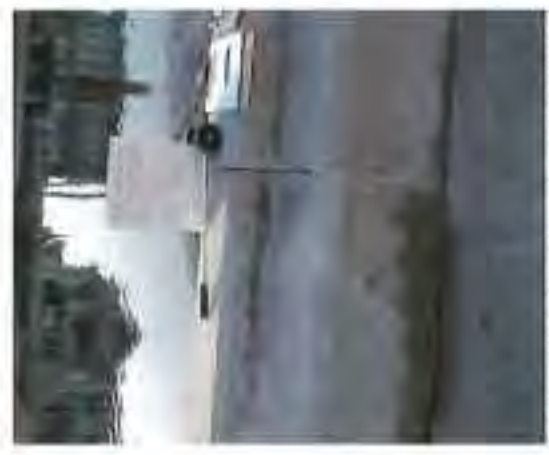
Grand Canal East, 116 ft N. of South Bay Front

| Item | Location | Description |
|---|---|---|
| 9 | 116' North of South Bay Front | Construction joint, sealant missing on landside, waterside sealant in good shape. |

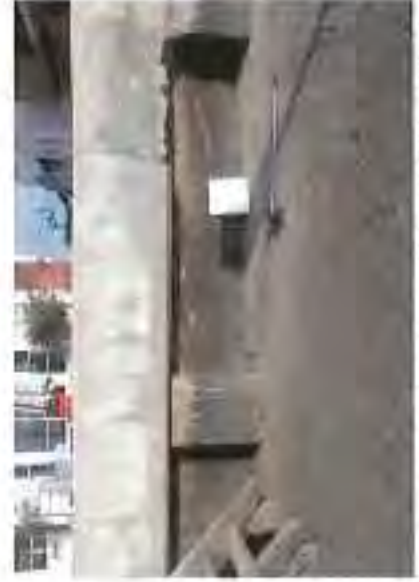
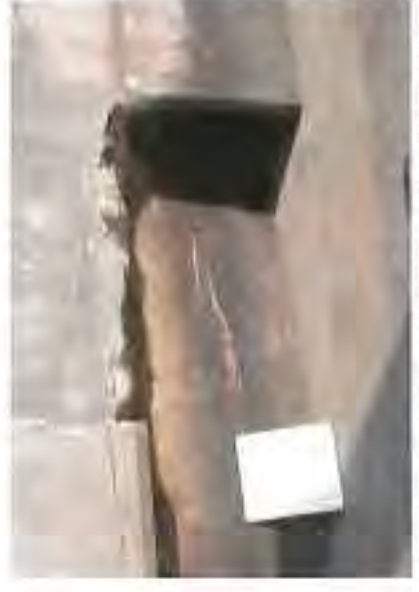
Grand Canal East, 119 ft N. of South Bay

| Item | Location | Description |
|---|---|---|
| 10 | 119' North of South Bay Front | Waterside, spall at bottom of cap 180" long x 6" x 12" |
