4 SEAWALL CONDITION ASSESSMENT

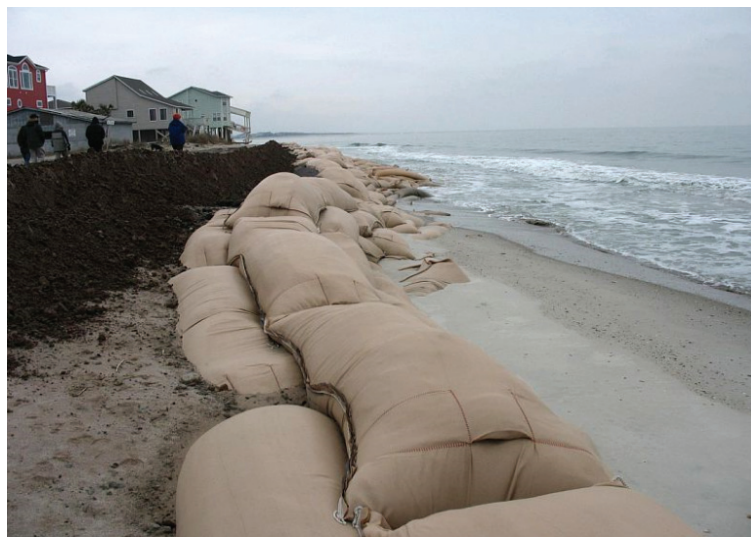
Figure 5.1 Geotextile Sandbags Used as a Seawall Along a Beach

The other sandbag-type option (Alternative 2, Option 3) consists of geotextile (Longard) bags or tubes. An example of using geotextile bags for flood protection is shown in Figure 5.1. These geotextile bags are made of thicker and stronger material than the traditional polypropylene sandbag (Alternative 2, Option 2). These bags can be left in place until the seawalls are replaced, and given their thickness, only one bag will be needed to meet the required height. Just like any other plastic material, ultraviolet (UV) degradation is a concern. The use of UV inhibitors in the geotextile material or the placement of a protective tarp overtop the geotextile bags may be sufficient to shield the bags from UV light.
