**CITY OF NEWPORT BEACH  
COMMUNITY DEVELOPMENT DEPARTMENT**

**Re: Response to Request for Additional Information for the City of Newport Beach**

**Case No.: 12-09-1324S  
Docket No.: FEMA-B-1673**

January 2018  
City of Newport Beach

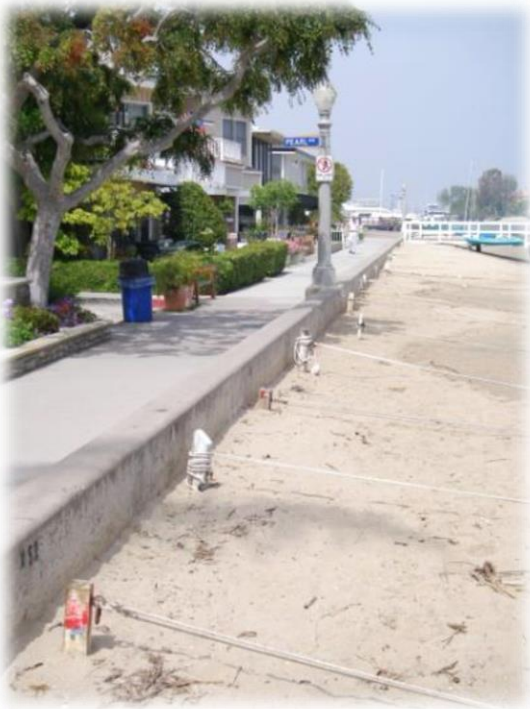
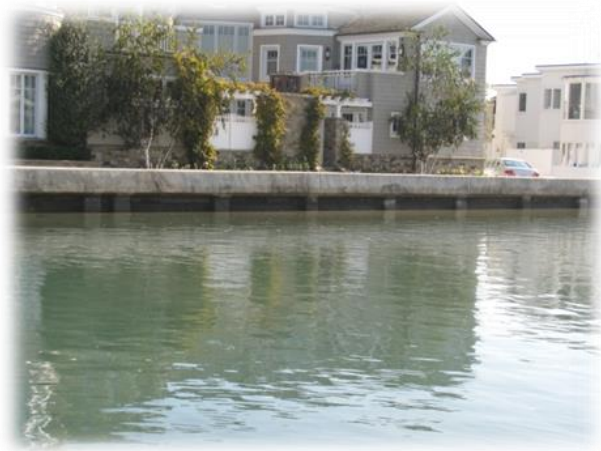
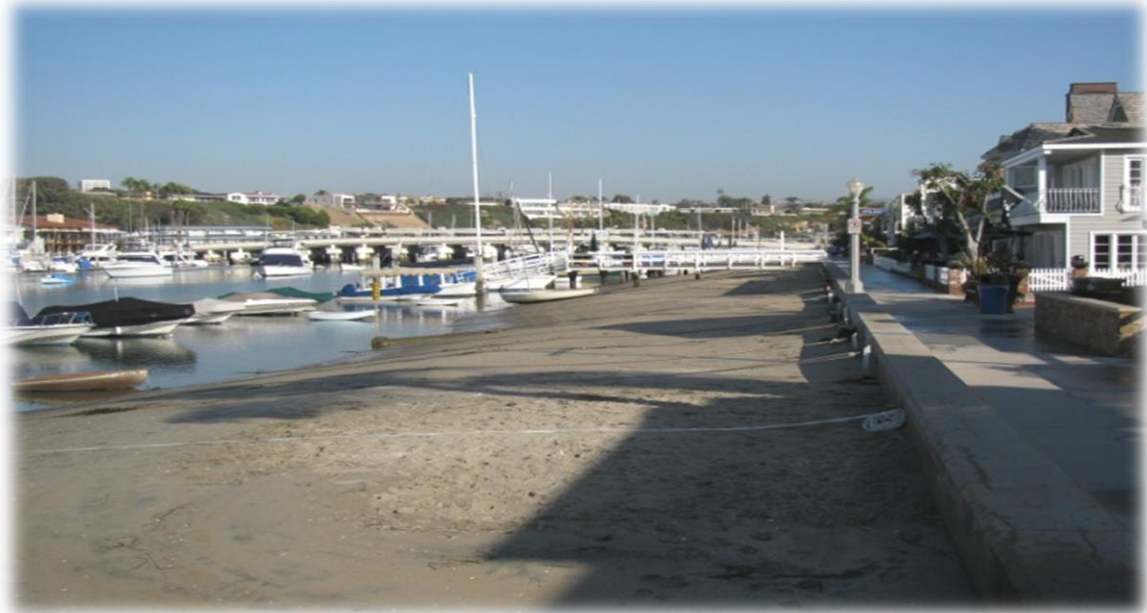
**Figure 1.      Example Seawalls**

The objective of the survey is to identify the location and height of the seawalls for the use of the HEC-RAS model to simulate flood extent in Newport Bay. As shown in Figure 1 (attached), most of the seawall segments along the shoreline of Balboa Island and Newport Bay are straight and of uniform heights and can be captured by two survey points at the two ends of a seawall segment. Hence, the density of the survey points is sufficient to meet the objective. The survey team kept very detailed field notes and photos to ensure all the necessary detail of the seawall was captured. Example survey field notes and photos are provided in Figures 2 and 3 (attached). Nevertheless, the City has retained Coast Surveying to conduct an additional survey, which added 1,427 survey points of the seawall elevations. The top of wall elevations were extracted from digital models developed from 1"=20' scale photogrammetric mapping. The locations of these new surveys points are shown in Figure 4 (attached). In Figure 4, the previously submitted survey points conducted in 2017 are also shown. A reference of the data points is shown in the attached Seawall Survey 2018 Map. The following link shows the data points that were referenced in 2017 as submitted to FEMA as well as the new additional data collected in 2018; when zoomed you will be able to see the elevation labels turn on:

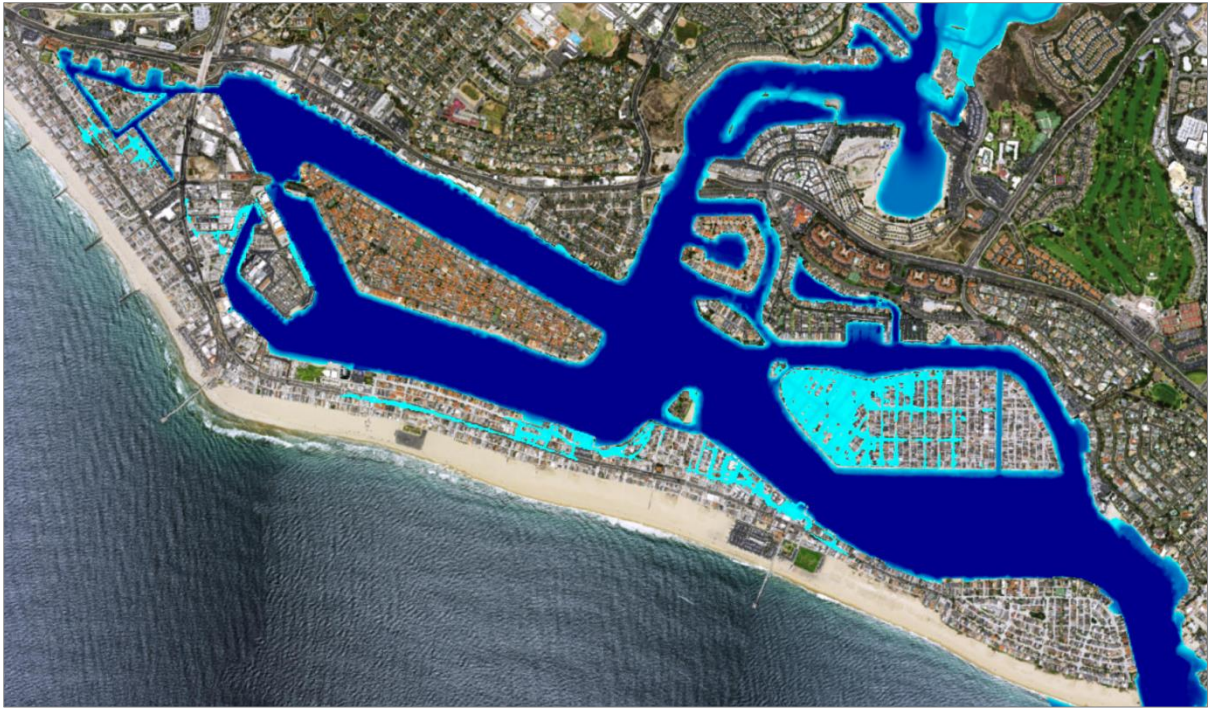
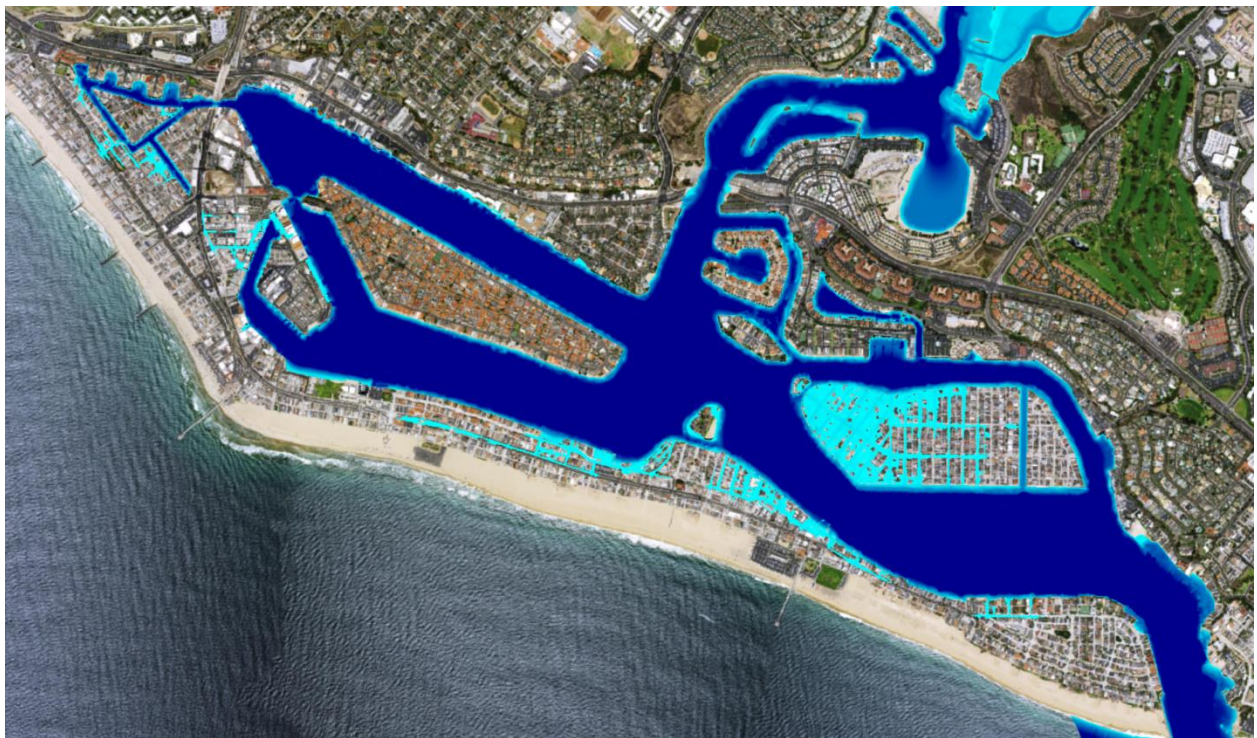
**Figure 5. Comparison of Updated Proposed Revised Flood Zone with the Previous One Submitted in the Letter of Appeal**

The HEC-RAS Model was updated to include all the additional seawall elevations data. In addition, the model grid was revised to reduce the width of the cells representing the seawall to approximately 5 ft. as requested. In Figure 5, the updated HEC-RAS Model predicted flood zones are compared with the previously submitted proposed revised flood zones described in the Letter of Appeal dated August 30, 2017. As can be seen in the figure, there is only very slight changes in the predicted areas with the updated HEC-RAS Model.

**(a) Proposed revised flood zone submitted in the Letter of Appeal dated August 30. 2017**

**(b) Updated proposed revised flood zone**

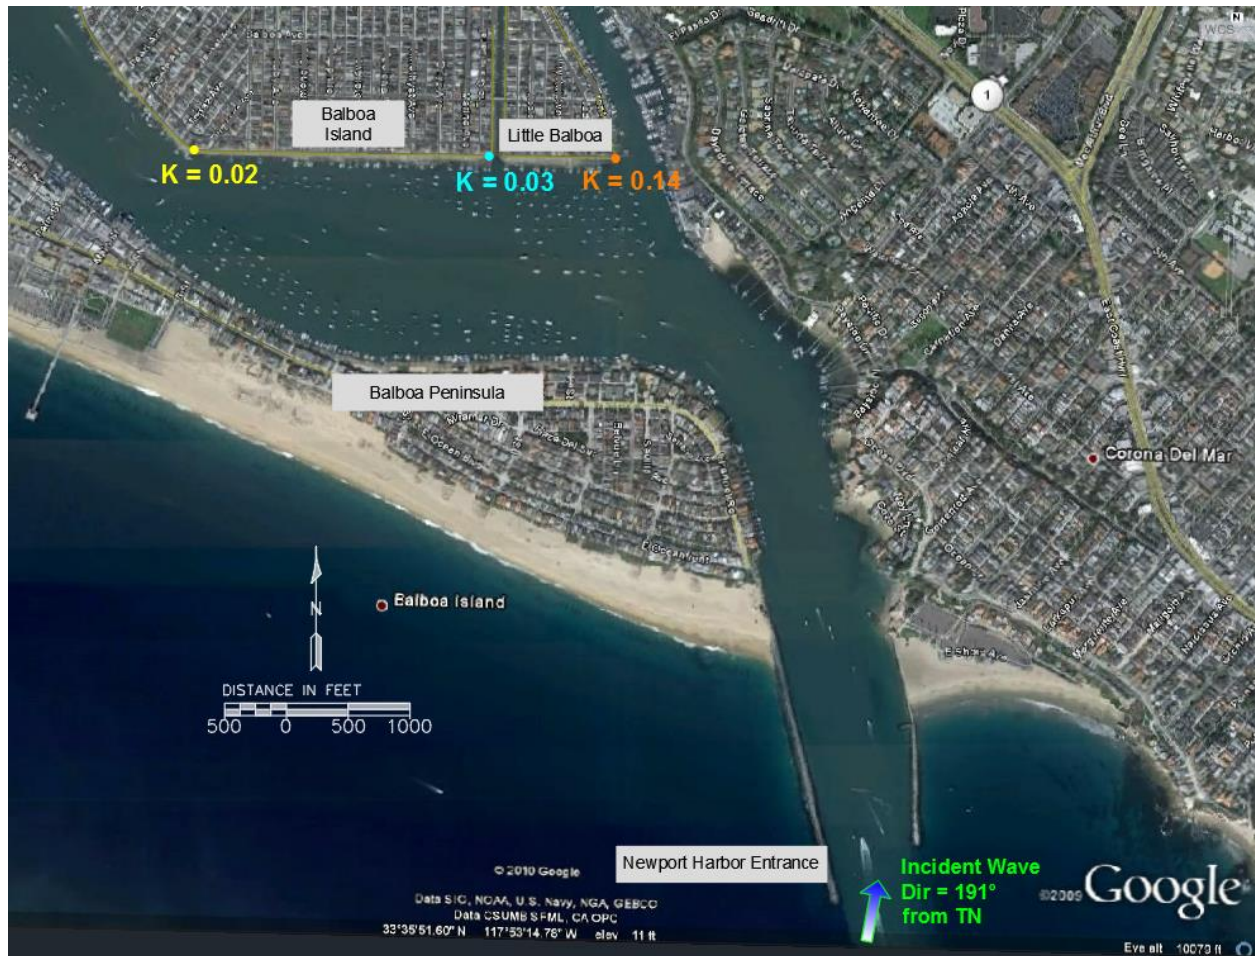
Figure 6. Wave Diffraction Coefficients for Newport Harbor

In lieu of conducting wave modeling, a simple wave diffraction analysis was conducted to provide a quick estimate of penetration of offshore swells through the harbor inlet channel into Newport Harbor. Figure 6 shows the approximated wave diffraction coefficients for a few locations along Balboa Island and Little Balboa Island for a wave direction of 191° from true north (average of the most common wave directions from south and south-south-west based on Dana Point data). As shown in the figure, the wave diffraction coefficient (K) along the southern face of Balboa and Little Balboa Island ranges from approximately 0.02

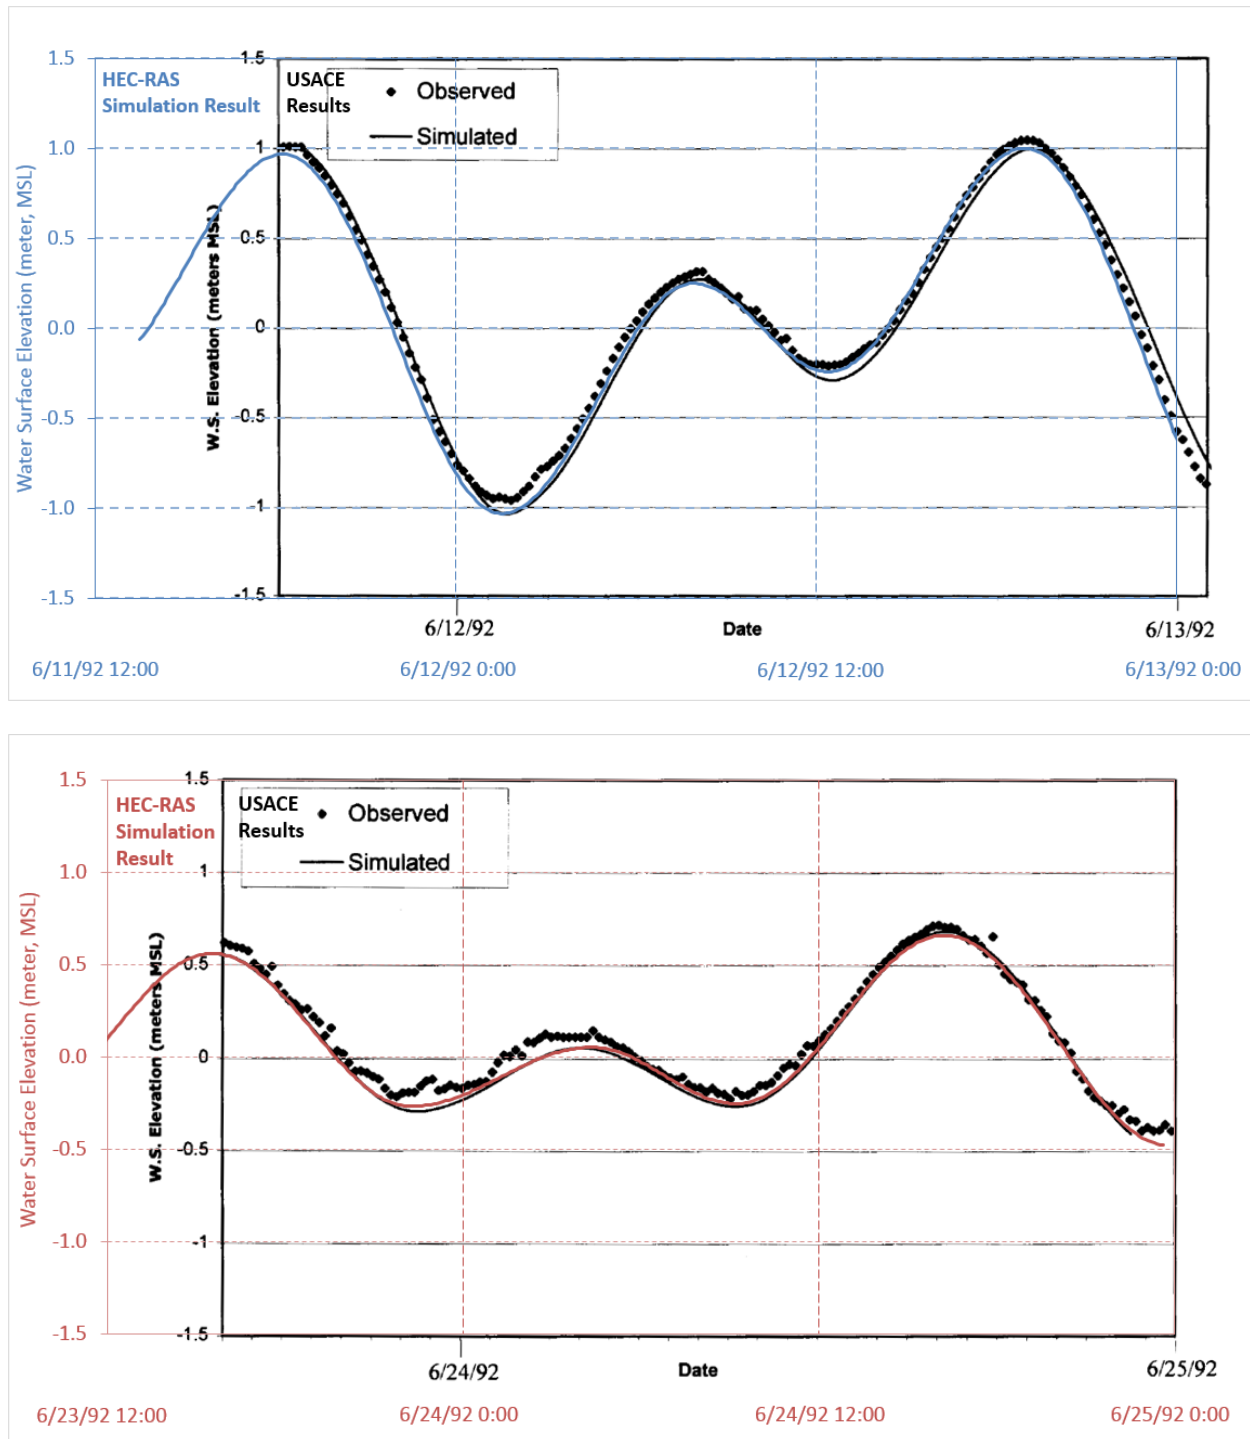
**Figure 7. Comparison of Water Surface Elevation Results at Dover Shore for June 11-12, 1992 & June 23-24, 1992 (HEC-RAS results shown in blue & red-orange, original USACE results shown in black)**

In the 1998 U.S. Army Corps of Engineers (USACE) Feasibility Report on Upper Newport Bay Numerical Model Development: Baseline Conditions Analysis, model results were compared with data from two tide gage stations. These stations are situated at Dover Shores and salt dike. Only data from Dover Shore was used in our modeling efforts to compare HEC-RAS model results with the field data. This is because since the USACE study was completed, the salt dike area has undergone extensive restoration and dredging as a part of the Upper Newport Bay Ecosystem Restoration Project—and now has completely different bathymetry. The Dover Shore data consisted of observed and simulated water surface elevations for June 11-12 and June 23-24, 1992. A comparison of the USACE data and our modeling results at Dover Shore show an almost exact match for water surface elevations, as presented in Figure 7. Specifically, the Figure includes a comparison plot for each of the two data timeframes, while each of these individual plots compares RMA modeling results from the USACE study, our HEC-RAS modeling results, and observed data from the USACE study. As such, the close match between the USACE data and our results provides additional model validation for ensuring accuracy of the HEC-RAS model used in our analyses.
