# Balboa Islands Seawall Rehabilitation Project

Tidelands Management Committee  
October 29, 2014

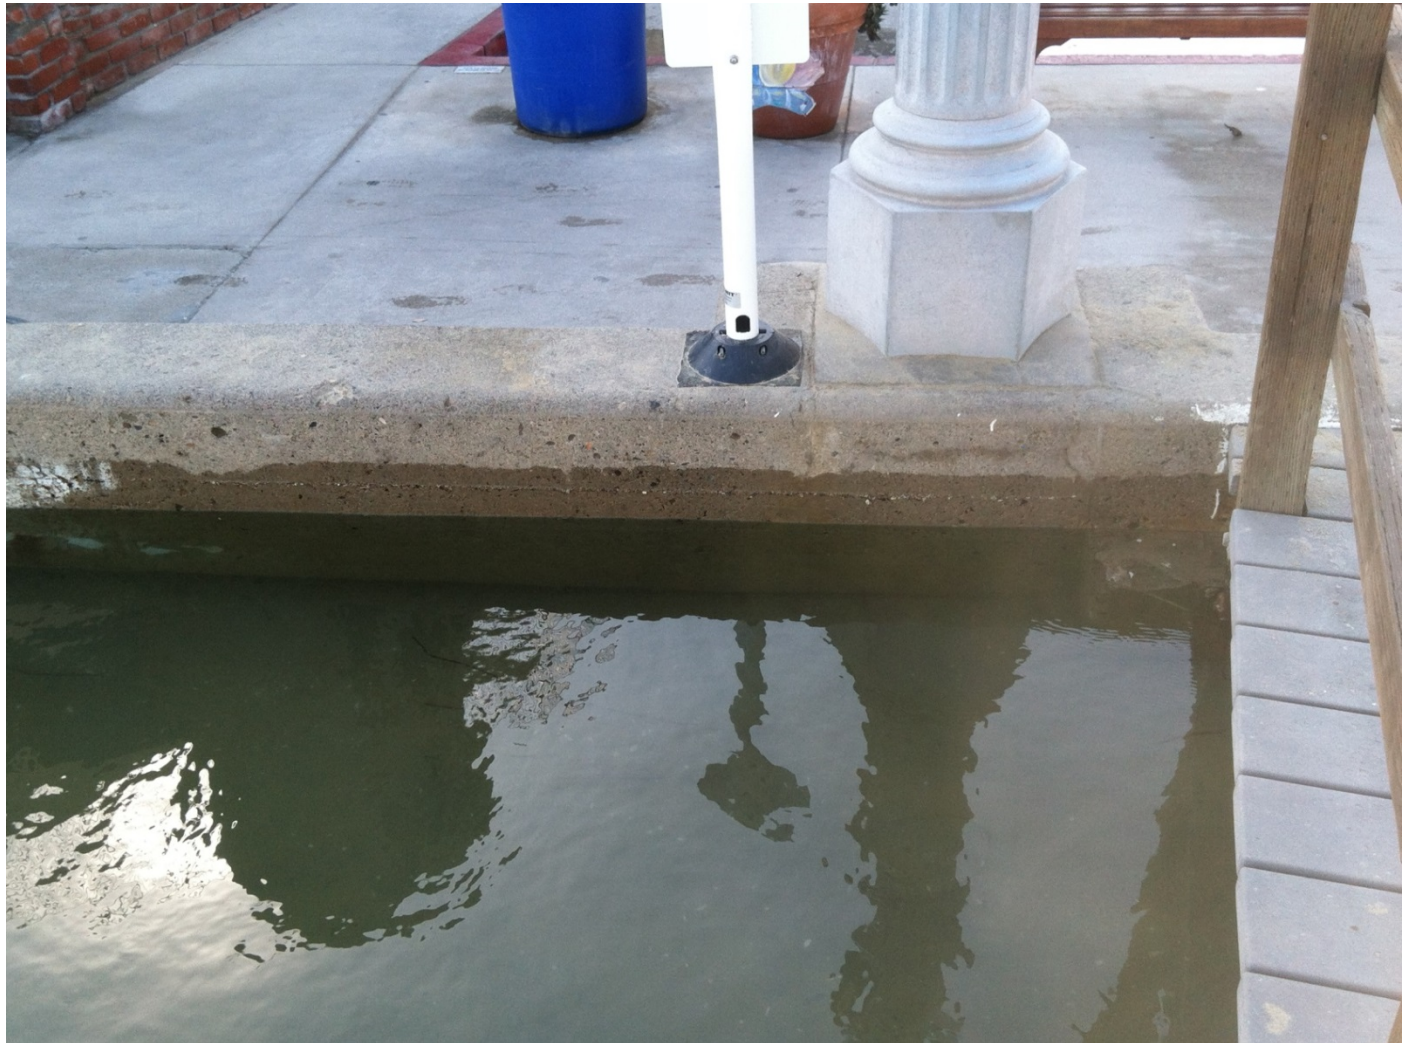
North Side of Balboa Island  
10/9/14 – 10 AM: 6.5' High Tide (MLLW)  
**10 inches of freeboard!**

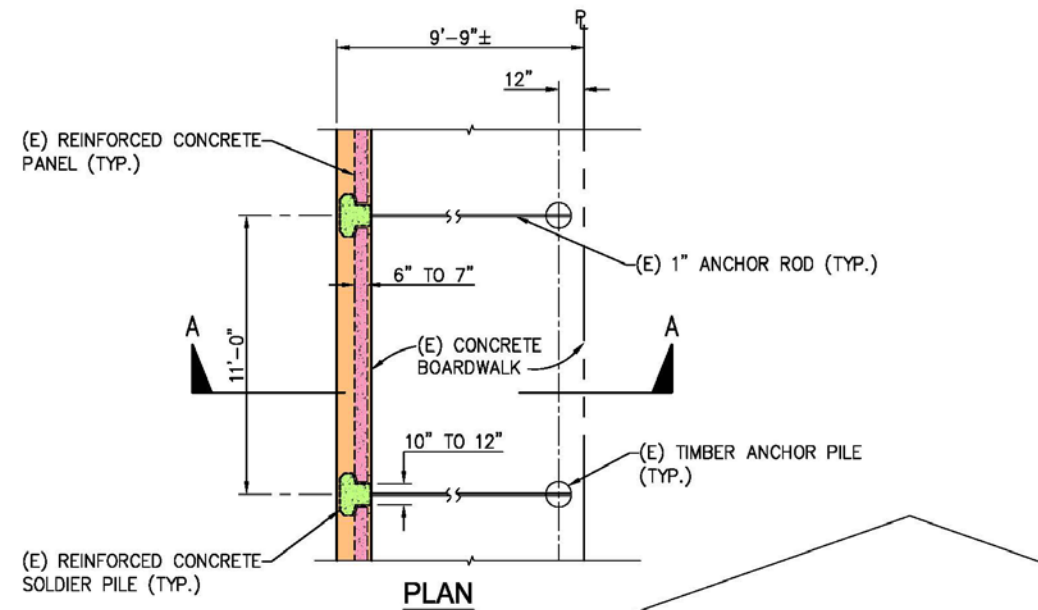
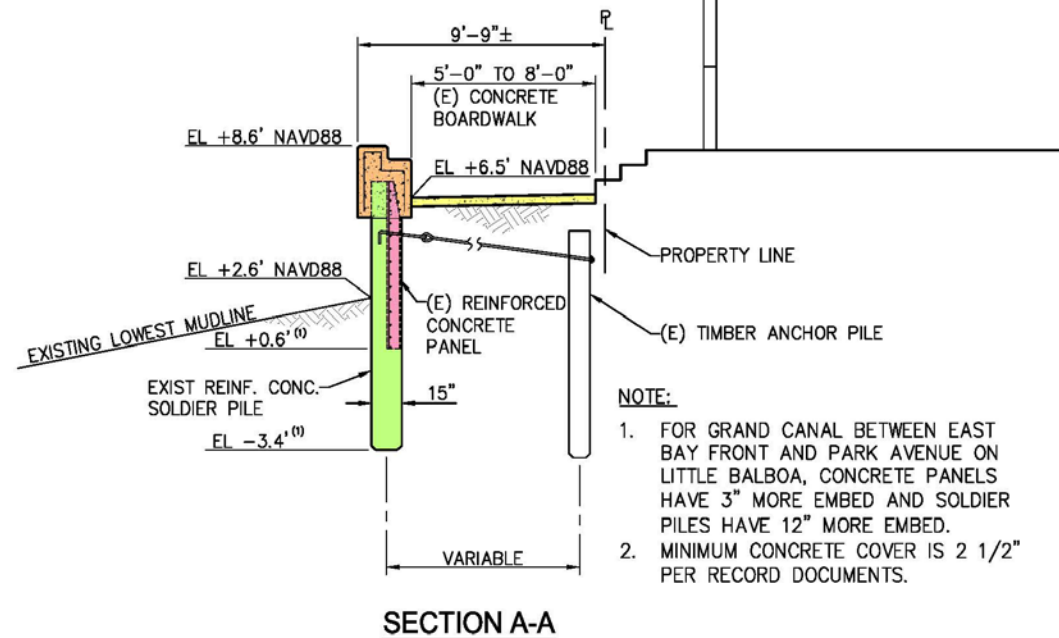
CASE 1 - EXISTING CONDITION at GRAND CANAL

# Existing Seawall Along Grand Canal

Constructed:  
1930, 1935

- 85yr old walls, with an approx. 75yr original lifespan
- Walls are exhibiting obvious signs of deterioration and stress.
- Existing walls subject to seismic risk
- Depth of wall in the mudline is very shallow. (Grand Canal)
- Many unknowns: seawall rebar, sheetpile condition below mudline, tiebacks

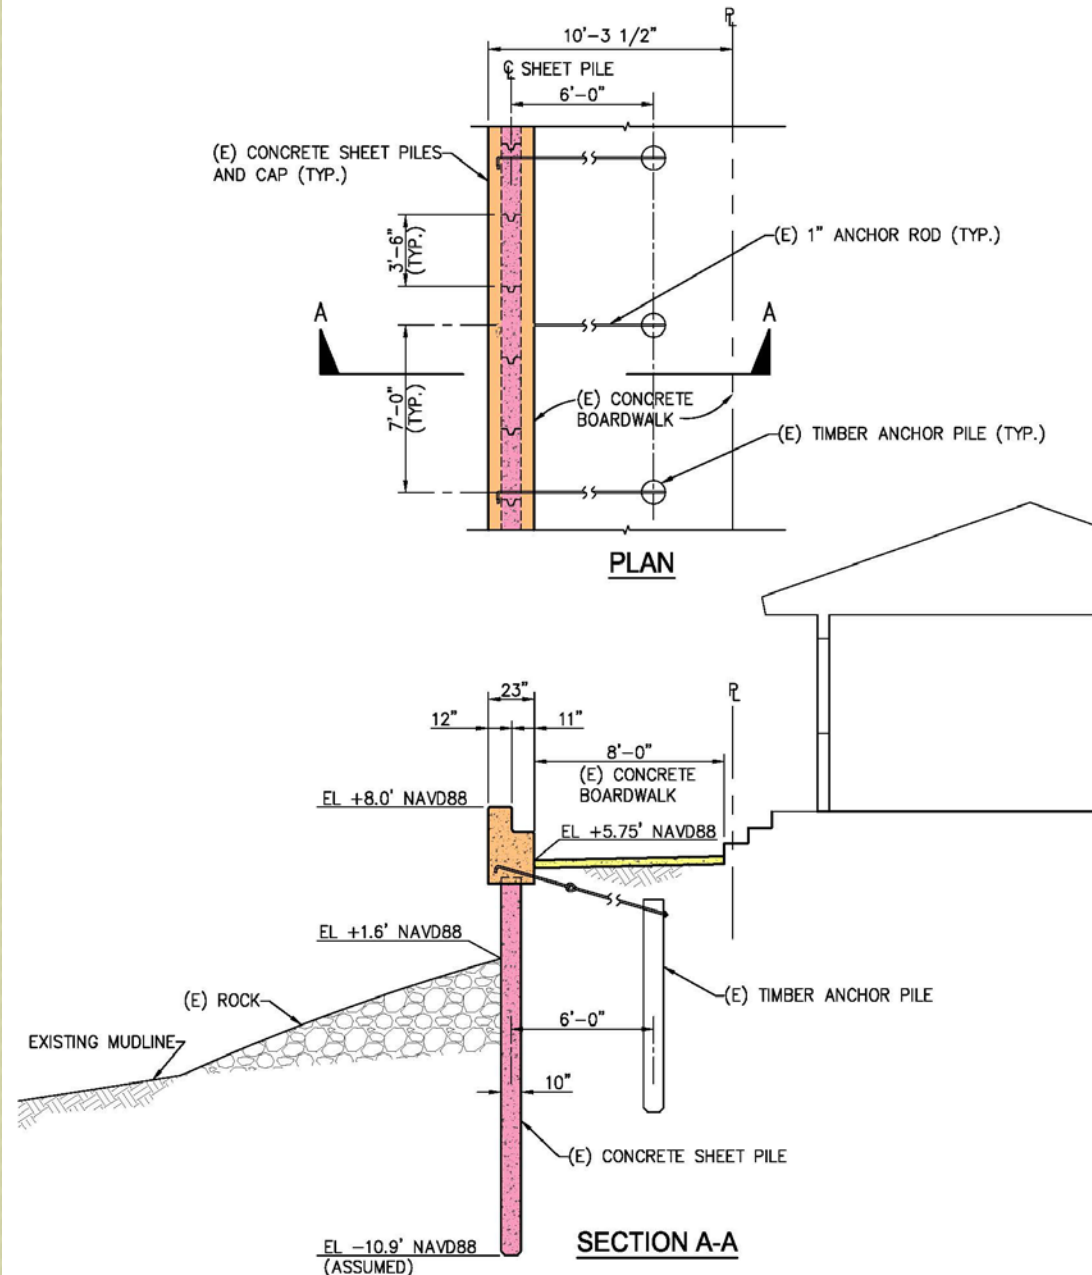
CASE 2 - EXISTING CONDITION at WEST END

# Existing Seawall at Balboa Island West End

Constructed:  
pre-1935

Rock reinforcement  
installed 1985

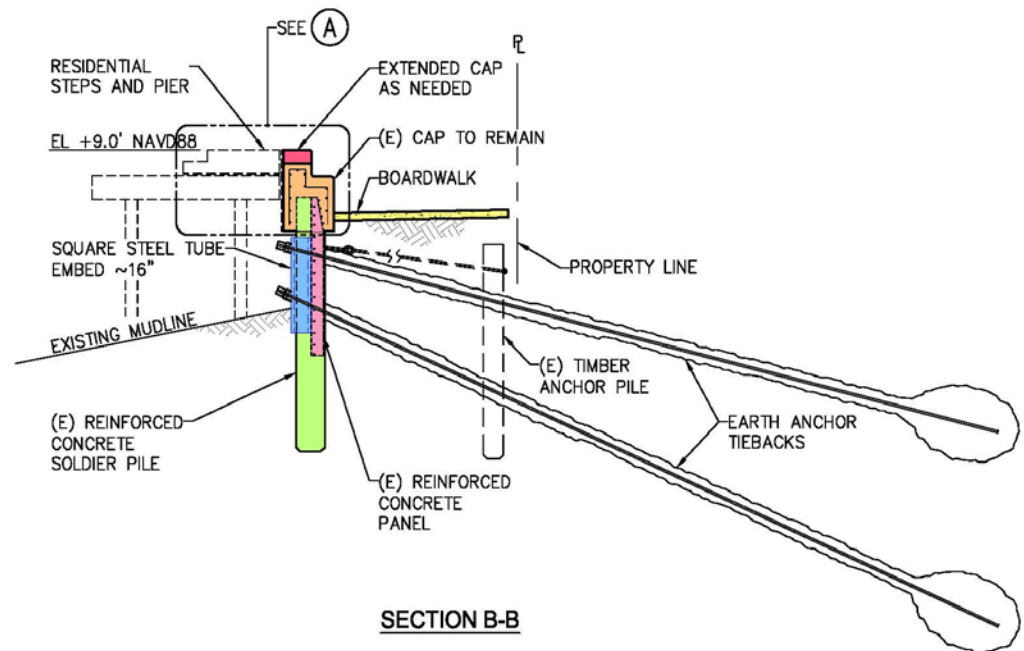
Option 1 - Grand Canal

Possible Retrofit  
Option:  
**Vertical  
Struts with  
Tiebacks  
along Grand  
Canal**

## Vertical Struts/Tiebacks (Grand Canal): Challenges and Concerns

- Installation of lower tieback for the vertical strut will be negatively impacted by tides, thus extending the overall schedule to complete.
- The success of this retrofit is dependent upon the structural integrity of the concrete panels (Grand Canal) and concrete piles (West End).
- Compared to a new wall, there is no cost advantage. Option rejected.

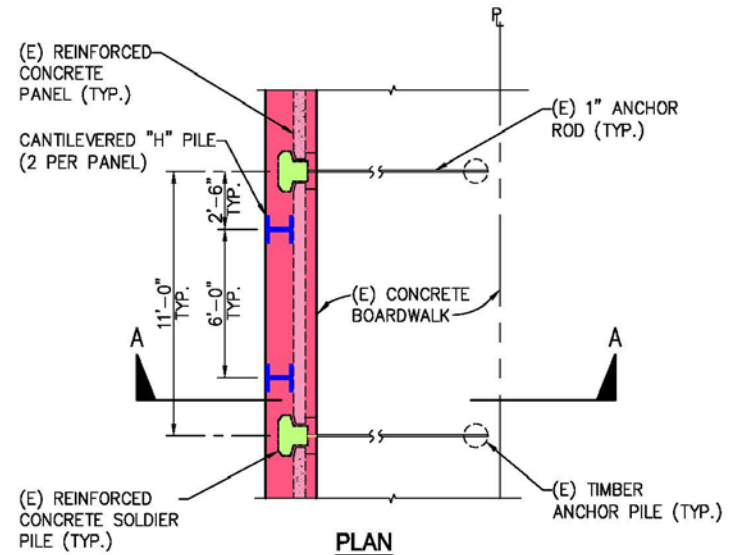
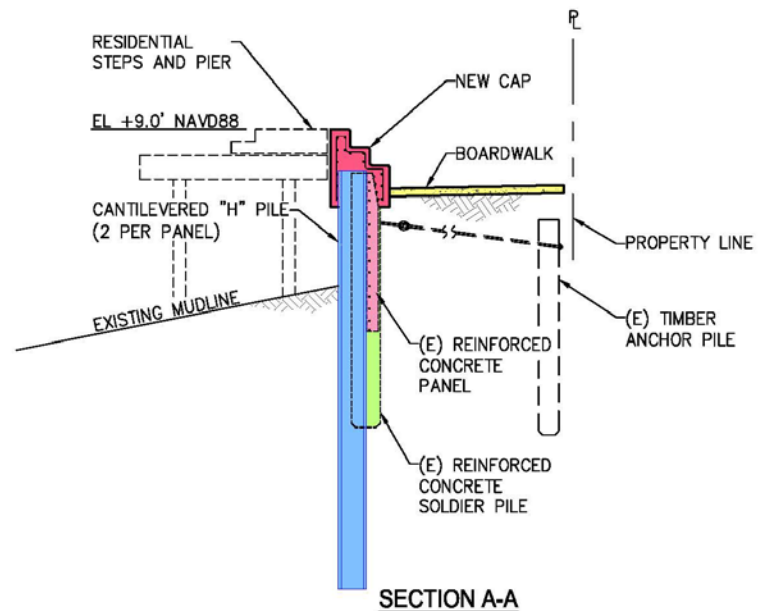
Option 2 - Grand Canal

# H-Pile Supports along Grand Canal

### 3. H-Pile Supports along Grand Canal: Challenges and Concerns

- There will be noise and vibration impacts of diesel hammer equipment to install H-Piles.
- There is the potential for additional damage to seawall during retrofit, as well as residential disturbance/damage.
- Testing required. Compared to the cost for new seawalls, this is a favorable, short-term option.

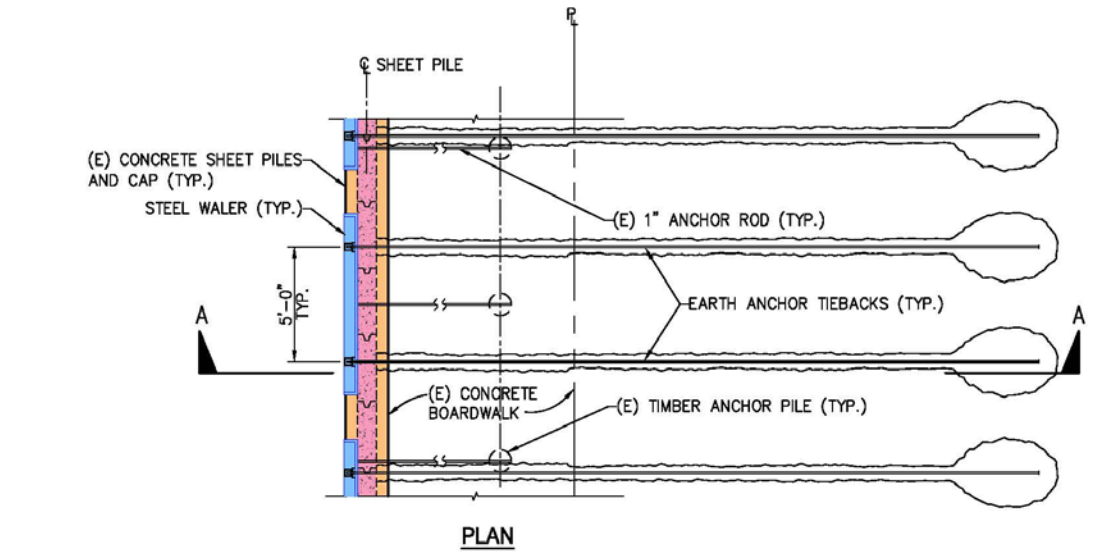
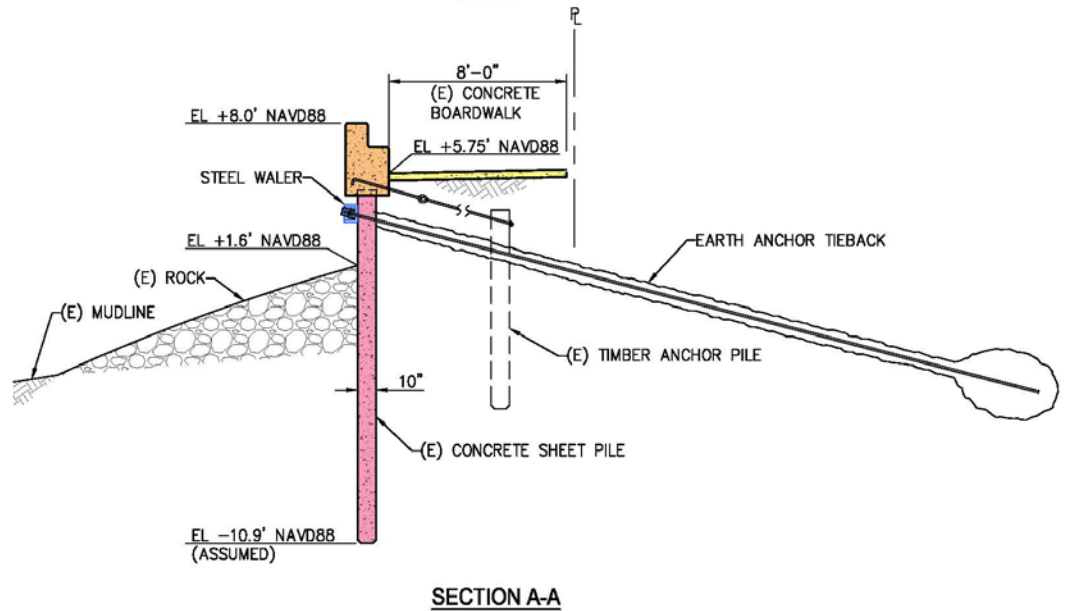
### Retrofit Option - West End

# Retrofit option for the West End:

## Beam Sections with Anchors

## Beam Segments/Anchors at West End: Concerns

- The success of this retrofit using beam segments/anchors is dependent upon the structural integrity of the concrete piles (West End). Testing required.

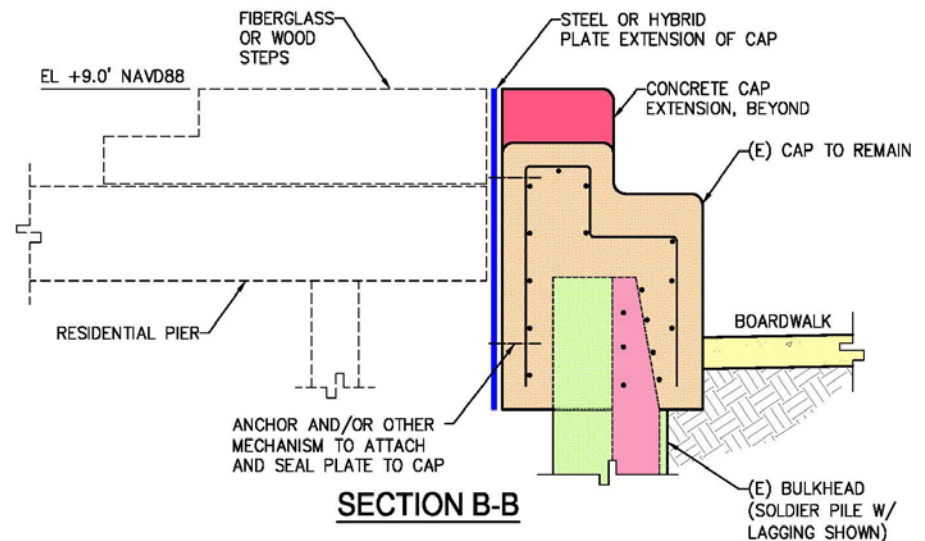
**DETAIL A - CONCEPT**  
(Steps Over Cap Extensions)

# Proposed Steps Over Extended Cap
