Harbor Commission

A Presentation on Newport Harbor's Base Flood Elevation (BFE) & Balboa Island Sea Wall Height

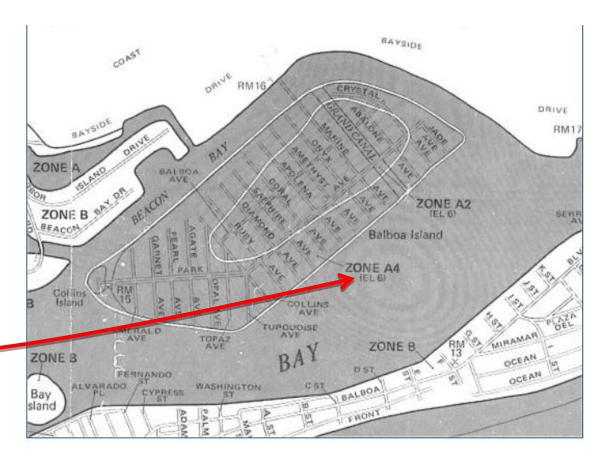
1978 The FIRM showed a Base Flood

Elevation of 6.0' NGVD29.

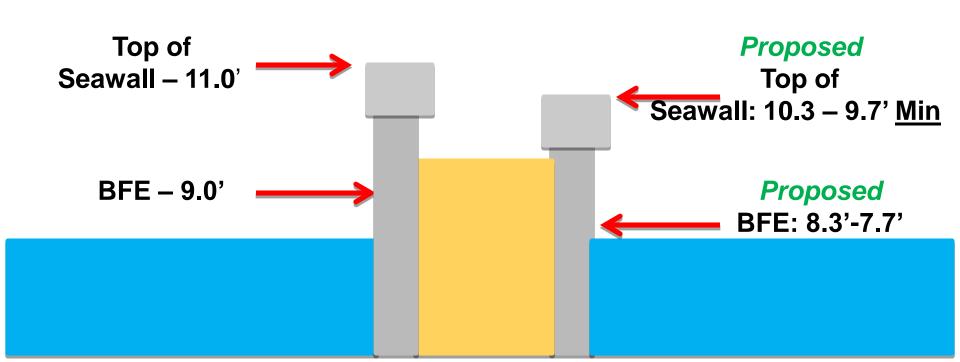
Seawall Height

To be considered as a coastal levee, a
 2-foot freeboard is required on the seawall.

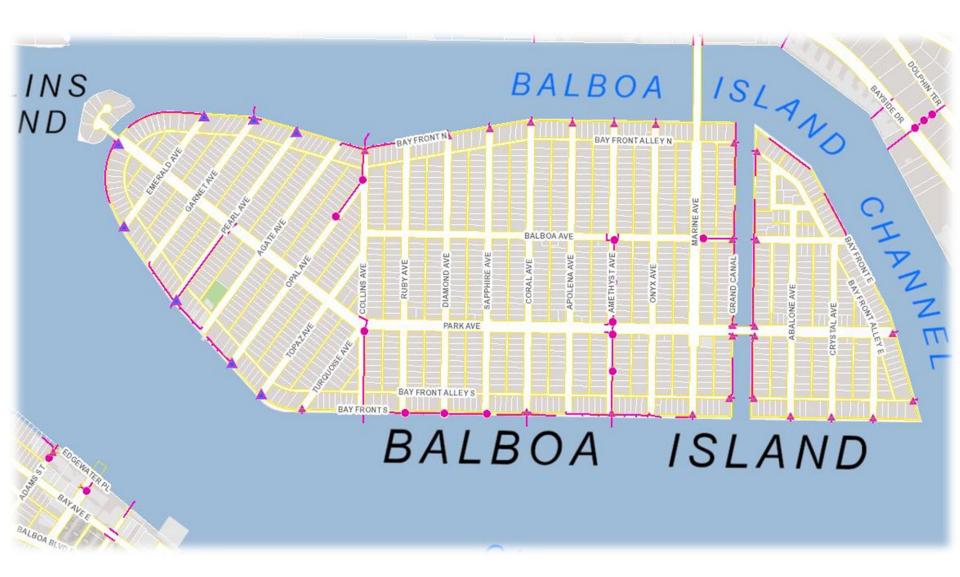
Existing Drainage System on Balboa Island

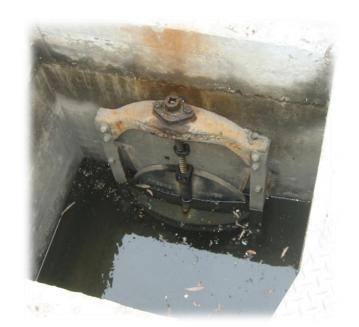
Tide Valves

Protects the Island from Flooding due to High Tides Currently Manually Operated

Manually Operated Up/Down Switch

Power Assisted with

Manually Operated with Valve Key

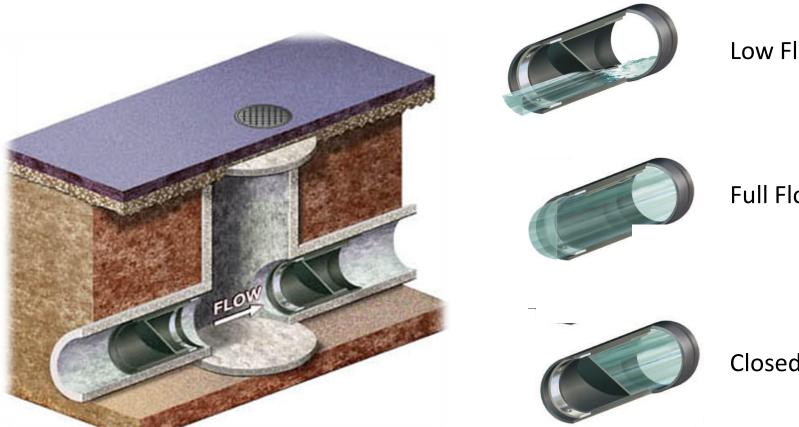
New Rubber Tide Valve (Check Valve)

- No Moving Mechanical Parts Silent, Non-Slamming
- ➤ Non-Corrosive Durable Rubber Construction
- Minimal Maintenance and Periodic Inspection Needed
- > Around 1" of Water Pressure Opens Valve helping Eliminate Standing Water
- Simple Installation. Estimated 25-Year Life

Low Flow Open

Full Flow Open

Closed Against Tide

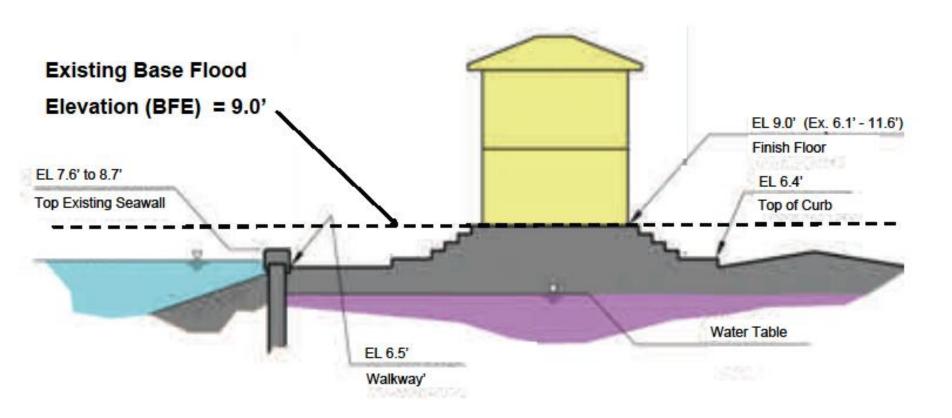
Existing Island Seawall and Flood Protection Conditions

- Existing FEMA Base Flood Elevation = 9.0' (NAVD 88)
- Finish Floor's at or above 9.0' will pay a lower Flood Insurance Rate.
- Finish Floor's below 9.0' will pay a higher Flood Insurance rate...

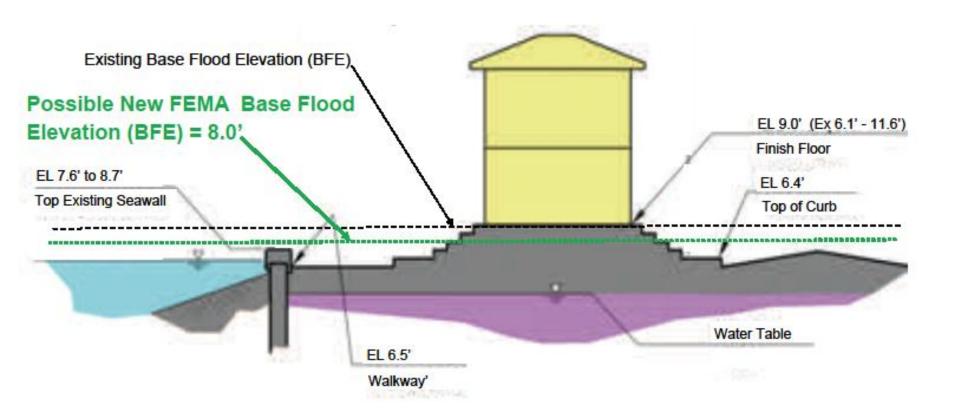
Existing Island Seawall and New FEMA Base Flood Elevation

- Possible New FEMA Base Flood Elevation = 8.0' (NAVD 88)
- Requires Letter of Map Revision (LOMR) by FEMA
- Finish Floor's at or above 8.0' will pay a lower Flood Insurance Rate.
- Finish Floor's below 8.0' will pay a higher Flood Insurance Rate.

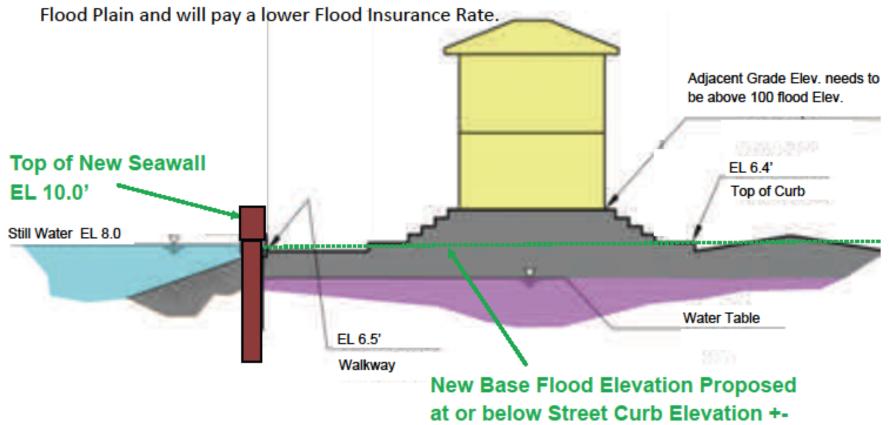
Proposed New FEMA Certified Island Seawall with Drainage System That would provide 100 Year Storm Protection

- ◆ Island Removed from prior FEMA Flood Plain with Seawall Elev. = 10.0' (Stillwater Elev. of 8.0' + 2.0' of Freeboard)
- ◆ Base Flood Elevation Determined by Drainage System—100 Year Storm Water Elevation.

♦ Adjacent Grade of Structure must be above 100 Year Storm Water Elevation to be out of the

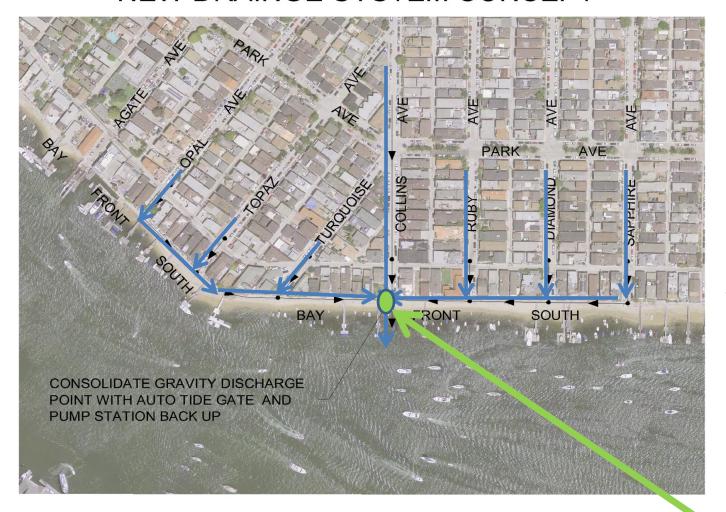
NEW DRAINGE SYSTEM CONCEPT

- ➤ Reduce Number of Discharge Points
- ➤ Automate Tide Values
- Provide High Water Pump-Out Capacity

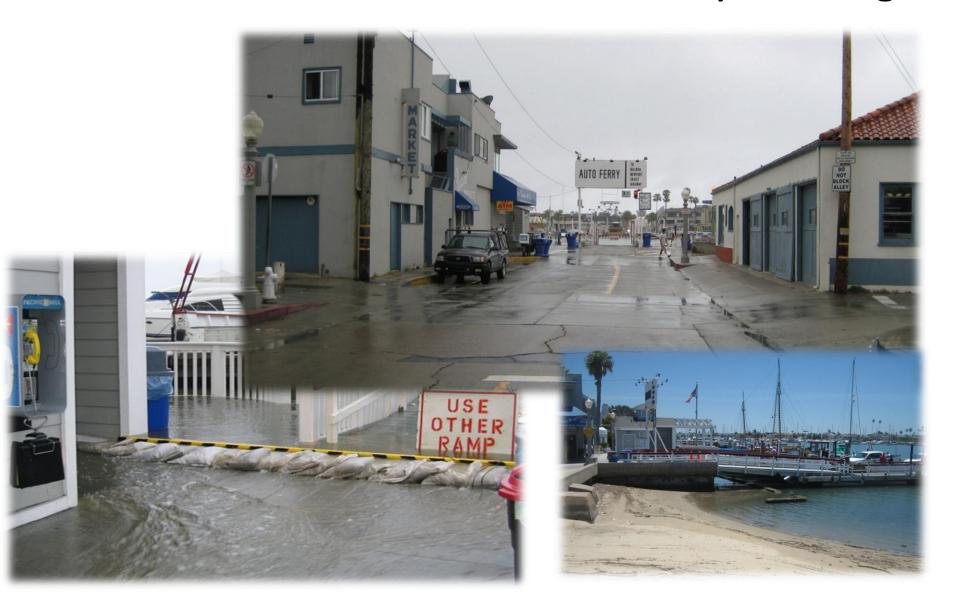
Sub-Terrain Storm Water Pump Station

Will also Need to Develop Acceptable Flood Proof Solution for Ferry Landing
